APPENDIX C USACE Routine Wetland Determination Forms & TRC's Stream Inventory Data Forms

Project/Site: Excelsior	City/County: Byron, Genesee County	Sampling Date: 2019-June-17
Applicant/Owner: Excelsior	State: Ne	w York Sampling Point: W-WSH-01_PEM-1
Investigator(s): Weston Hillegas, Isaac Pallant	Section, Township	, Range:
Landform (hillslope, terrace, etc.): Depression	Local relief (concave, con	vex, none): Concave Slope (%): 0 to 1
Subregion (LRR or MLRA): LRR L	Lat: 43.0428935	Long: -78.0403443 Datum: WGS84
Soil Map Unit Name: Lima silt loam, 0 to 3 perce	nt slopes (LmA)	NWI classification: None
Are climatic/hydrologic conditions on the site typical	-	o <u>✓</u> (If no, explain in Remarks.)
		al Circumstances" present? Yes No
Are Vegetation, Soil, or Hydrology _	naturally problematic? (If needed	, explain any answers in Remarks.)
SUMMARY OF FINDINGS – Attach site map	showing sampling point locations, tra	nsects, important features, etc.
Hydrophytic Vegetation Present? Yes _	✓_ No	
Hydric Soil Present? Yes _	✓ No Is the Sampled Area with	in a Wetland? Yes _✓_ No

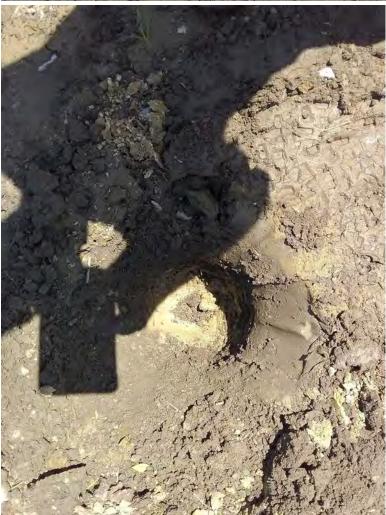
Soil Photos

Profile Des	cription: (Describe Matrix	to the d	epth needed to d			indicator	or confirm the	absence of indicato	ors.)
(inches)	Color (moist)	%	Color (moist)		Type ¹	l oc²	Τρ	xture	Remarks
0 - 12	7.5YR 2.5/1	100	Color (ITIOISE)		Турс			lay Loam	Remarks
12 - 20	10YR 5/2	80	10YR 5/6	20					
12 - 20	1018 3/2	80	1018 3/0	20			Clay	/ Loam	
				· —

Dark Su	ırface (S7) (LRR R, I	MLRA 14	9B)					Other (Expla	
								•	
3Indicators	of hydrophytic veg	getation	and wetland hyd	rology	/ must be	e presen	t, unless disturl	bed or problematic.	
Restrictive	Layer (if observed)):							
	Type:		None	-		Hydric	Soil Present?		Yes No
	Depth (inches):								
Remarks:									
The second second se	6								
The criterio	on for hydric soil is	met.

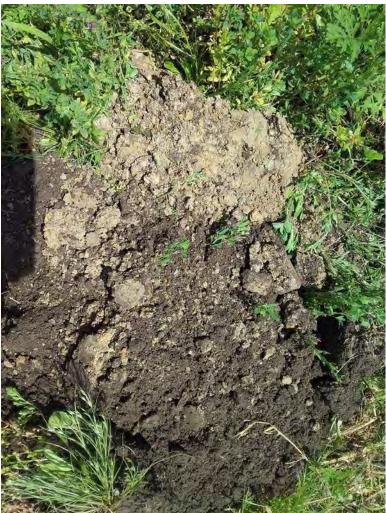
Soil Photos

Profile Des	cription: (Describe Matrix	to the d	epth needed to d			indicato	or confirm the	absence of indicator	rs.)
(inches)	Color (moist)	%	Color (moist)		Type ¹	Loc2	Te	exture	Remarks
0 - 12	10YR 4/1	100	Color (ITIOISC)		Турс			Clay Loam	Remarks
12 - 20	7.5YR 6/1	80	7.5YR 5/6	20					
12 - 20	7.518 0/1	80	7.518 5/0	20			Cla	y Loam	
								_	
¹Tvpe: C = (Concentration, D =	Depleti	on. RM = Reduced	d Matr	ix. MS =	Masked	Sand Grains.	² Location: PL = Pore	Lining, M = Matrix.
Hydric Soil			,		,				oblematic Hydric Soils ³ :
Histoso			Polyvalue Be	low S	urface (S	(8) (I RR I	R MIRA 149R)		•
	oipedon (A2)		Thin Dark Su						10) (LRR K, L, MLRA 149B)
	istic (A3)		Loamy Muck						Redox (A16) (LRR K, L, R)
	en Sulfide (A4)		Loamy Gleye	•		(=::::,	-,		Peat or Peat (S3) (LRR K, L, R)
	d Layers (A5)		Depleted Ma					Dark Surface	
	d Below Dark Surf	ace (A11							low Surface (S8) (LRR K, L)
Thick Da	ark Surface (A12)		Depleted Da	rk Sur	face (F7))			rface (S9) (LRR K, L) ese Masses (F12) (LRR K, L, R)

Sandy N	/lucky Mineral (S1)		Redox Depre	ession	ıs (F8)				
Sandy 0	Gleyed Matrix (S4)								oodplain Soils (F19) (MLRA 149B) : (TA6) (MLRA 144A, 145, 149B)
Sandy F	Redox (S5)								
Strippe	d Matrix (S6)							Red Parent M	Dark Surface (TF12)
Dark Su	ırface (S7) (LRR R, I	MLRA 14	9B)					Other (Explai	
									II III Keiliai ks)
3Indicators	of hydrophytic veg	getation	and wetland hyd	rology	/ must b	e preser	t, unless distur	bed or problematic.	
Restrictive	Layer (if observed)):							
	Type:		None	-		Hydric	Soil Present?		Yes No/_
	Depth (inches):								
Remarks:									
NI iti	in diameter of break								
No positive	indication of hydr	TIC SOIIS V	vas observed.

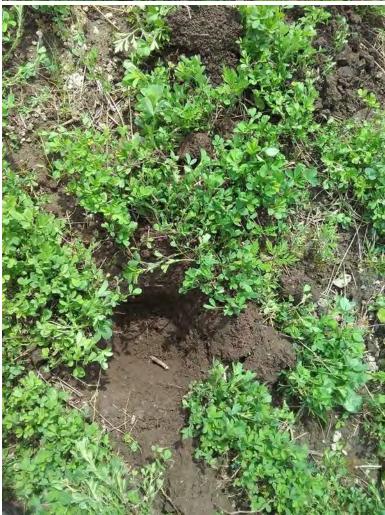
Soil Photos

0 - 12	Color (moist)	%	Color (moist)	%	Type ¹	Loc2	Texture	Remarks
0-12	10YR 2/1	100		_			Silt Loam	
				_				
				_				
				_				
				_				
				_				
ype: C = C	oncentration, D =	 Depletion	, RM = Reduced	 Matr	rix, MS =	Masked S	Sand Grains. ² Lo	ocation: PL = Pore Lining, M = Matrix.
dric Soil I	ndicators:							Indicators for Problematic Hydric Soils ³ :
Black His Hydroge Stratified Depleted Thick Da Sandy M Sandy G Sandy Re Stripped Dark Sur	ipedon (A2) stic (A3) n Sulfide (A4) I Layers (A5) I Below Dark Surfark Surface (A12) ucky Mineral (S1) leyed Matrix (S4) edox (S5) Matrix (S6) fface (S7) (LRR R, M	 ace (A11)_ _ _ _ _ _ _ _ _ _	Depleted Dar Redox Depre:	face Mind Mar rix (F urfact k Sur ssion	(S9) (LRR eral (F1) trix (F2) F3) ce (F6) rface (F7) is (F8)	R, MLRA	149B)	2 cm Muck (A10) (LRR K, L, MLRA 149B) Coast Prairie Redox (A16) (LRR K, L, R) 5 cm Mucky Peat or Peat (S3) (LRR K, L, R) Dark Surface (S7) (LRR K, L) Polyvalue Below Surface (S8) (LRR K, L) Thin Dark Surface (S9) (LRR K, L) Iron-Manganese Masses (F12) (LRR K, L, R) Piedmont Floodplain Soils (F19) (MLRA 149B) Mesic Spodic (TA6) (MLRA 144A, 145, 149B) Red Parent Material (F21) Very Shallow Dark Surface (TF12) Other (Explain in Remarks)

of hydrophytic veg		nd wetland hydr	ology	y must be	e present	unless disturbe	d or problematic.
Strictive L	ayer (if observed): Type:		avel layer			Hydric 9	oil Present?	Yes No ∠ _
	iype.	u	averiayer			liyunc	on resent:	163 140 <u></u>
	Depth (inches):		12

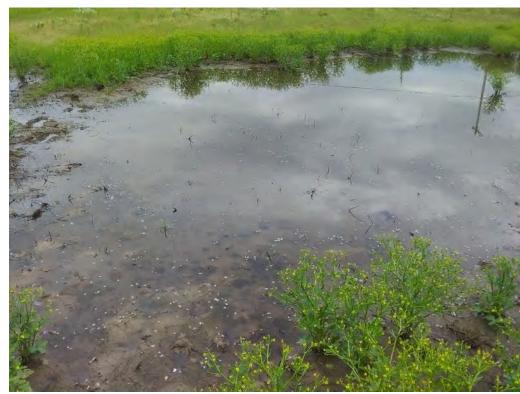
Hydrology Photos

Hydrophytic Vegetation Present?	? Yes No						
Hydric Soil Present?	Yes No	Is the Sampled Area withi	in a Wetland?	Yes _,	No		
Wetland Hydrology Present?	Yes ∠ _ No	If yes, optional Wetland S	ite ID:	W-WS	H-03		
	ocedures here or in a separate repor			·			
	nd, all three wetland parameters are p		TO VOOR				
Covertype is PEM. Area is wellan	u, all three wetland parameters are p	oresent. Wetter than averag	ge year.				
HYDROLOGY							
IIIDKOLOGI							
Wetland Hydrology Indicators:					_		
Primary Indicators (minimum of	one is required; check all that apply)		-	icators (minimum of	f two required)		
∕ Surface Water (A1)	Water-Stained Le	aves (B9)		il Cracks (B6)			
High Water Table (A2)	Aquatic Fauna (B		Drainage Patterns (B10)				
Saturation (A3)	Marl Deposits (B1		Moss Trim Lines (B16)				
Water Marks (B1)	Hydrogen Sulfide		Dry-Season Water Table (C2) Crayfish Burrows (C8)				
Sediment Deposits (B2)	<u></u> Oxidized Rhizosp	heres on Living Roots (C3)	-	urrows (C8) Visible on Aerial Imagery (C9)

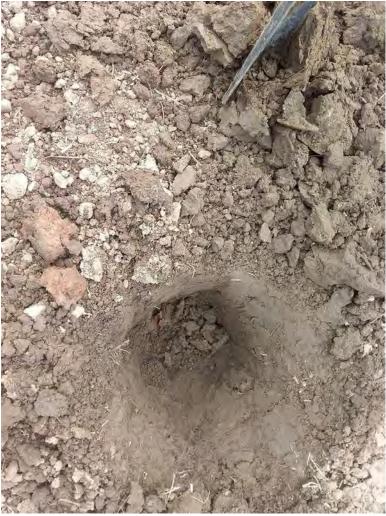
Soil Photos

inches)	Color (moist)	%	Color (moist)	%	Type ¹	Loc ²	Texture	Remarks
0 - 12	10YR 3/2	100		_			Silt Loam	
12 - 18	7.5YR 5/3	100		_			Clay	
				_				
·		 -		_				
				_				
		· —		_				
				_				
		· —		_				
·		 -		_				
	oncentration, D =	Depletio	n, RM = Reduced	Mati	rix, MS =	Masked S	Sand Grains. ² Lo	ocation: PL = Pore Lining, M = Matrix.
	ndicators:			_		a		Indicators for Problematic Hydric Soils ³ :
_ Histosol			Polyvalue Bel		-		•	2 cm Muck (A10) (LRR K, L, MLRA 149B)
_ Histic Ep _ Black His	ipedon (A2)		Thin Dark Sur Loamy Mucky					Coast Prairie Redox (A16) (LRR K, L, R)
	n Sulfide (A4)		Loamy Gleyed			(LIXIX IX, L)		5 cm Mucky Peat or Peat (S3) (LRR K, L, R)
	d Layers (A5)		Depleted Mat					Dark Surface (S7) (LRR K, L)
	d Below Dark Surfa	ace (A11)						Polyvalue Below Surface (S8) (LRR K, L)
	rk Surface (A12)		Depleted Dar					Thin Dark Surface (S9) (LRR K, L)
	ucky Mineral (S1)		Redox Depres					Iron-Manganese Masses (F12) (LRR K, L, R)

leyed Matrix (S4)		•					Piedmont Floodplain Soils (F19) (MLRA 149B)
	edox (S5)							Mesic Spodic (TA6) (MLRA 144A, 145, 149B)
	Matrix (S6)							Red Parent Material (F21)
	face (S7) (LRR R, N	/II RA 149	9R)					Very Shallow Dark Surface (TF12)
_ Dark Sai	idee (57) (ERR II, II	ILIU (I T.	,,,					Other (Explain in Remarks)
	of hydrophytic veg		and wetland hydr	olog	y must be	e present I	, unless disturbe	d or problematic.
	ayer (if observed):		None			Lludric (ail Dracant?	Voc. No. (
	Type:		None			Hyaric	Soil Present?	Yes No⁄_
	Depth (inches):							
marks:								
positive	indication of hydri	ic soils w	as observed.

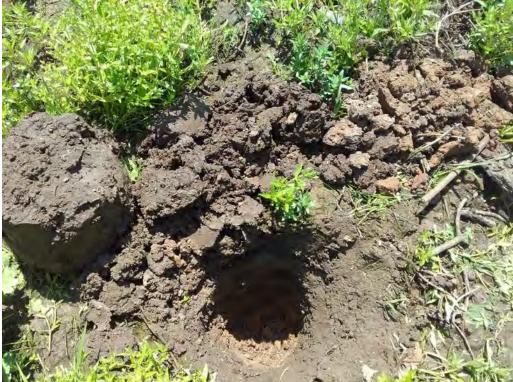
Soil Photos

Profile Deso	cription: (Describe Matrix	to the d	lepth needed to d			ndicato	or confirm the al	bsence of indicato	ors.)
(inches)	Color (moist)	%	Color (moist)	% %	Type ¹	Loc ²	Text	ure	Remarks
0 - 11	10YR 3/2	100	Color (Inolst)		<u> </u>		Silty Clay		Kemarko
11 - 20	10YR 5/2	75	7.5YR 5/6	25			Cla

-	Gleyed Matrix (S4)								c (TA6) (MLRA 144A, 145, 149B)
-	Redox (S5)							Red Parent N	
	d Matrix (S6)								v Dark Surface (TF12)
Dark Su	rface (S7) (LRR R, l	MLRA 14	9B)					Other (Expla	
3Indicators	of hydrophytic ve	getation	and wetland hyd	rology	/ must be	e preser	it, unless disturbe	d or problematic.	
Restrictive	Layer (if observed)):						·	
	Type:		None			Hydric	Soil Present?	,	Yes No
	Depth (inches):			-					
Remarks:									
	ndication of hydric	soil was	s observed.						
71 positive ii	idication of flyant	. Jon wa.	observed.

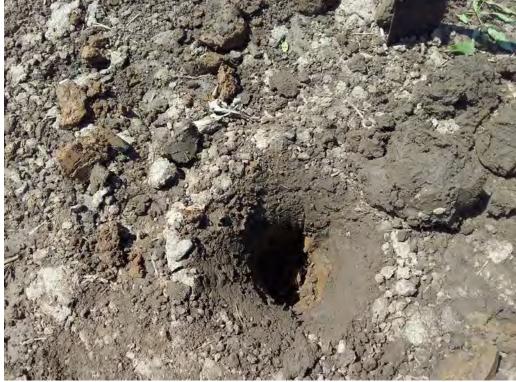
Soil Photos

Profile Des Depth	cription: (Describe Matrix	to the c	lepth needed to o Redox			indicato	r or confirm the a	bsence of in	dicators.)
(inches)	Color (moist)		Color (moist)	%	Type ¹	Loc ²	Texture	e	Remarks
0 - 14	10YR 3/2	100			5 -5		Clay Loa		-
14 - 20	10YR 4/1	50	7.5YR 5/8	50		M	Clay Loa		
20 -				_					
¹Type: C = 0	Concentration, D =	Depleti	on, RM = Reduced	d Mat	rix, MS =	Masked	Sand Grains. ² L	ocation: PL =	Pore Lining, M = Matrix.
Hydric Soil	Indicators:			_				Indicators	for Problematic Hydric Soils³:
Histoso			•				R, MLRA 149B)	2 cm N	luck (A10) (LRR K, L, MLRA 149B)
	pipedon (A2)		Thin Dark Su					Coast F	Prairie Redox (A16) (LRR K, L, R)
	istic (A3)		Loamy Muck			(LRR K,	L)	5 cm N	lucky Peat or Peat (S3) (LRR K, L, R)
	en Sulfide (A4) ed Layers (A5)		Loamy Gleye Depleted Ma						urface (S7) (LRR K, L)
	ed Below Dark Surf	face (A1						-	ue Below Surface (S8) (LRR K, L)
	ark Surface (A12)		Depleted Da)			ark Surface (S9) (LRR K, L)

Sandy N	Mucky Mineral (S1))	Redox Depre	essior	ıs (F8)				anganese Masses (F12) (LRR K, L, R)
Sandy (Gleyed Matrix (S4)								ont Floodplain Soils (F19) (MLRA 149B) Spodic (TA6) (MLRA 144A, 145, 149B)
Sandy F	Redox (S5)								rent Material (F21)
Strippe	d Matrix (S6)								nallow Dark Surface (TF12)
Dark Su	urface (S7) (LRR R, I	MLRA 14	19B)					-	Explain in Remarks)
3Indicators	of hydrophytic ve	getation	and wetland hvd	rolog	v must h	e nreser	nt unless disturbe	ed or probler	natic
	Layer (if observed)	_	and Welland nya	10106	y mase b	Preser	it, amess astarbe	ed of problet	nacic.
	Type:	,-	None			Hvdric	Soil Present?		Yes No/_
	Depth (inches):					•			
Remarks:						ı			•
No positive	indication of hydi	ric soils v	was observed.						
Ī									
1									
Ì

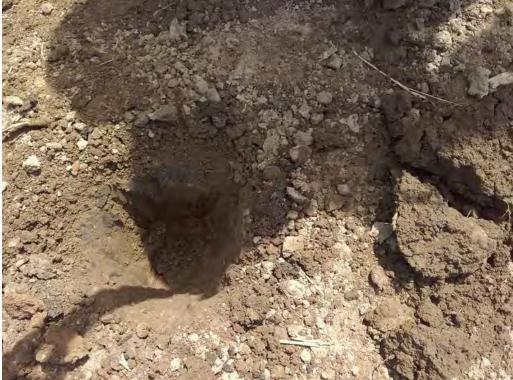
Soil Photos

0 - 12	Color (moist)	%	Color (moist)	%	Type ¹	Loc ²	Texture	Remarks
0 12	7.5YR 4/4	100					Silt Loan	1
12 - 20	10YR 6/4	100					Clay Loar	m
				_				
		· — ·		_				
		· — ·		_				
				_				
				_				
				_				
		· — ·		_				
				_				
ype: C = C	oncentration, D =	Depletio	n, RM = Reduced	Mati	rix, MS =	Masked S	Sand Grains. ² Lo	ocation: PL = Pore Lining, M = Matrix.
dric Soil I	ndicators:							Indicators for Problematic Hydric Soils ³ :
_ Histosol			Polyvalue Bel		-		•	2 cm Muck (A10) (LRR K, L, MLRA 149B)
_ Histic Ep _ Black Hi:	oipedon (A2)		Thin Dark Sur Loamy Mucky				·='	Coast Prairie Redox (A16) (LRR K, L, R)
	en Sulfide (A4)		Loamy Gleyed			(LKK K, L)		5 cm Mucky Peat or Peat (S3) (LRR K, L, R)
	d Layers (A5)		Depleted Mat					Dark Surface (S7) (LRR K, L)
	d Below Dark Surfa		'	-	•			Polyvalue Below Surface (S8) (LRR K, L)
_ Thick Da	irk Surface (A12)		Depleted Dar	k Sui	face (F7)			Thin Dark Surface (S9) (LRR K, L) Iron-Manganese Masses (F12) (LRR K, L, R)

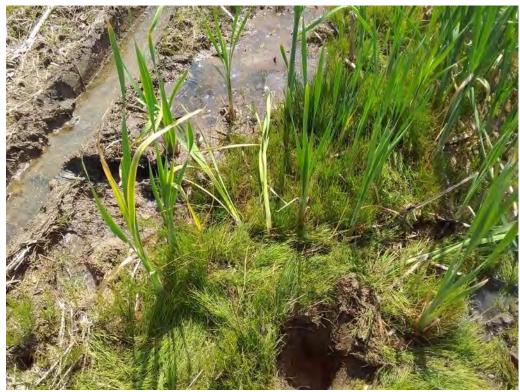
Hydrology Photos

Hydrophytic Vegetation Presen	t? Yes No			
Hydric Soil Present?	Yes No	Is the Sampled Area within a	Wetland?	Yes/_ No
Wetland Hydrology Present?	Yes _ ∠ _ No	If yes, optional Wetland Site	D:	W-WSH-05
Remarks: (Explain alternative p	rocedures here or in a separate rep	ort)		
	·			
Covertype is PEM. Area is wetla	nd, all three wetland parameters ar	e present. Wetter than average y	ear.	
HADBOLOCA				
HYDROLOGY				
Wetland Hydrology Indicators:				
	f one is required; check all that app	lv) So	condary Indicators (min	imum of two required)
Frimary indicators (minimum o				•
⁄ Surface Water (A1)	Water-Stained	Leaves (D5)	Surface Soil Cracks (B6	•
High Water Table (A2)	Aquatic Fauna		Drainage Patterns (B10	J)
✓ Saturation (A3)	Marl Deposits	(613)	_ Moss Trim Lines (B16) _ Dry-Season Water Tabl	lo (C2)
Water Marks (B1)	Hydrogen Sulfi	de Odor (C1) —		ie (C2)
Sediment Deposits (B2)	Oxidized Rhizo	spheres on Living Roots (C3) —	Saturation Visible on A	erial Imagen/(C9)

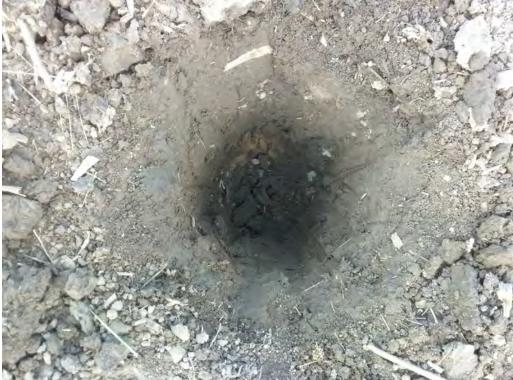
Soil Photos

Profile Des	cription: (Describe Matrix	to the de	epth needed to de			indicato	or confirm the al	bsence of indicator	rs.)
(inches)	Color (moist)	<u></u> %	Color (moist)	%	Type ¹	Loc ²	Text	ure	Remarks
0 - 12	10YR 3/2	100	Color (moist)	70	Турс		Silty Clay Loam		Remarks
12 - 20	7.5YR 4/6	100		_			Clay		
12 20	7.511(4/0	100		_					
			_	_					
				_					
				_					
				_

Dark Su	rface (S7) (LRR R, N	MLRA 14 9	9B)					Other (Explai	
3Indicators	of hydrophytic veg	otation :	and watland bydr	مامھ	, must b	n nrocon	t unlace dieturba	•	,
	Layer (if observed)		and Welland Hydr	ology	y must be	preser	it, uriless disturbe	d of problematic.	
	Type:		None			Hvdric	Soil Present?		Yes No/_
	Depth (inches):					, ,			
Remarks:	Depart (interies).								
The criterio	n for hydric soil is	not met.	Active Ag field.

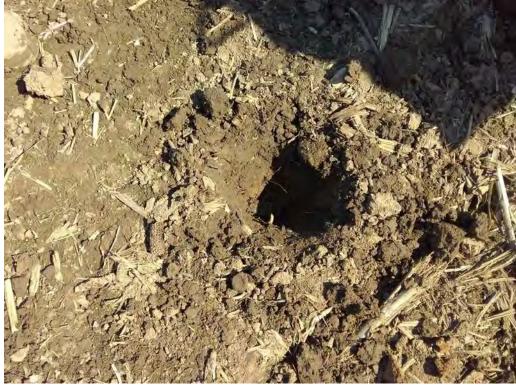
Soil Photos

· · · -	Matrix		Redox	Feat				osence of indicators.)
(inches)	Color (moist)	<u>%</u>	Color (moist)	<u>%</u>	Type ¹	Loc²	Texture	Remarks
0 - 12	10YR 3/3	100		_			Clay Loar	m
12 - 20	5YR 4/6	100		_			Clay	
				_				
				_				
				_

-	Gleyed Matrix (S4) Redox (S5)							Mesic Spodic (TA6) (MLRA 144A, 145, 149B)
-	d Matrix (S6)							Red Parent Material (F21)
	rface (S7) (LRR R, N	/II RA 149	9R)					Very Shallow Dark Surface (TF12)
bank sa	ridee (37) (Eracity ii		,,,					Other (Explain in Remarks)
	of hydrophytic veg		and wetland hydr	olog	y must be	preser	t, unless disturbe	d or problematic.
Restrictive	Layer (if observed):							
	Type:		None			Hydric	Soil Present?	Yes No <u>_</u> ✓
	Depth (inches):							
temarks:								
√o positive	indication of hydr	ic soils w	as observed. Acti	ve til	led Ag fie	eld.

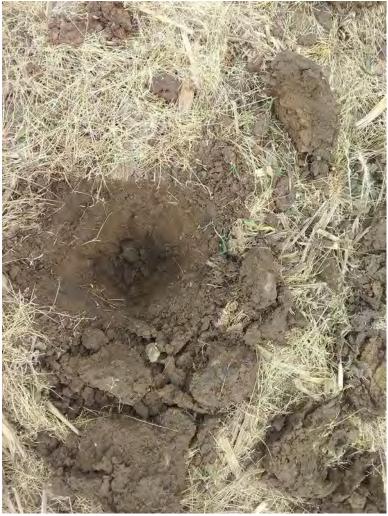
Soil Photos

Profile Deso	cription: (Describe Matrix	to the de	epth needed to de Redox			indicato	or confirm the al	osence of indicator	rs.)
(inches)	Color (moist)	%	Color (moist)	%	Type ¹	Loc ²	Text	ure	Remarks
0 - 12	10YR 4/3	100			.,,,,,		Silty Cla		The state of the state of the state of the state of the state of the state of the state of the state of the state of the state of the state of the state of the state of the state of the state of the state of the state of the state of the state of the state of the state of the state of the state of the state of the state of the state of the state of the state of the state of the state of the state of the state of the state of the state of the state of the state of the state of the state of the state of the state of the state of the state of the state of the state of the state of the state of the state of the state of the state of the state of the state of the state of the state of the state of the state of the state of the state of the state of the state of the state of the state of the state of the state of the state of the state of the state of the state of the state of the state of the state of the state of the state of the state of the state of the state of the state of the state of the state of the state of the state of the state of the state of the state of the state of the state of the state of the state of the state of the state of the state of the state of the state of the state of the state of the state of the state of the state of the state of the state of the state of the state of the state of the state of the state of the state of the state of the state of the state of the state of the state of the state of the state of the state of the state of the state of the state of the state of the state of the state of the state of the state of the state of the state of the state of the state of the state of the state of the state of the state of the state of the state of the state of the state of the state of the state of the state of the state of the state of the state of the state of the state of the state of the state of the state of the state of the state of the state of the state of the state of the state of the state of the state of the state of the state of the state of the state of the state of the s

-	Redox (S5)								(TA6) (MLRA 144A, 145, 149B)
-	d Matrix (S6)							Red Parent M	
	rface (S7) (LRR R, N	/LRA 149	9B)					Other (Explai	Dark Surface (TF12)
21 1: .	61 1 1							•	THI Kellulks)
	of hydrophytic veg		and wetland hydr	ology	/ must be	e preser I	t, unless disturbe	d or problematic.	
	Layer (if observed)	•	None			Lludric	Cail Bracant?		Voc. No. (
	Type:		None			пуштс	Soil Present?		Yes No/_
	Depth (inches):								
Remarks: No positive	indication of hydr	ic soils w	vas observed.						
positive	a.cat.o oya.	555	as observed.

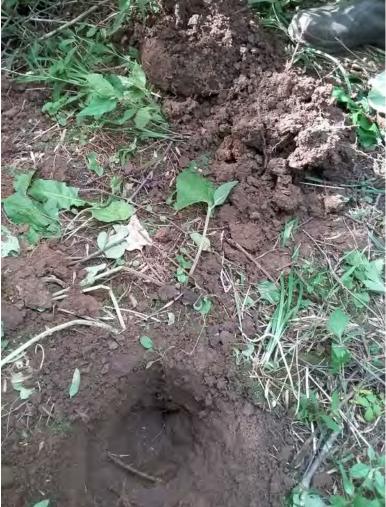
Soil Photos

Profile Des	cription: (Describe Matrix	to the de	epth needed to do Redox			indicato	r or confirm the a	absence of ind	licators.)
						12	Taratum	_	Domonika
(inches)	Color (moist)	<u>%</u>	Color (moist)	9/0	Type ¹	Loc ²	Textur		Remarks
0 - 20	7.5YR 4/4	100		_			Clay Loa	am	
				_					
						,			_
				_					
				_					
		· ·		_					_
				_				 -	
				_					
				_				 -	
				_					
¹Type: C = 0	Concentration, D =	Depletio	n, RM = Reduced	Mati	rix, MS =	Masked	Sand Grains. 2	Location: PL =	Pore Lining, M = Matrix.
Hydric Soil	Indicators:							Indicators f	or Problematic Hydric Soils³:
Histoso	(A1)		Polyvalue Bel	ow S	urface (S	8) (LRR I	R, MLRA 149B)	2 cm Mı	uck (A10) (LRR K, L, MLRA 149B)
Histic Epipedon (A2) Thin Dark Surface (S9) (LRR R, M									rairie Redox (A16) (LRR K, L, R)
Black Histic (A3) Loamy Mucky Mineral (F1) (LRR K, L)							L)		ucky Peat or Peat (S3) (LRR K, L, R)
, ,	en Sulfide (A4)		Loamy Gleyed						ırface (S7) (LRR K, L)

-			and wettand nyur	olog	y must b	e preser	it, uriless disturb	ed of problem	latic.
	Layer (if observed):		Niere			l la calacta	C-: D	,	Van Na V
	Type:		None			Hyaric	Soil Present?	,	Yes No/_
	Depth (inches):								
Remarks:									
The criterio	n for hydric soil is	not met.

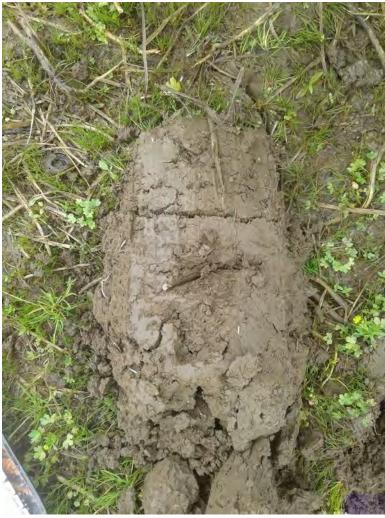
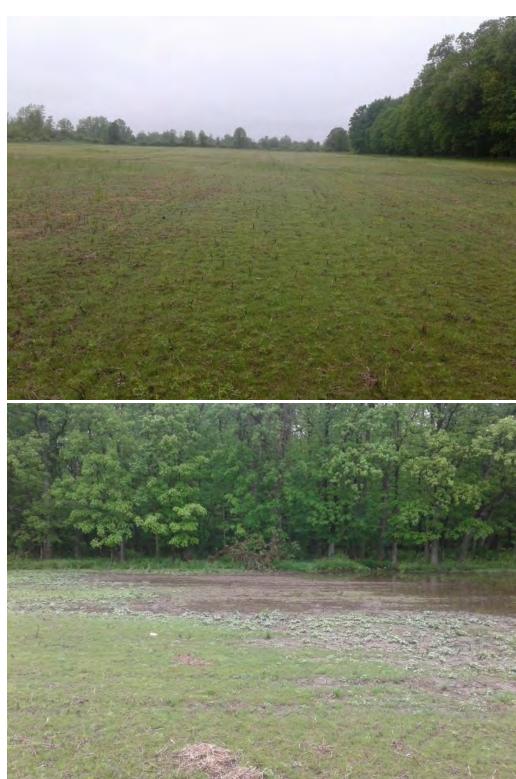
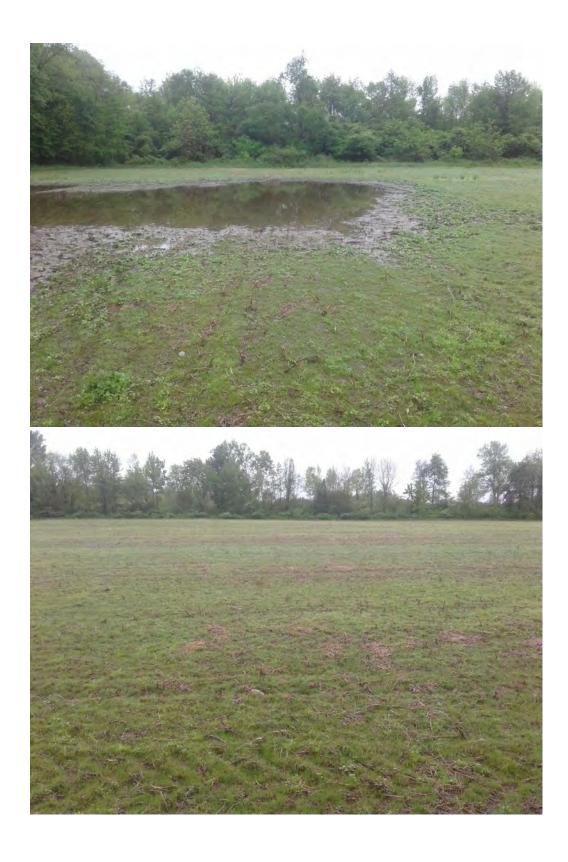
Soil Photos

cription: (Describe	to the de	epth needed to d	ocun	ent the	indicato	r or confirm the al	osence o	f indicators.)
Depth	Matrix		Redox	Feat	ures				
(inches)	Color (moist)	%	Color (moist)	%	Type ¹	Loc ²	Texture		Remarks
0 - 20	10YR 5/4	100					Silty Clay		
				_					
				_					
				_					
				_					
				_			_		
				_					-
				_			-		
 .				. 		 .			
	Concentration, D =	Depletio	n, RM = Reduced	Mati	rix, MS =	Masked	Sand Grains. ² Lo		PL = Pore Lining, M = Matrix.
Hydric Soil								Indicate	ors for Problematic Hydric Soils³:
Histosol	` '						R, MLRA 149B)	2 cr	n Muck (A10) (LRR K, L, MLRA 149B)
Histic Ep	oipedon (A2)		Thin Dark Su	rface	(S9) (LRF	RR, MLR	A 149B)		st Prairie Redox (A16) (LRR K, L, R)
Black Hi	Black Histic (A3) Loamy Mucky Mineral (F1) (LRR K, L)				L)		n Mucky Peat or Peat (S3) (LRR K, L, R)		
Hydroge	Hydrogen Sulfide (A4) Loamy Gleyed Matrix (F2)								k Surface (S7) (LRR K, L)
	d Layers (A5)		Depleted Ma						value Below Surface (S8) (LRR K, L)

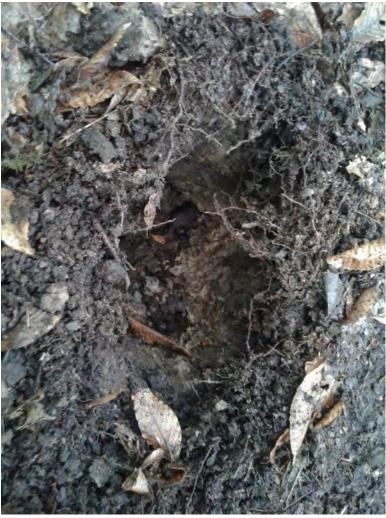
Soil Photos

cription: (Describe	to the d	•			indicato	r or confirm the	e absence of inc	dicators.)	
Depth	Matrix		Redox				_			
(inches)	Color (moist)		Color (moist)	<u>%</u>	Type ¹	Loc ²	Text		Remarks	
0 - 3	10YR 3/2	100		_			Clay L	oam		
3 - 20	2.5Y 6/3	100		_			Clay L	oam		
				_						
				_						
				_						
				_						
				_						
				_						
				_						
				_						
1Type: C = 0	Oncentration D =	 Depletic	n RM = Reduced	 Mat	rix MS =	Masked	Sand Grains	²l ocation: Pl =	Pore Lining, M = Matrix.	
Hydric Soil		Depictio	ni, Kivi Kedacea	iviac	112, 1415	Maskea	Sana Grains.		for Problematic Hydric Soils ³ :	
Histoso			Polyvalue Bel	۰،۰۰۰	iurfaca (S	מם ו) (2)	D MIDA 140DV		•	
	oipedon (A2)		Polyvalue Bei						uck (A10) (LRR K, L, MLRA 149B)	
	istic (A3)		Loamy Mucky						rairie Redox (A16) (LRR K, L, R)	
	en Sulfide (A4)		Loamy Gleye			(LIXIX IX,	- ,		ucky Peat or Peat (S3) (LRR K, L, R)	
	d Layers (A5)		Depleted Mat						urface (S7) (LRR K, L)

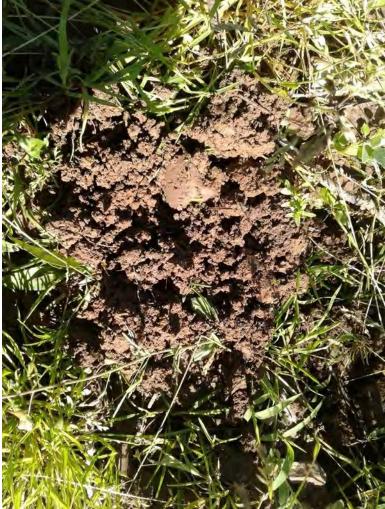
Soil Photos

-	to the de	-			indicato	r or confirm the a	absence of indicators.)
Depth _	Matrix		Redox					
(inches)	Color (moist)	<u> %</u>	Color (moist)	<u>%</u>	Type ¹	Loc²	Texture	
0 - 6	10YR 4/4	100		_			Silt Loar	n
				_				
				_				
		· ·		_				
		· ·		_				
		· ·		_				
				_				
				_				
				_				
¹Type: C = C	Concentration, D =	Depletio	n, RM = Reduced	Mati	rix, MS =	Masked	Sand Grains. 2l	Location: PL = Pore Lining, M = Matrix.
Hydric Soil	Indicators:				· · · · · ·			Indicators for Problematic Hydric Soils ³ :
Histosol			Polyvalue Bel	ow S	urface (S	8) (LRR	R, MLRA 149B)	2 cm Muck (A10) (LRR K, L, MLRA 149B)
	oipedon (A2)		Thin Dark Sur					2 cff Muck (A10) (LRR K, L, MLRA 1498) Coast Prairie Redox (A16) (LRR K, L, R)
Black Histic (A3) Loamy Mucky Mineral (F1) (LRR K, L)						5 cm Mucky Peat or Peat (S3) (LRR K, L, R)		
Hydroge	en Sulfide (A4)		Loamy Gleyed	d Ma	trix (F2)			Dark Surface (S7) (LRR K, L)
Stratifie	d Layers (A5)		Depleted Mat	rix (f	- 3)			Polyvalue Below Surface (S8) (LRR K, L)

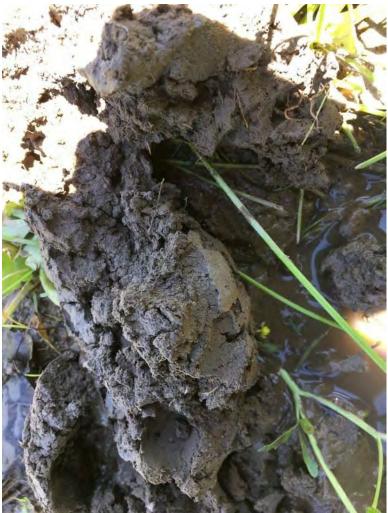
Soil Photos

_	Redox (S5)								sic Spodic (TA6) (MLRA 144A, 145, 149B)
_	d Matrix (S6)								Parent Material (F21)
	ırface (S7) (LRR R, N	ИLRA 1	49B)						y Shallow Dark Surface (TF12)
	,,,,,,,,,,,,,,,,,,,,,,,,,,,,,,,,,,,,,,,		,					Oth	er (Explain in Remarks)
			n and wetland hyd	drolo	gy must l	be presei	nt, unless disturbe	d or prob	plematic.
Restrictive	Layer (if observed)	•	Pocks			Uvdric 9	Fail Procent?		Voc. / No
	Type:		Rocks			Hydric	Soil Present?		Yes No
	Depth (inches):		8						
Remarks:									
ı									
ı									
Ì									
l									
Ì									
Ì

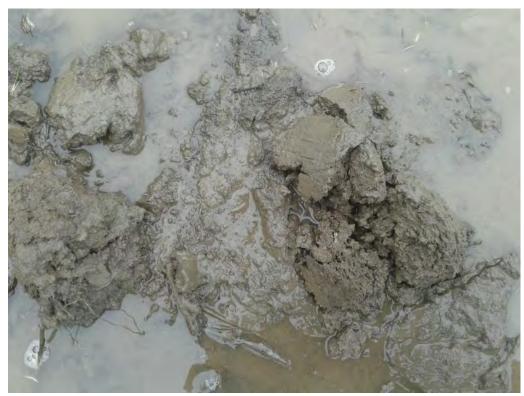
Soil Photos

Depth _	-	to the d	-			ndicator o	r confirm the al	osence of indicators.)	
	Matrix		Redox						
(inches)	Color (moist)	<u>%</u>	Color (moist)	%	Type ¹	Loc ²	Texture	Remarks	
0 - 6	10YR 5/2	100					Clay Loan	<u> </u>	
6 - 16	10YR 5/1	92	10YR 5/4	8	C	M	Clay Loan	<u> </u>	
				_

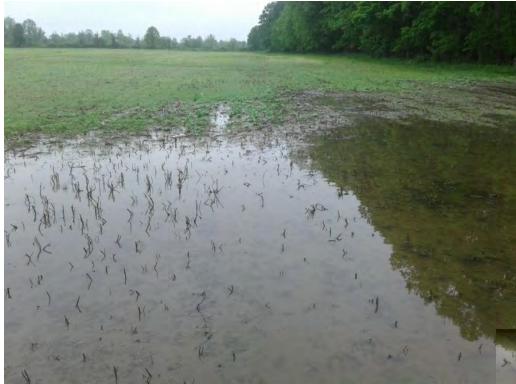
Photo of Sample Plot

Hydrophytic Vegetation Present						
Hydric Soil Present?	Yes No	Is the Sampled Area within	a Wetland?	Yes No		
Wetland Hydrology Present?	Yes No	If yes, optional Wetland Sit	e ID:	W-JDV-01		
Remarks: (Explain alternative pr	ocedures here or in a separate report	t)				
TRC covertype is PEM. Circumsta	ances are not normal due to agricultu	ıral activities				
HYDROLOGY						
r r r r r r r r r r r r r r r r r r r						
Wetland Hydrology Indicators:						
Primary Indicators (minimum of	one is required; check all that apply)		Secondary Indicators (minir	num of two required)		
∕ Surface Water (A1)	Water-Stained Le	aves (DJ)	Surface Soil Cracks (B6)			
<u>✓</u> High Water Table (A2)	⁄ Aquatic Fauna (B´	.3)	Drainage Patterns (B10)			
✓ Saturation (A3)	Marl Deposits (B1		Moss Trim Lines (B16)	(C2)		
Water Marks (B1)	Hydrogen Sulfide	6 (1.1.5 (60)				
Sediment Deposits (B2)	Oxidized Rnizosp	neres on Eiving Roots (es)	✓ Saturation Visible on Ae	rial Imagery (C9)

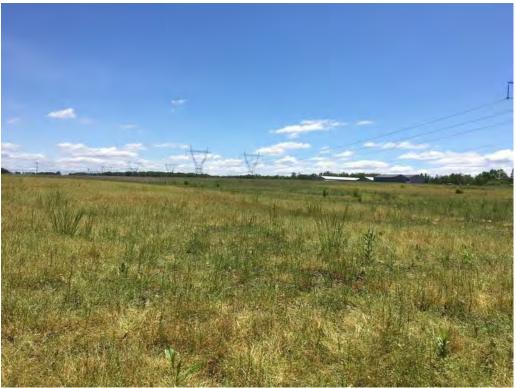
Photo of Sample Plot

•				
Remarks: (Explain alternative pro	ocedures here or in a separate report)				
TRC covertype is UPL. Circumstar	nces are not normal due to agricultur	al activities, Wetter than av	rerage year			
HYDROLOGY						
TIDROLOGI						
Wetland Hydrology Indicators:						
Primary Indicators (minimum of	one is required; check all that apply)		Secondary Indicators (minimum of two required)			
Surface Water (A1)	Water-Stained Lea	aves (B9)	Surface Soil Cracks (B6)			
High Water Table (A2)	Aquatic Fauna (B1	3)	Drainage Patterns (B10)			
Saturation (A3)	Marl Deposits (B1		Moss Trim Lines (B16)			
Water Marks (B1)	Hydrogen Sulfide		Dry-Season Water Table (C2) Crayfish Burrows (C8)			
Sediment Deposits (B2)	Oxidized Rhizosph	neres on Living Roots (C3)	Craynsh Burrows (C8) Saturation Visible on Aerial Imagery (C9)			
Drift Danasits (R3)	Prosonce of Podu	sed Iron (CA)	Stunted or Stressed Plants (D1)			
Drift Deposits (B3) Algal Mat or Crust (B4)	Presence of Reduce	ction in Tilled Soils (C6)	Geomorphic Position (D2)

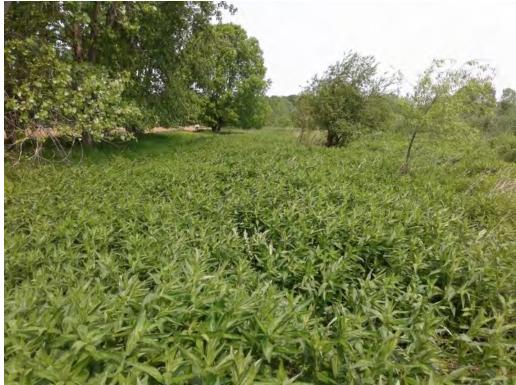
Photo of Sample Plot

Hydrophytic Vegetation Present?	Yes _ ✓ _ No			
Hydric Soil Present?	Yes _ ✓ No	Is the Sampled Area withi	n a Wetland?	Yes∕_ No
		·		
Wetland Hydrology Present?	Yes No	If yes, optional Wetland Si	ITE ID:	W-JDV-13
Remarks: (Explain alternative proce	dures here or in a separate report	·)		
TRC covertype is PEM. Area is wetla	nd, all three wetland parameters a	are present.		
HYDROLOGY				
Wetland Hydrology Indicators:				
Primary Indicators (minimum of on	e is required; check all that apply)		Secondary Indicators (min	imum of two required)
Surface Water (A1)	Water-Stained Lea	aves (RQ)	Surface Soil Cracks (B6	•
✓ High Water Table (A2)	Aquatic Fauna (B1		✓ Drainage Patterns (B10	•
✓ Saturation (A3)	Marl Deposits (B1		Moss Trim Lines (B16)	
Water Marks (B1)	Hydrogen Sulfide		Dry-Season Water Tab	le (C2)
Sediment Deposits (B2)	, ,	heres on Living Roots (C3)	Crayfish Burrows (C8)	
			Saturation Visible on A	erial Imagery (C9)

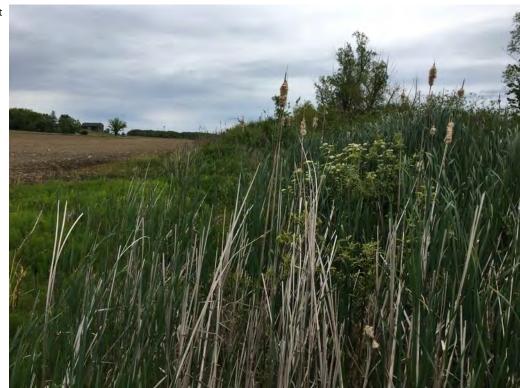
Photo of Sample Plot

Hydrophytic Vegetation Present	:? Yes _ ✓ _ No					
Hydric Soil Present?	Yes _ No	Is the Sampled Area withi	in a Wetland	d? Yes	No	
_		i				
Wetland Hydrology Present?	Yes No	If yes, optional Wetland S	ite ib.	<u></u>	B-15	
Remarks: (Explain alternative pr	ocedures here or in a separate report	()				
TRC covertype is PEM. Wetter th	ian average year					
HYDROLOGY						
Wetland Hydrology Indicators:	5 a.a. ia wa muiwa du aha ah a lu all aha a a an lu a		Casamalam	. In diantana (mainima	-£ h

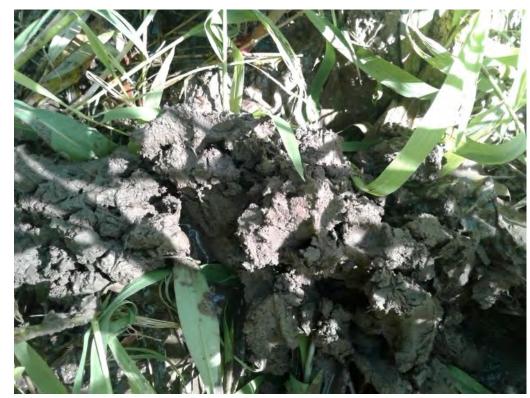
Soil Photos

-	Matrix	e depth needed to o Redox	r Feature		or or confirm the a	bsence of indicato	ors.)
(inches) Color	(moist) 9	6 Color (moist)	% Ty	pe¹ Loc²	Text	ure	Remarks
0 - 18 10YI	R 3/2 9	4 7.5YR 4/6	6	C M	Silty Cla	y Loam	
		_					
Type: C = Concentra	tion, D = Depl	letion, RM = Reduced	d Matrix,	MS = Masked	Sand Grains. ² L	ocation: PL = Pore	Lining, M = Matrix.
Hydric Soil Indicators	:					Indicators for Pr	roblematic Hydric Soils³:
Thick Dark Surfac Sandy Mucky Min Sandy Gleyed Ma Sandy Redox (S5) Stripped Matrix (S Dark Surface (S7) Bindicators of hydrop Restrictive Layer (if o Type: Depth (in	(A4) A5) Dark Surface (A5) eral (S1) trix (S4) G6) (LRR R, MLRA hytic vegetati	Thin Dark Su Loamy Muck Loamy Gleye Depleted Ma A11)/ Redox Dark Depleted Da Redox Depre	urface (SS sy Minera ed Matrix etrix (F3) Surface (rk Surfac essions (I) (LRR R, MLF I (F1) (LRR K, (F2) F6) e (F7) F8) ust be prese	L)	Coast Prairie 5 cm Mucky Dark Surface Polyvalue Be Thin Dark Su Iron-Mangar Piedmont Flc Mesic Spodic Red Parent N Very Shallow Other (Expla	elow Surface (S8) (LRR K, L) urface (S9) (LRR K, L) nese Masses (F12) (LRR K, L, R) oodplain Soils (F19) (MLRA 149B) c (TA6) (MLRA 144A, 145, 149B) Waterial (F21) v Dark Surface (TF12)

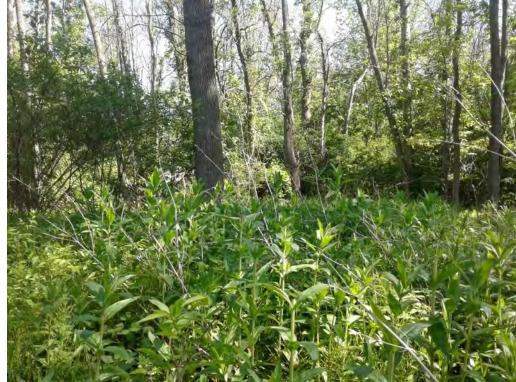
Photo of Sample Plot

Hydrophytic Vegetation Present?	Yes _ ✓ _ No					
Hydric Soil Present?	Yes No	Is the Sampled Area with	in a Wetland?	Yes .	∠_ No	
Wetland Hydrology Present?		If yes, optional Wetland S		W-JJB-		
	Yes _ ✓ No		ite iD.		-21	
Remarks: (Explain alternative pro 	ocedures here or in a separate report))				
TRC covertype is PEM. Wetter tha	an average year					
HYDROLOGY						
Wetland Hydrology Indicators:					c	
Primary Indicators (minimum of	one is required; check all that apply)		-	icators (minimum o	f two required)	
✓ Surface Water (A1)	Water-Stained Lea		Surface Soi			
✓ High Water Table (A2)	Aquatic Fauna (B1		Drainage Patterns (B10) Moss Trim Lines (B16)			
✓ Saturation (A3)	Marl Deposits (B1)		Dry-Season Water Table (C2)			
Water Marks (B1) Sediment Deposits (B2)	Hydrogen Sulfide	neres on Living Roots (C3)	6 6 1 5 (60)			
Sediment Deposits (B2)	Oxidized Kriizospi	ieres on Living Roots (C3)	-	Visible on Aerial Ima	agery (C9)

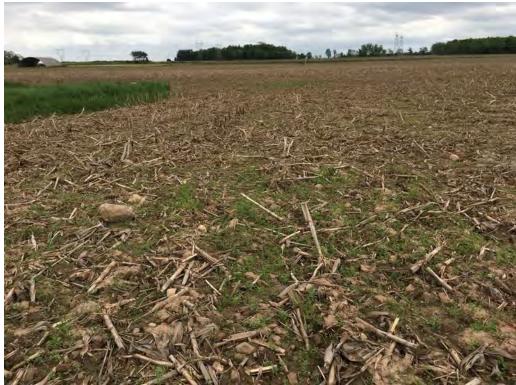
Photo of Sample Plot

Hydrophytic Vegetation Present	:? Yes No _ _ ✓						
Hydric Soil Present?	Yes No	Is the Sampled Area withi	n a Wetland? Yes	No⁄_			
		·					
Wetland Hydrology Present?	Yes No _ _	If yes, optional Wetland Si	ite ID:				
Remarks: (Explain alternative pr	ocedures here or in a separate report	t)					
TRC covertype is UPL. Circumsta	ances are not normal due to agricultur	ral activities					
LIVEROLOCV							
HYDROLOGY							
Wetland Hydrology Indicators:							
Primary Indicators (minimum of	fone is required; check all that apply)		Secondary Indicators (minimum of	two required)			
Surface Water (A1)	Water-Stained Lea	aves (B9)	Surface Soil Cracks (B6)				
High Water Table (A2)	Aquatic Fauna (B1		Drainage Patterns (B10)				
Saturation (A3)	Marl Deposits (B1	15)	Moss Trim Lines (B16)				
Water Marks (B1)	Hydrogen Sulfide		Dry-Season Water Table (C2)				
Sediment Deposits (B2)	Oxidized Rhizosp	heres on Living Roots (C3)

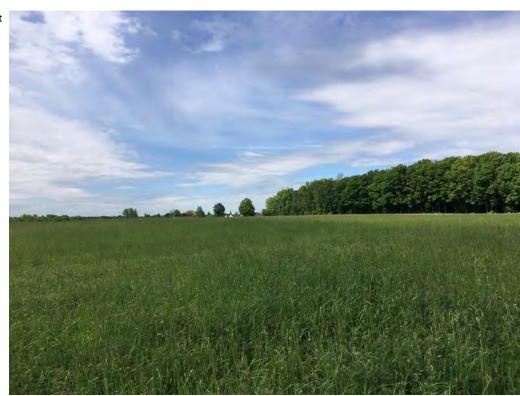
Photo of Sample Plot

Hydrophytic Vegetation Present?			<u> </u>			
Hydric Soil Present?	Yes No _ _ _	Is the Sampled Area within	n a Wetland?	Yes No		
Wetland Hydrology Present?	Yes No	If yes, optional Wetland Si	te ID:			
	ocedures here or in a separate report					
TRC covertype is UPL. Circumstar	nces are not normal due to agricultur	ral activities, Wetter than av	rerage year			
HYDROLOGY Wetland Hydrology Indicators:						
	one is required; check all that apply)		Secondary Indicators (minimum of two required)		
		ayos (DO)	Surface Soil Cracks (B6)			
Surface Water (A1) High Water Table (A2)	Water-Stained Lea Aquatic Fauna (B1		Drainage Patterns (
Saturation (A3)	Marl Deposits (B1		Moss Trim Lines (B			
Water Marks (B1)	Hydrogen Sulfide		Dry-Season Water Table (C2)			
Sediment Deposits (B2)	Oxidized Rhizospl	heres on Living Roots (C3)				
			Saturation Visible o			
Drift Deposits (B3)	Presence of Redu		Stunted or Stressed Plants (D1)

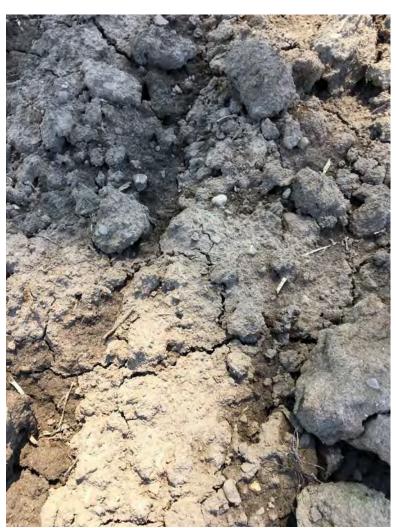
Hydrology Photos

•			
Remarks:					
Reilidiks.					
One (1) secondary indicator was	s present, surface cra	acks may he from	fact spring was so wet as	versus typical conditions. No	other hydrolov signs
assume no wetland hydrology p	•	may be nom	3511118 4443 30 4464, 43	. c. sas cypical conditions. No	5 11yan 010y 51g113
and the state of the state of the state of the state of the state of the state of the state of the state of the state of the state of the state of the state of the state of the state of the state of the state of the state of the state of the state of the state of the state of the state of the state of the state of the state of the state of the state of the state of the state of the state of the state of the state of the state of the state of the state of the state of the state of the state of the state of the state of the state of the state of the state of the state of the state of the state of the state of the state of the state of the state of the state of the state of the state of the state of the state of the state of the state of the state of the state of the state of the state of the state of the state of the state of the state of the state of the state of the state of the state of the state of the state of the state of the state of the state of the state of the state of the state of the state of the state of the state of the state of the state of the state of the state of the state of the state of the state of the state of the state of the state of the state of the state of the state of the state of the state of the state of the state of the state of the state of the state of the state of the state of the state of the state of the state of the state of the state of the state of the state of the state of the state of the state of the state of the state of the state of the state of the state of the state of the state of the state of the state of the state of the state of the state of the state of the state of the state of the state of the state of the state of the state of the state of the state of the state of the state of the state of the state of the state of the state of the state of the state of the state of the state of the state of the state of the state of the state of the state of the state of the state of the state of the state of the state of the state of the state of the state of the state of t

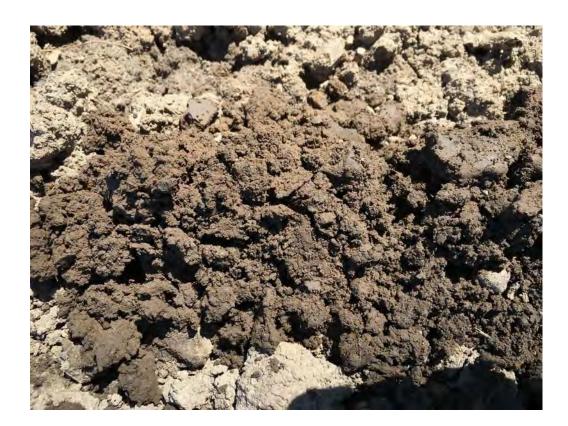
Soil Photos

-	oe to the c	-			ndicato	r or confirm the al	osence of indicators.)
Depth _	Matrix		Redox Fe					
(inches) 0 - 8	7.5YR 3/2	100	Color (moist)	<u> %</u>	Type ¹	Loc ²	Texture Loam	Remarks
¹Tvne· C =	Concentration D	= Denleti	on, RM = Reduced N		MS = 1	Masked	Sand Grains 21	ocation: PL = Pore Lining, M = Matrix.
	I Indicators:	Depieti	on, Kwi Kedaced P	· / u (1 1/	V, 1413 - 1	· iuskeu	. Jana GranisLi	Indicators for Problematic Hydric Soils ³ :
Histos			Polyvalue Belo	w Sui	rface (S8	3) (LRR	R, MLRA 149B)	2 cm Muck (A10) (LRR K, L, MLRA 149B)
Histic I	Epipedon (A2)		Thin Dark Surf	ace (S	9) (LRR	R, MLR	A 149B)	Coast Prairie Redox (A16) (LRR K, L, R)
	Histic (A3)		Loamy Mucky			LRR K,	L)	5 cm Mucky Peat or Peat (S3) (LRR K, L, R)

-	Redox (S5)	•,						Mesic Spodic (TA6) (MLRA 144A, 145, 149B)
_	ed Matrix (S6)							Red Parent Material (F21)
	Surface (S7) (LRR F	R, MLRA 14	19B)					Very Shallow Dark Surface (TF12) Other (Explain in Remarks)
			and wetland hydro	logy	must be	preser	nt, unless disturbe	d or problematic.
	Layer (if observe		- (l			L to color	- C-!! D	Wes No. 4
	Type: Depth (inches):	nardpa	n/rock enountered 10	_		Hyarı	c Soil Present?	Yes No _ ∠ _
Remarks:	Depth (inches).		10					
Remarks.

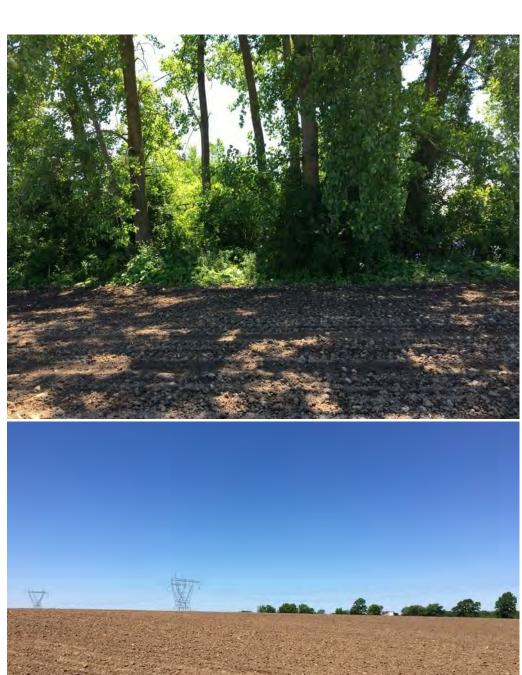
Photo of Sample Plot

Hydric Soil Present?		No	Is the Sampled Area withi	n a Wetland?	Yes No/_
			·		163110
Wetland Hydrology Present?	Yes	No / _	If yes, optional Wetland S	te ID:	
Remarks: (Explain alternative p	ocedures here or in	a separate report	t)		
TRC covertype is UPL. Circumsta	ances are not norma	l due to agricultui	ral activities. Wetter than a	verage vear	
The covertype is of E. circuitisa	ances are not norma	rade to agricultar	raractivities, wetter than a	verage year	
HYDROLOGY					
Wetland Hydrology Indicators:					
Primary Indicators (minimum o	one is required; che	ck all that apply)		Secondary Indicators (minim	ium of two required)
Surface Water (A1)		Water-Stained Le		✓ Surface Soil Cracks (B6)	
High Water Table (A2)		Aquatic Fauna (B		Drainage Patterns (B10)	
Saturation (A3)		Marl Deposits (B1		Moss Trim Lines (B16)	(C2)
Water Marks (B1)		Hydrogen Sulfide		Dry-Season Water Table (Crayfish Burrows (C8)	(C2)

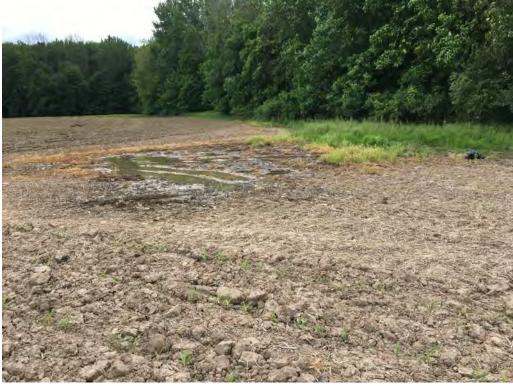
Photo of Sample Plot

M4	/ N- /
Hydric Soil Present?	Yes No	Is the Sampled Area withi		′es No _ _ ∠
Wetland Hydrology Present?	Yes No	If yes, optional Wetland Si	te ID:	
TRC covertype is UPL. Circumstan	ices are not normal due to agricultur	al activities, Wetter than a	verage year	
HYDROLOGY Wetland Hydrology Indicators:				
Primary Indicators (minimum of c	one is required; check all that apply)		Secondary Indicators (minimu	ım of two required)
Surface Water (A1)	Water-Stained Lea	aves (B9)	Surface Soil Cracks (B6)	•
High Water Table (A2)	Aquatic Fauna (B1		Drainage Patterns (B10)	
Saturation (A3)	Marl Deposits (B1		Moss Trim Lines (B16)	
Water Marks (B1)	Hydrogen Sulfide		Dry-Season Water Table (C	(2)
Sediment Deposits (B2)	Oxidized Rhizosph	neres on Living Roots (C3)	Crayfish Burrows (C8)	l Imagany (CO)
Duift Danasita (D2)	Dunnan of Dady	and Ivan (CA)	Saturation Visible on Aeria	
Drift Deposits (B3) Algal Mat or Crust (B4)	Presence of Redu	ced fron (C4) ction in Tilled Soils (C6)	Stunted or Stressed PlantsGeomorphic Position (D2)	(101)

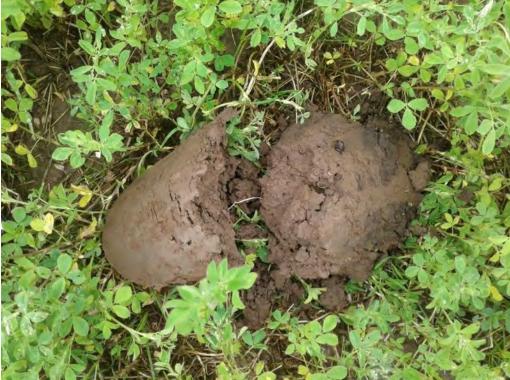
Soil Photos

cription: (Describe	to the d	•			indicato	r or confirm the	absence of	findica	itors.)	
Depth	Matrix		Redox				_				
(inches)	Color (moist)		Color (moist)	<u>%</u>	Type ¹	Loc ²	Textur			Remarks	
0 - 13	10YR 3/2	100		_			Silty Cla				
13 - 13	10YR 4/3			_			Silty Cla	ay			
				_							
				_							
				_							
						·					
				_							
				_		-			-		
				_			-				
				_							
				_			-				
1Typo: C = 0	Concentration D =	Doplotic	n DM - Poducod	Mat	riv MC -	Macked	Sand Crains	21 ocation: F		re Lining, M = Matrix.	
		Depletic	ori, Kivi – Reduced	IVIAL	11X, 1VI3 -	iviaskeu	Saliu Grailis.				
Hydric Soil			Data de la constante de la constante de la constante de la constante de la constante de la constante de la constante de la constante de la constante de la constante de la constante de la constante de la constante de la constante de la constante de la constante de la constante de la constante de la constante de la constante de la constante de la constante de la constante de la constante de la constante de la constante de la constante de la constante de la constante de la constante de la constante de la constante de la constante de la constante de la constante de la constante de la constante de la constante de la constante de la constante de la constante de la constante de la constante de la constante de la constante de la constante de la constante de la constante de la constante de la constante de la constante de la constante de la constante de la constante de la constante de la constante de la constante de la constante de la constante de la constante de la constante de la constante de la constante de la constante de la constante de la constante de la constante de la constante de la constante de la constante de la constante de la constante de la constante de la constante de la constante de la constante de la constante de la constante de la constante de la constante de la constante de la constante de la constante de la constante de la constante de la constante de la constante de la constante de la constante de la constante de la constante de la constante de la constante de la constante de la constante de la constante de la constante de la constante de la constante de la constante de la constante de la constante de la constante de la constante de la constante de la constante de la constante de la constante de la constante de la constante de la constante de la constante de la constante de la constante de la constante de la constante de la constante de la constante de la constante de la constante de la constante de la constante de la constante de la constante de la constante de la constante de la constante de la con	~	·e	.0) (1.55	D MI DA 4 405°			Problematic Hydric Soils ³ :

-	Gleyed Matrix (S4)				. ,					Floodplain Soils (F19) (MLRA	
	Redox (S5)									dic (TA6) (MLRA 144A, 145, 1 4	·9B)
_	d Matrix (S6)									t Material (F21)	
	urface (S7) (LRR R, N	ЛІ RA 14	9R)					-		ow Dark Surface (TF12)	
			,					Oth	er (Exp	lain in Remarks)	
3Indicators	of hydrophytic veg	getation	and wetland hydr	olog	y must b	e preser	nt, unless distur	bed or prob	lemati	C.	
Restrictive	Layer (if observed)	:									
	Type:		Rocks			Hydric	Soil Present?		Yes _	No <u>_</u>	
	Depth (inches):		13								
Remarks:	•

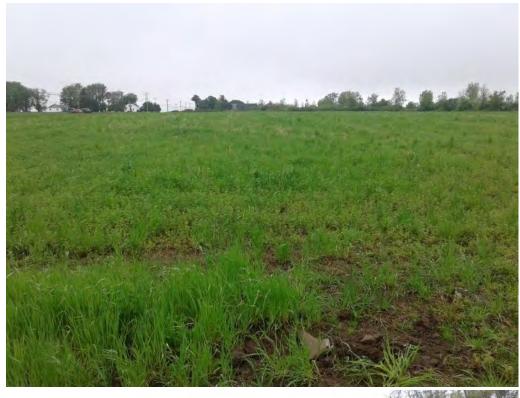
Photo of Sample Plot

Hydrophytic Vegetation Present	? Yes No _ _/ _					
Hydric Soil Present?	Yes No	Is the Sampled Area withi	in a Wetland?	Yes	No	
		·		-		
Wetland Hydrology Present?	Yes No _ _	If yes, optional Wetland S	ite iD:	<u> </u>		
Remarks: (Explain alternative pro	ocedures here or in a separate report	()				
TRC covertype is UPL. Circumsta	inces are not normal due to agricultur	ral activities

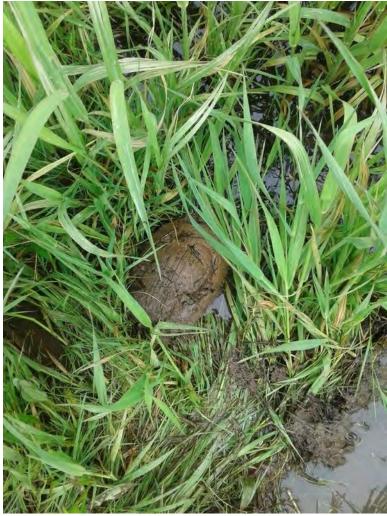
Soil Photos

Depth _	Matrix	to the d	epth needed to o			indicato	or confirm the a	osence of indicators.)
(inches)	Color (moist)		Color (moist)	%	Type ¹	Loc ²	Texture	Remarks
0 - 4	10YR 4/2	100			.,,,,,		Silty Clay	- Normania
4 - 14	10YR 5/2	90	2.5Y 4/4	10			Clay	
				<u></u>

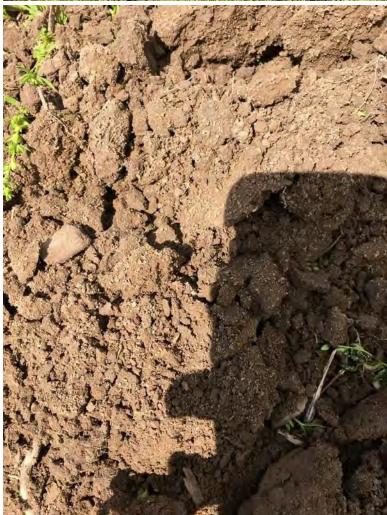
Soil Photos

cription: (Describe	to the de	•			indicato	r or confirm the ab	osence of	f indicators.)
Depth	Matrix		Redox				- .		B
(inches)	Color (moist)	<u>%</u>	Color (moist)	%	Type ¹	Loc ²	Texture		Remarks
0 - 18	10YR 3/3	100		-			Silt Loam		
		· —		-					
				_					
				_					
				_					
		· ·		_					
		· ·		-

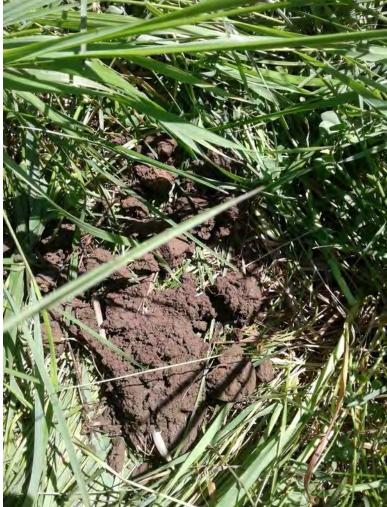
Soil Photos

Dark Su	ırface (S7) (LRR R, I	MLRA 149	9B)						ther (Explain in Remarks)
21	- 6 la								•
	of hydrophytic veg		and wetland nydr	olog	y must b	e preser	it, uniess distui	rbea or pr	obiematic.
Restrictive	Layer (if observed)):							
	Type:		Gravel			Hydric	Soil Present?		Yes No ✓
	Depth (inches):		10						
Remarks:

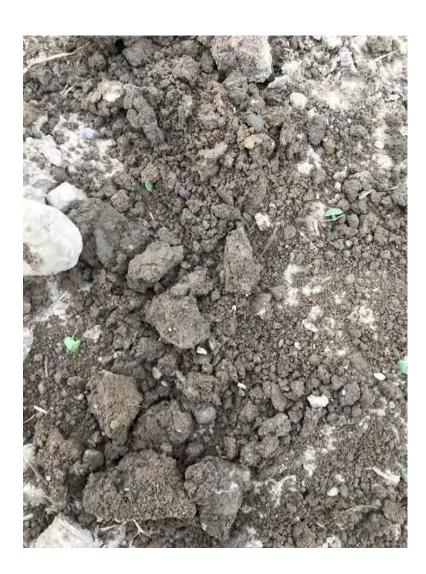
Soil Photos

-	Redox (S5)							Red Par	rent Material (F21)	
	d Matrix (S6)	AL DA 44	ND)					Very Sh	allow Dark Surface (TF12)	
Dark Su	rface (S7) (LRR R, N	VILKA 14	96)					Other (Explain in Remarks)	
3Indicators	of hydrophytic veg	getation a	and wetland hydr	olog	y must b	e preser	nt, unless distur	bed or problem	natic.	
	Layer (if observed)					ĺ		·		
	Type:		Hard pan			Hvdric	Soil Present?	,	Yes No⁄_	
	Depth (inches):		11			, ,				
Remarks:	Deptir (interies):					l .				
Remarks.

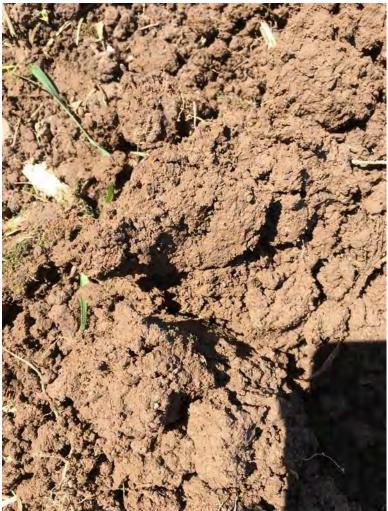
Soil Photos

-	edox (S5)							Red Parent Material (F21)
	Matrix (S6)							Very Shallow Dark Surface (TF12)
Dark Su	rface (S7) (LRR R, N	1LRA 149	9B)					Other (Explain in Remarks)
³ Indicators	of hydrophytic veg	etation a	and wetland hydr	ology	y must b	e preser	nt, unless disturb	ed or problematic.
Restrictive I	.ayer (if observed):							
	Туре:		Rocks			Hydric	Soil Present?	Yes No/_
	Depth (inches):		10	,				
Remarks:	•					·

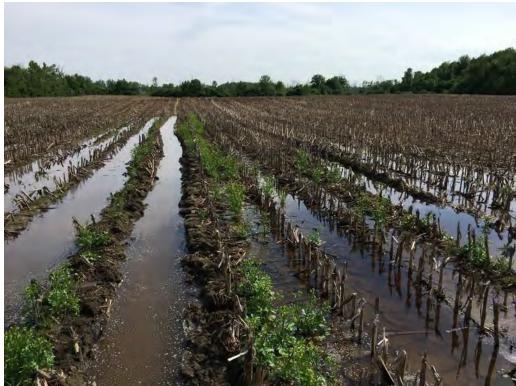
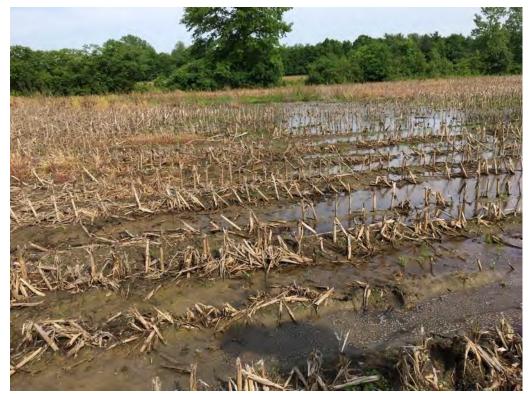
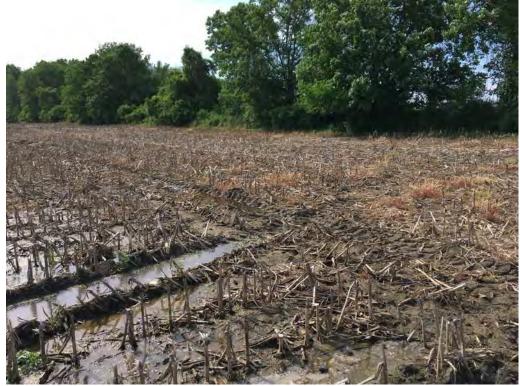
Soil Photos

Profile Desc Depth	cription: (Describe t Matrix	o the c	lepth needed to o			indicato	r or confirm the a	bsence of i	ndicators.)
(inches)	Color (moist)	%	Color (moist)	%	Type ¹	Loc ²	Texture	2	Remarks
0 - 12	10YR 3/1	96	7.5YR 4/6	4	.,,,,,		Clay Loa		
		_		_

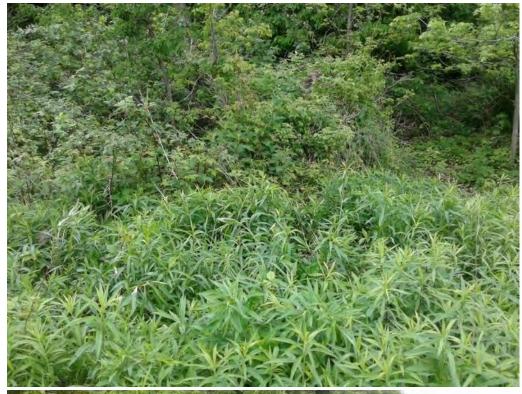
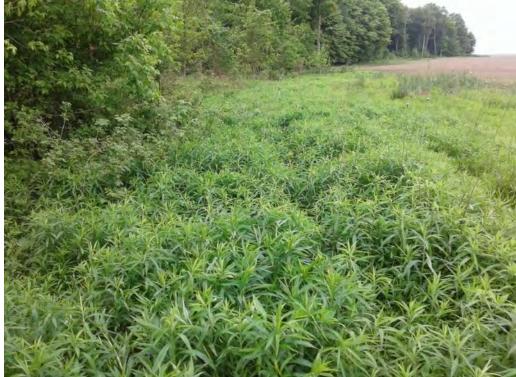
Photo of Sample Plot

•	Layer (if observed):			0.	,		,	р	_
	Type:		None			Lludric	Soil Present?	,	Yes No
			None			riyuric	Joil Flesell:		1es NO _ / _
l 	Depth (inches):	_							
Remarks:									
No positive	indication of hydri	c soils w	as observed.						
Tro positive	a.cacion or ny an		as 0250. rea.

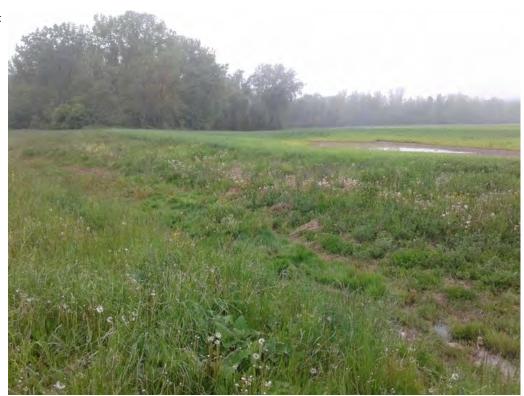
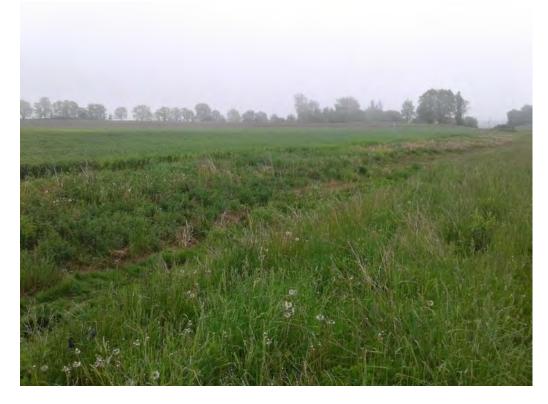
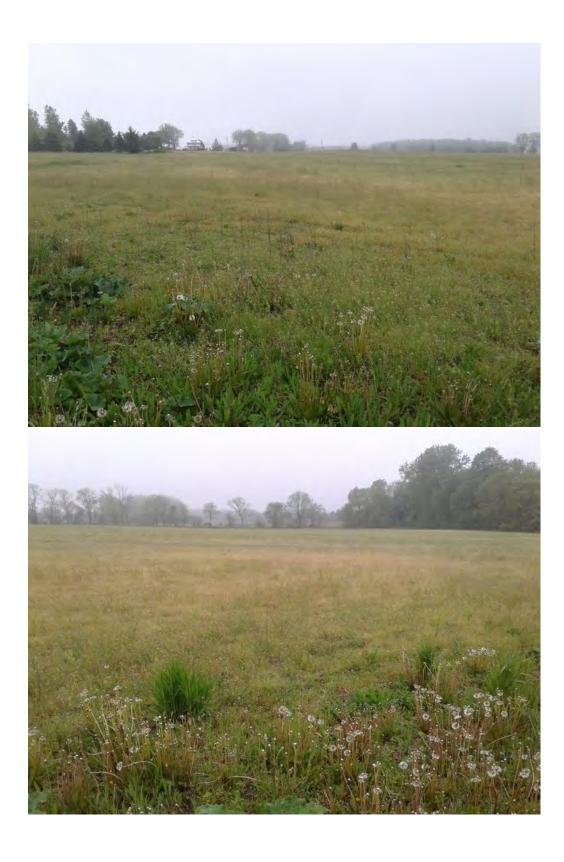
Photo of Sample Plot

Restrictive Layer (if observed): Type: Depth (inches): Rocks/Gravel Hydric Soil Present?	Other (Explain in Remarks)
Restrictive Layer (if observed): Type: Depth (inches): Rocks/Gravel Hydric Soil Present?	problematic.
Depth (inches): 14	
	Yes No/_
Remarks:
