APPENDIX C USACE Routine Wetland Determination Forms & TRC's Stream Inventory Data Forms

Project/Site: Excelsior	City/County: Byron, Genesee County	Sampling Date: 2019-June-17
Applicant/Owner: Excelsior	State: Ne	w York Sampling Point: W-WSH-01_PEM-1
Investigator(s): Weston Hillegas, Isaac Pallant	Section, Township	, Range:
Landform (hillslope, terrace, etc.): Depression	Local relief (concave, con	vex, none): Concave Slope (%): 0 to 1
Subregion (LRR or MLRA): LRR L	Lat: 43.0428935	Long: -78.0403443 Datum: WGS84
Soil Map Unit Name: Lima silt loam, 0 to 3 perce	nt slopes (LmA)	NWI classification: None
Are climatic/hydrologic conditions on the site typical	-	o <u>✓</u> (If no, explain in Remarks.)
		al Circumstances" present? Yes No
Are Vegetation, Soil, or Hydrology _	naturally problematic? (If needed	, explain any answers in Remarks.)
SUMMARY OF FINDINGS – Attach site map	showing sampling point locations, tra	nsects, important features, etc.
Hydrophytic Vegetation Present? Yes _	✓_ No	
Hydric Soil Present? Yes _	✓ No Is the Sampled Area with	in a Wetland? Yes _✓_ No

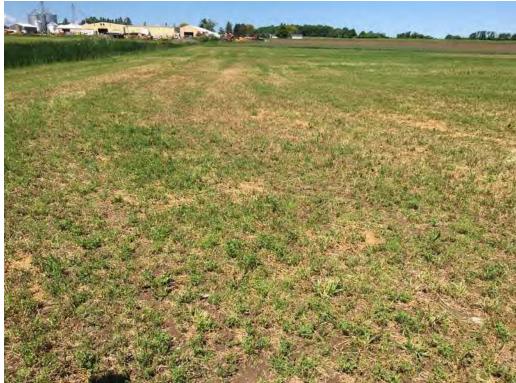
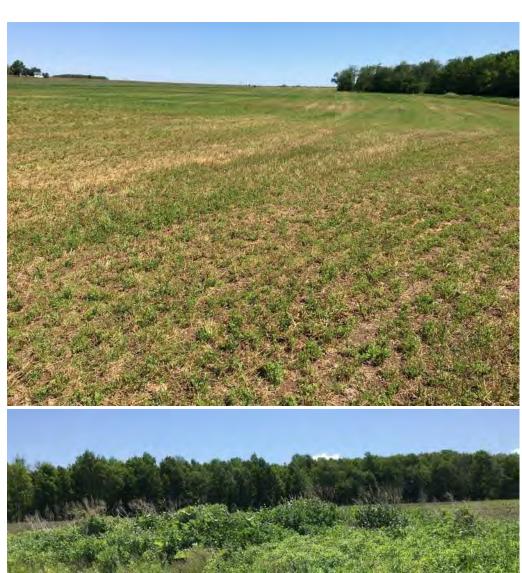
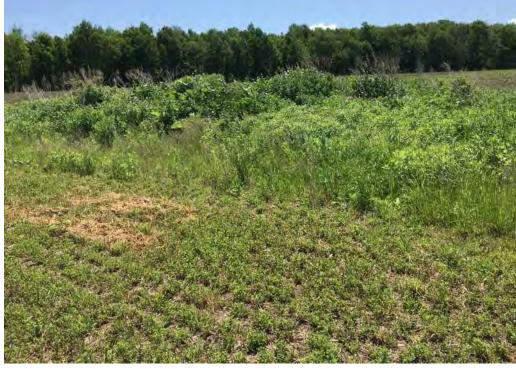
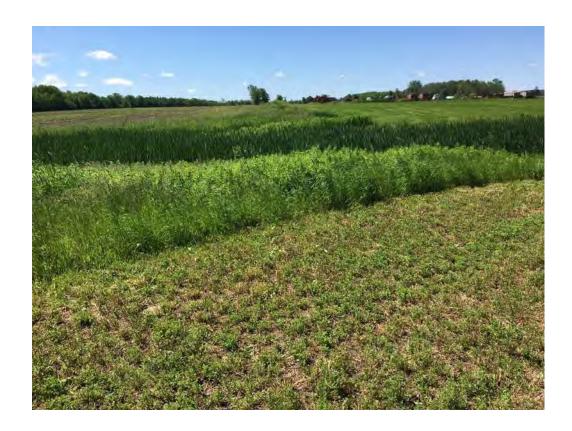
Photo of Sample Plot

-			n and wetland hydroloរូ	gy m	nust be	presen	it, unless distur	bed or problematic.	
	e Layer (if obsen								
	Type:	hard rock	/ gravel encountered			Hydri	c Soil Present?	Yes No <u>_</u> ✓	
	Depth (inches):		10						
Remarks:

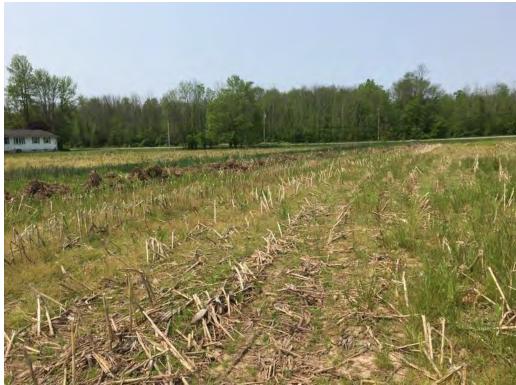
Photo of Sample Plot

-	d Matrix (S6)							Red Parent M		
	rface (S7) (LRR R, M	ILRA 14	9B)						Dark Surface (TF12)	
	,		•					Other (Explai	n in Remarks)	
3Indicators	of hydrophytic veg	etation	and wetland hyd	rolog	y must b	e presen	t, unless disturbe	d or problematic.		
Restrictive	Layer (if observed):									
	Type:		None	_		Hydric	Soil Present?		Yes No	
	Depth (inches):			_						
Remarks:										
Ì										
Ì										
Ì

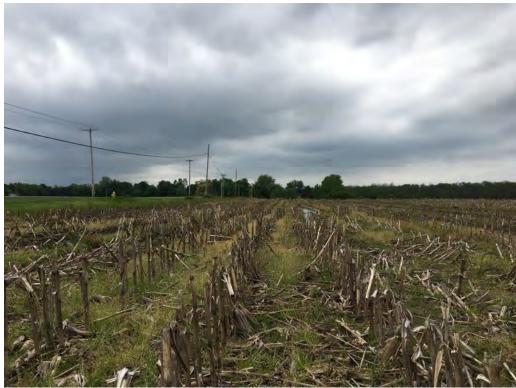
Photo of Sample Plot

ark Surface (A12)		Depleted Dar)			anganese Masses (F12) (LRR K, L, R)
Sandy N	Mucky Mineral (S1)		Redox Depre	ssior	ıs (F8)				ont Floodplain Soils (F19) (MLRA 149B)
Sandy 0	Gleyed Matrix (S4)								Spodic (TA6) (MLRA 144A, 145, 149B)
Sandy F	Redox (S5)								rent Material (F21)
Strippe	d Matrix (S6)								nallow Dark Surface (TF12)
Dark Su	ırface (S7) (LRR R, N	ILRA 149	9B)					-	Explain in Remarks)
21	-£	-4-4:							
	of hydrophytic veg Layer (if observed):		and wettand nydi	olog	y must b	e preser	it, uniess disturbe	d or problem	nauc.
resu reuve	Type:		None			Hydric	Soil Present?		Yes No⁄_
	Depth (inches):	-	None	•		liyanc	John resent:		163 NO <u></u>
	Depth (inches):								
Remarks:

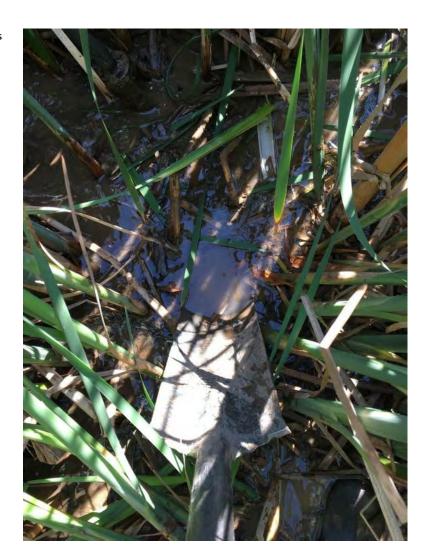
Hydrology Photos

Sandy Midcky Miller at (51) Redox Depressions (F8) Piedmont Floodplain Soils (F19) (MLRA 149B) Sandy Gleyed Matrix (S4)
Sandy Redox (S5) Mesic Spodic (TA6) (MLRA 144A, 145, 149B) Sandy Redox (S5)
Stripped Matrix (SS)
Devils Surface (C7) (LDD D. MLDA 140D)
Dark Surface (5/) (LRR R, MLRA 1498) Other (Explain in Remarks)
³ Indicators of hydrophytic vegetation and wetland hydrology must be present, unless disturbed or problematic.
Restrictive Layer (if observed):
Type: None Hydric Soil Present? Yes _ Vo
Depth (inches):
Remarks:
Soils were assumed to be hydric due to the presence of inundation, FACW and OBL vegetation species, and a definitive wetland boundary.
