**EXCELSIOR ENERGY CENTER
ARTICLE 10 EXHIBIT 24**

SIMULATIONS AND LINES OF SIGHT

Excelsior Energy Center
Byron, New York
Visual Simulation of Project
August 2020

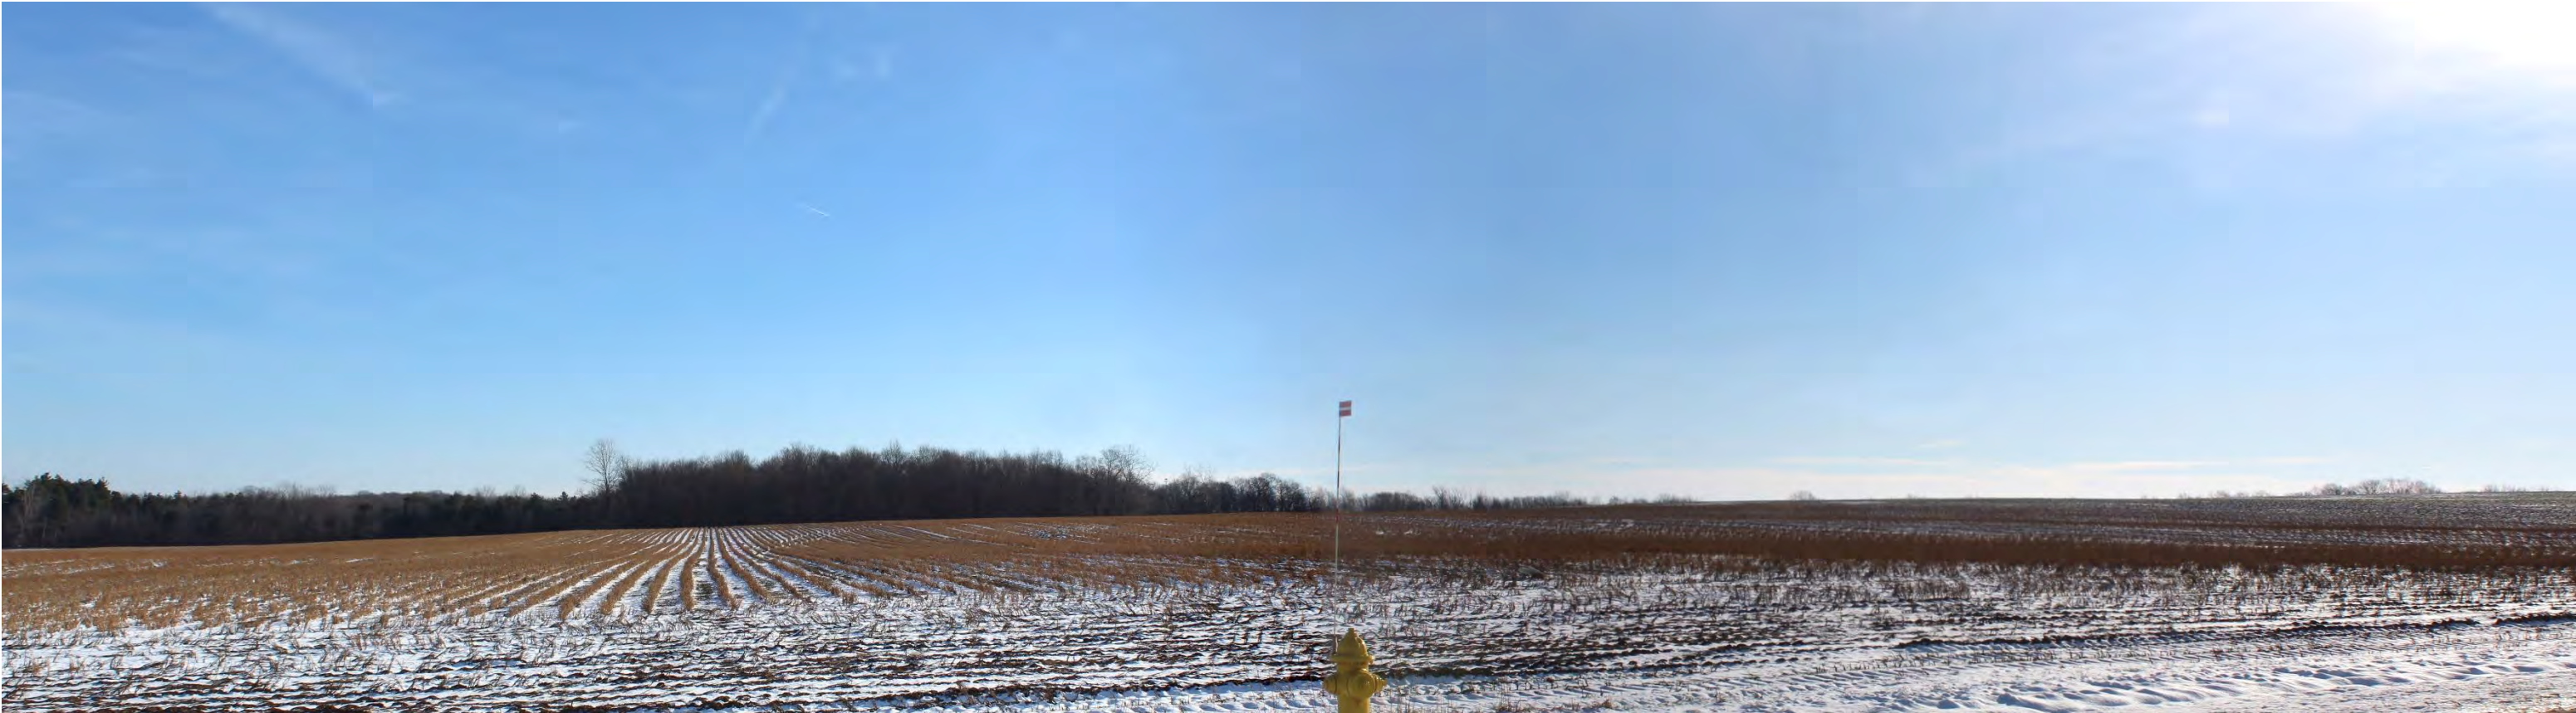
Existing Conditions

Viewpoint Coordinates in NY State Plane West	1284482.3 E 1114332.3 N
Town	Byron
Viewer Elevation (ft msl)	675
Distance to Fence Line	209 ft
Direction of View	E
Date/Time	12/13/19 11:21 AM

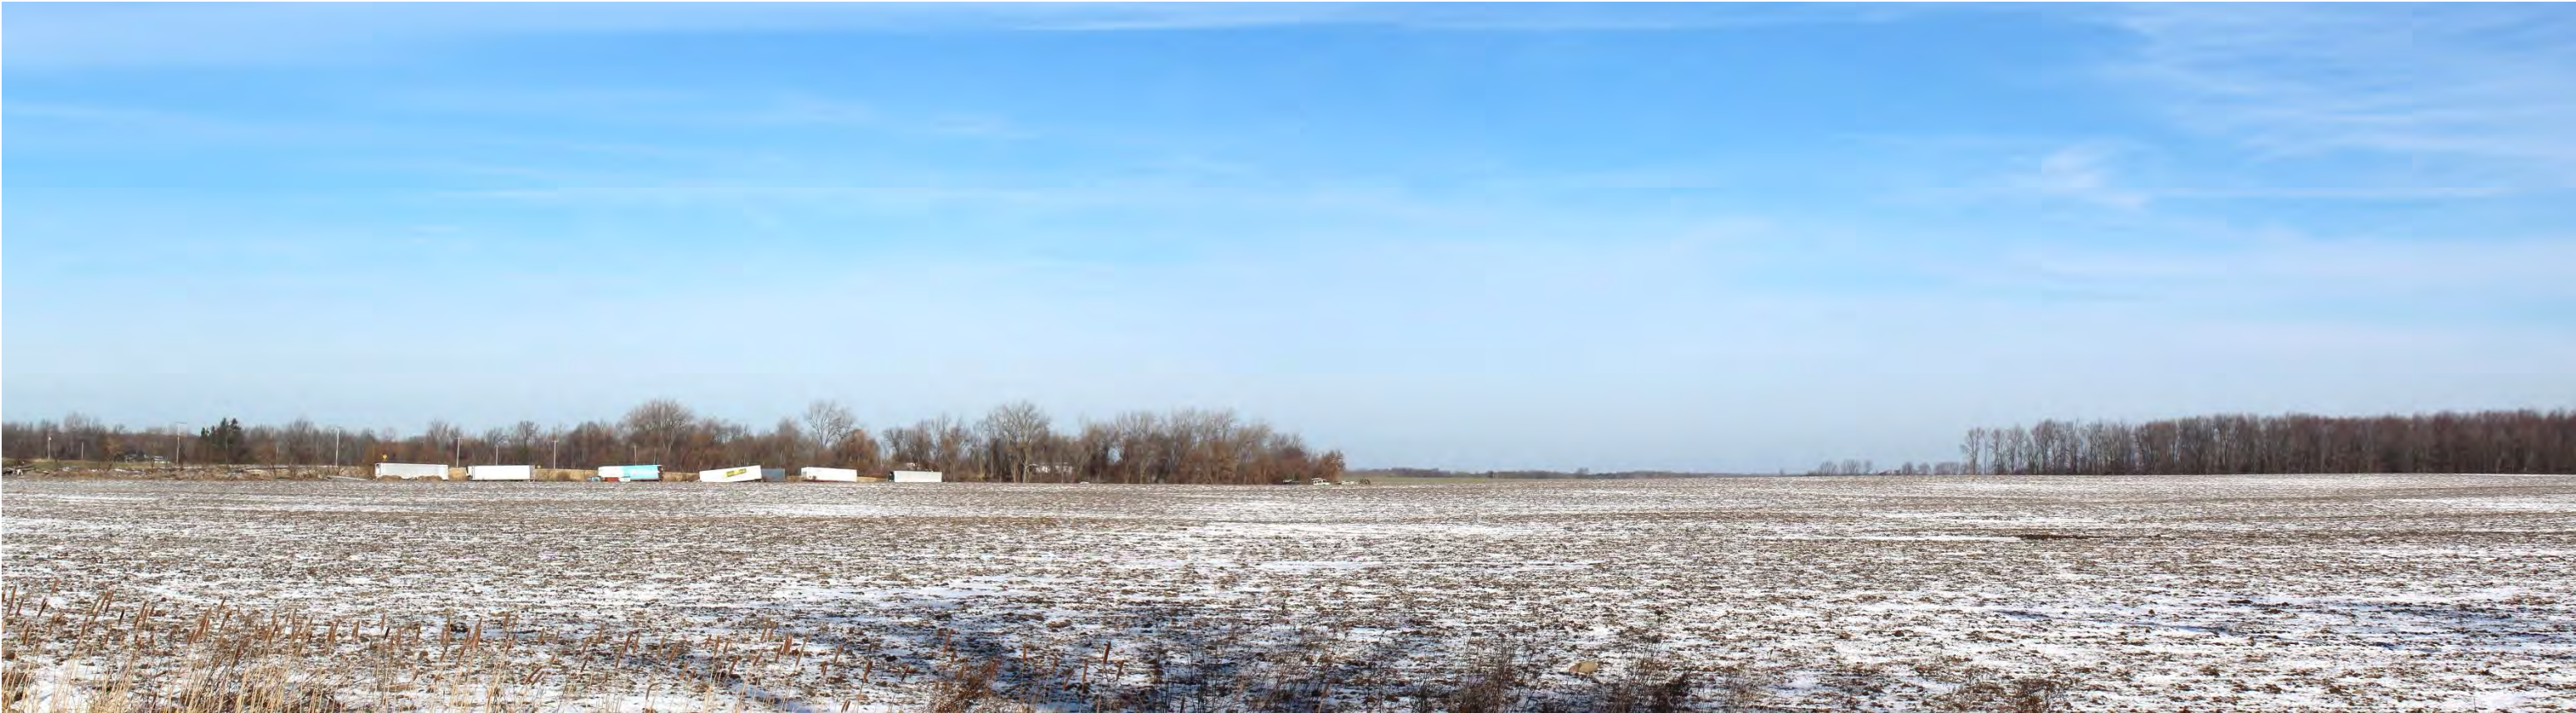
Existing Conditions

Viewpoint Coordinates in NY State Plane West	1274184.1 E 1111409.4 N
Town	Byron
Viewer Elevation (ft msl)	730
Distance to Fence Line	270 ft
Direction of View	N
Date/Time	12/13/19 11:46 AM

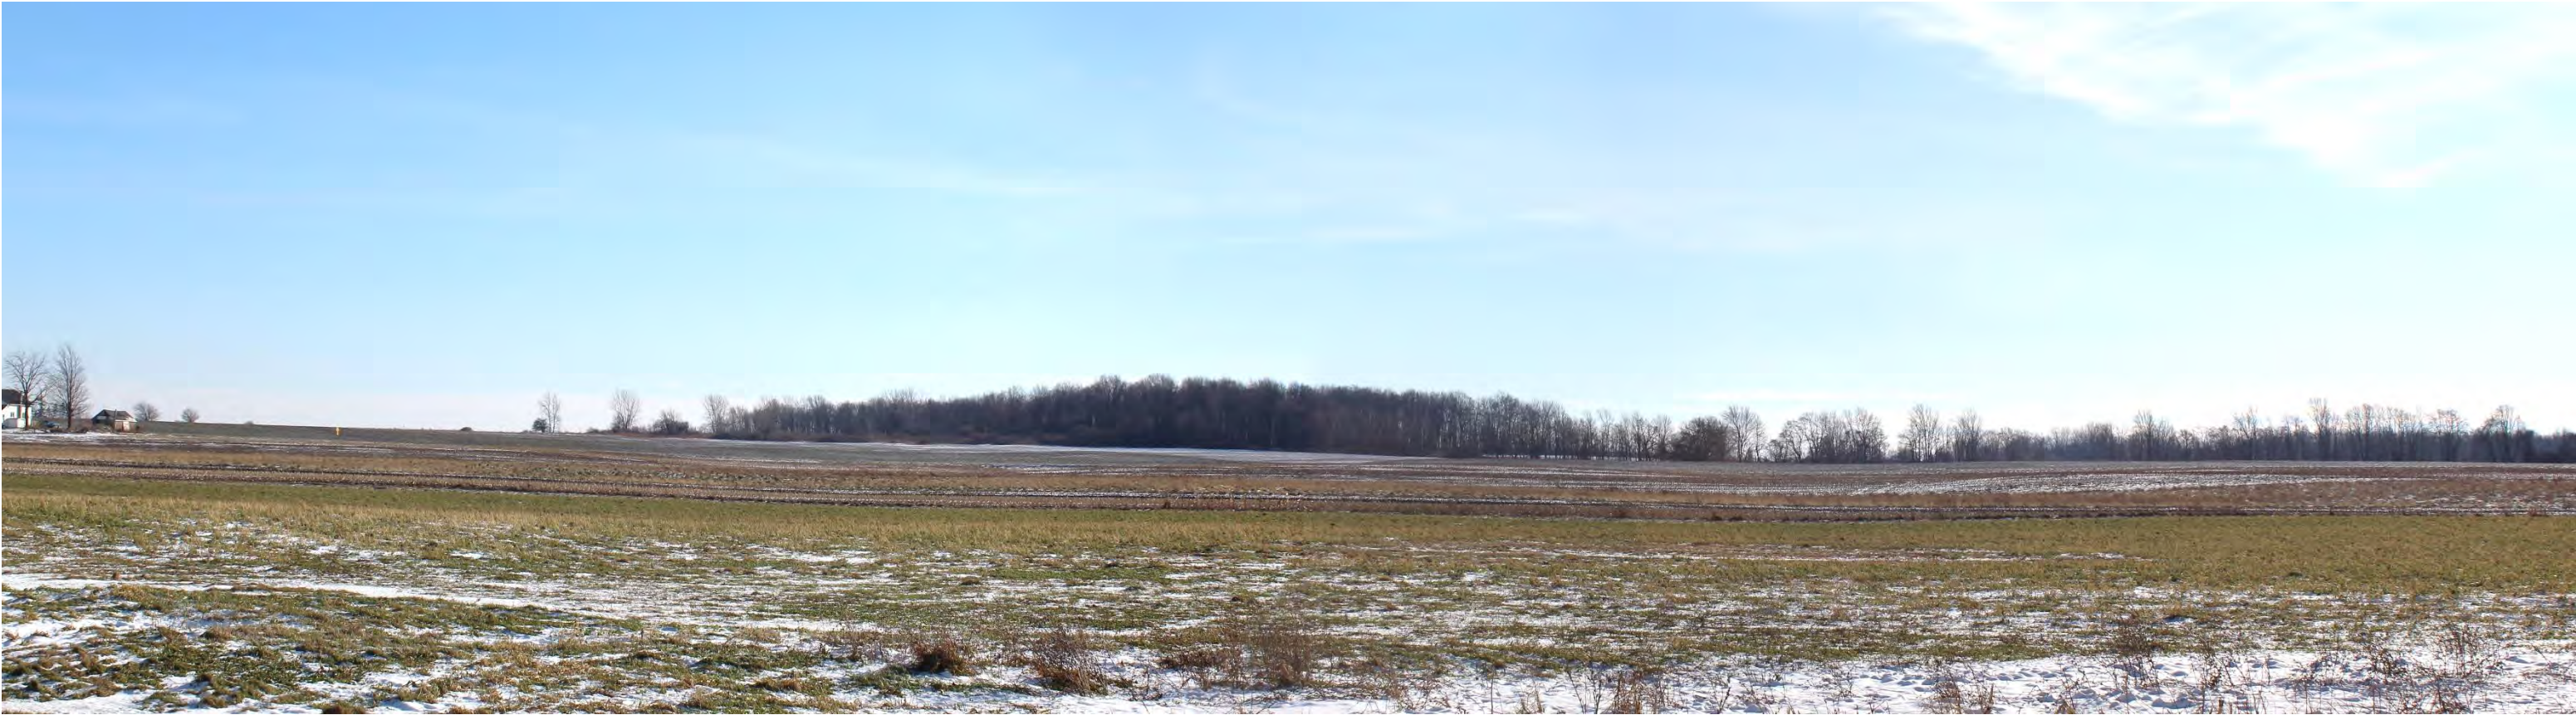
Existing Conditions

Viewpoint Coordinates in NY State Plane West	1274684.7 E 1118167.6 N
Town	Byron
Viewer Elevation (ft msl)	689
Distance to Fence Line	293 ft
Direction of View	SE
Date/Time	12/13/19 11:15 AM

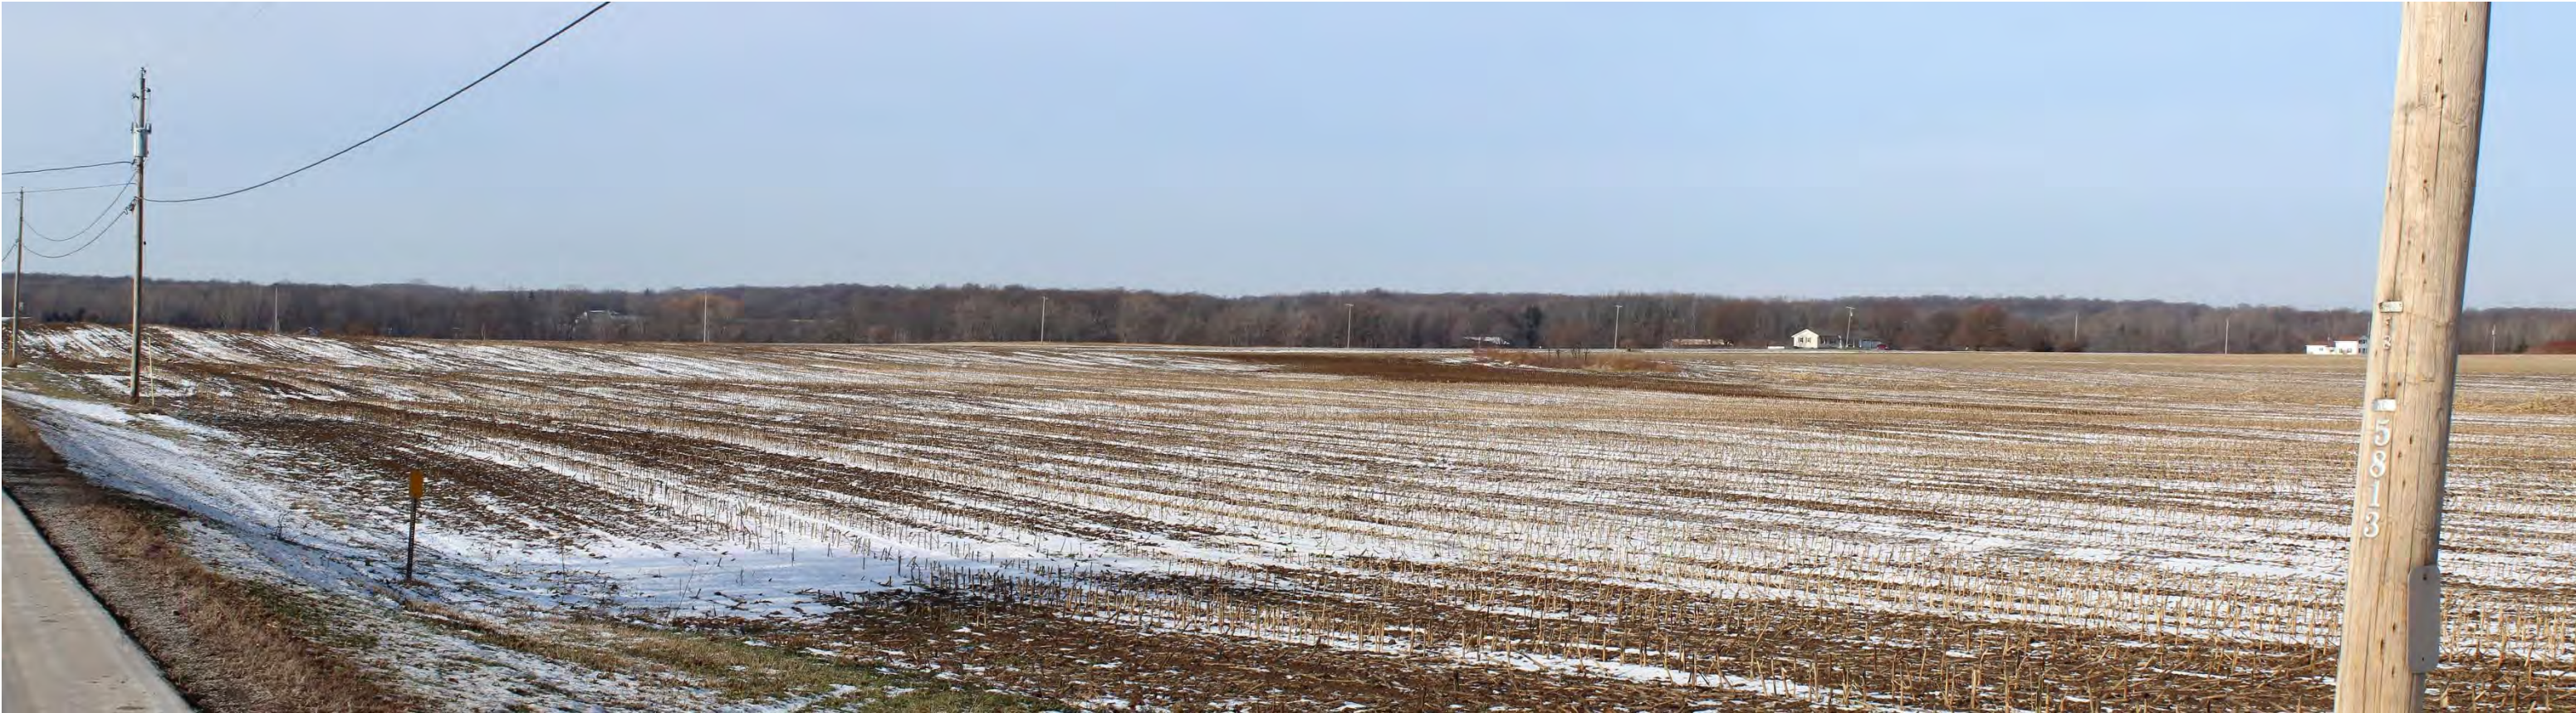
Existing Conditions

Viewpoint Coordinates in NY State Plane West	1278157.4 E 1118100.3 N
Town	Byron
Viewer Elevation (ft msl)	707
Distance to Fence Line	407 ft
Direction of View	NW
Date/Time	12/13/19 11:06 AM

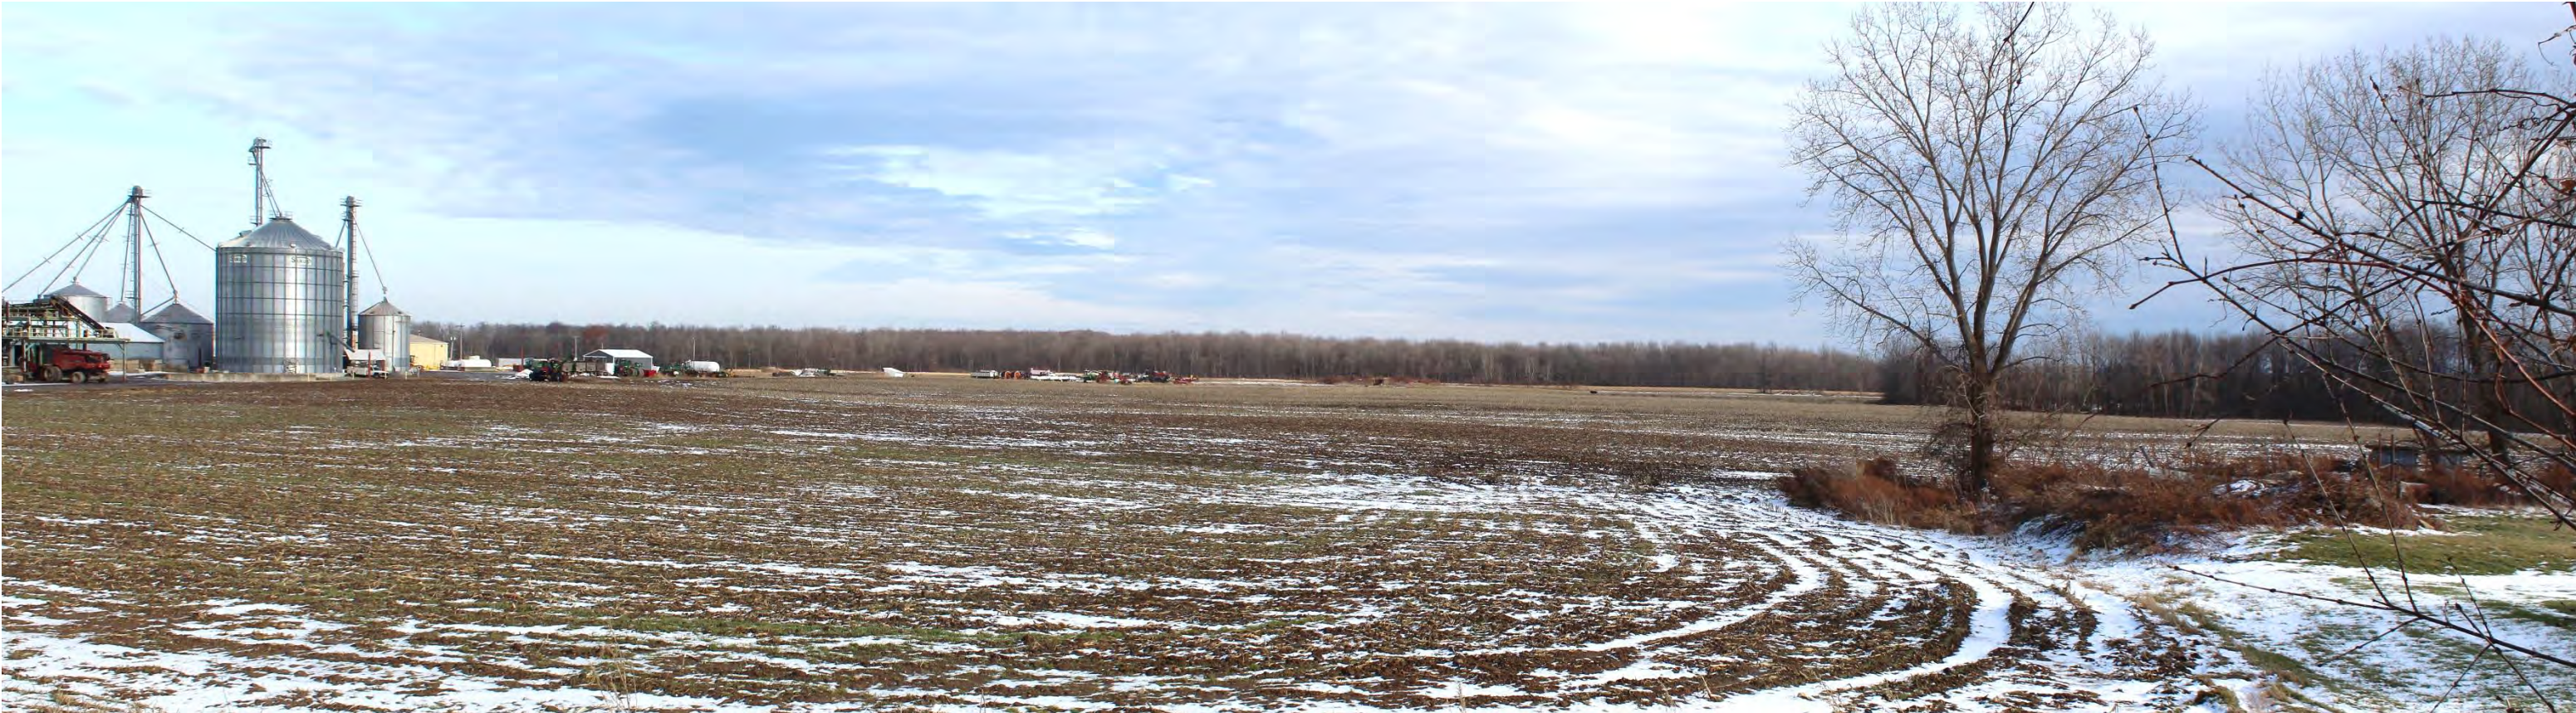
Existing Conditions

Viewpoint Coordinates in NY State Plane West	1278887.4 E 11114454.7 N
Town	Byron
Viewer Elevation (ft msl)	695
Distance to Fence Line	302 ft
Direction of View	NE
Date/Time	12/13/19 2:18 PM

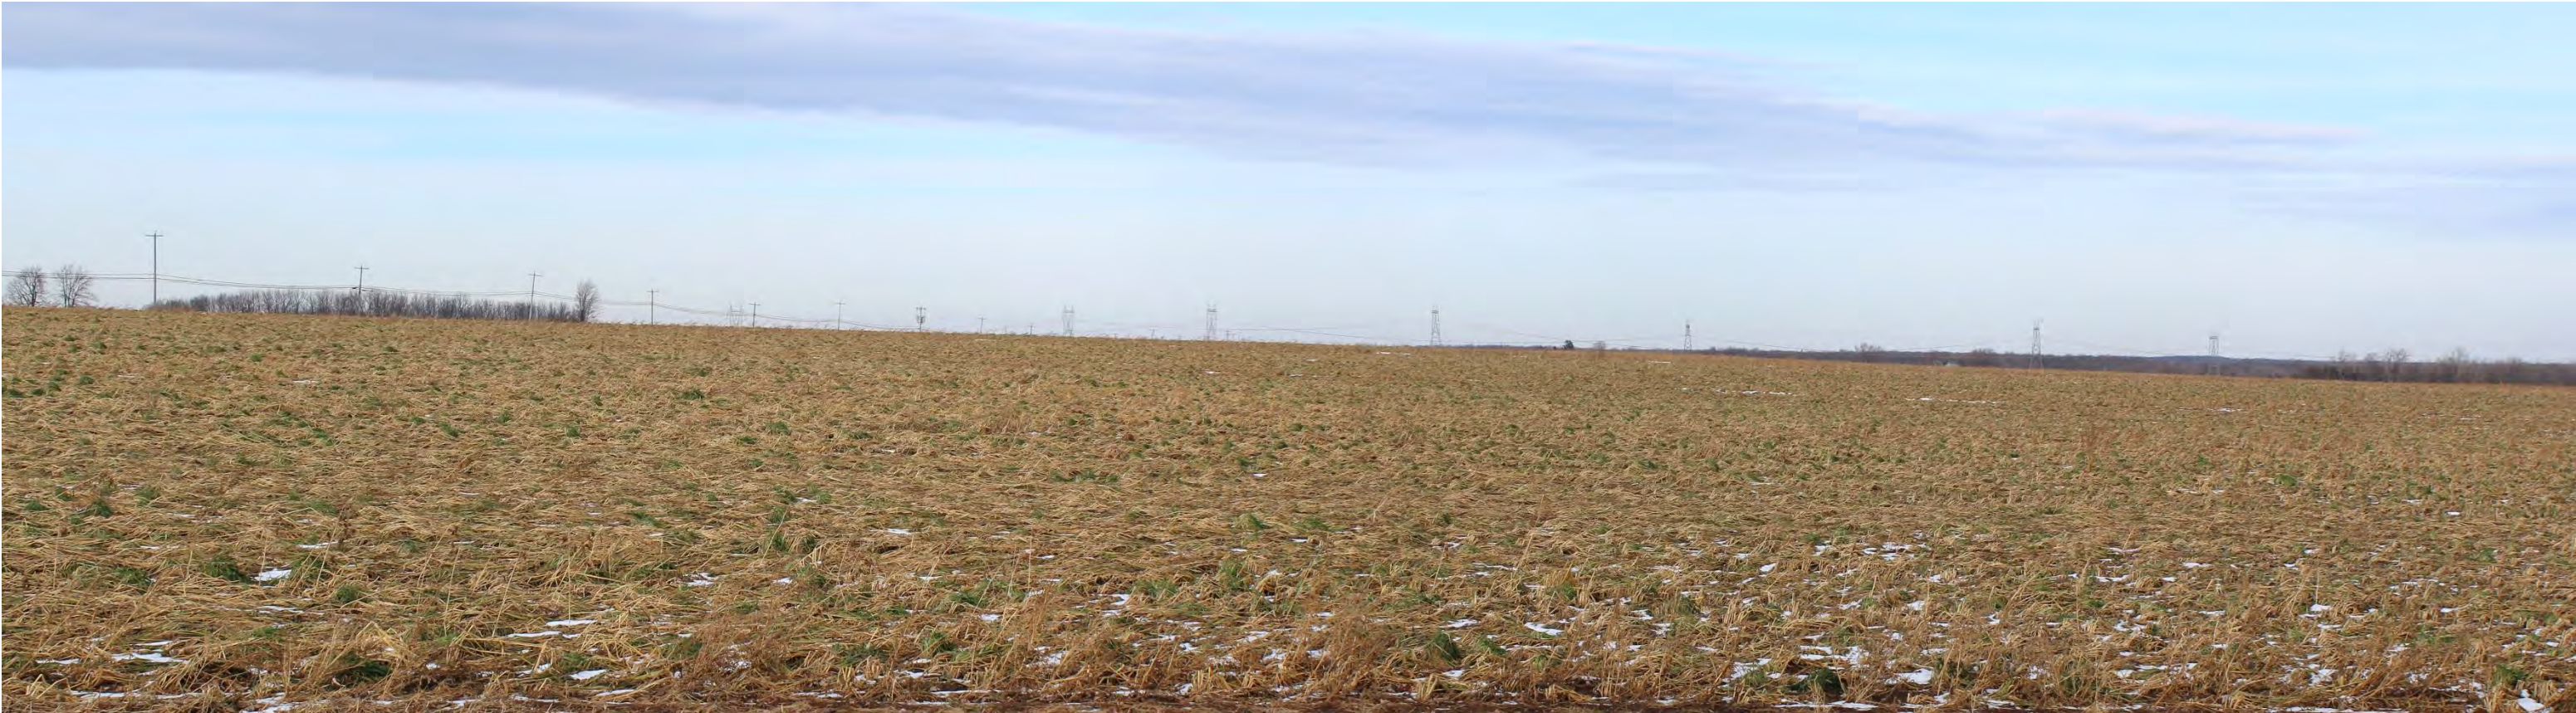
Existing Conditions

Viewpoint Coordinates in NY State Plane West	1280837.7 E 1117930.8 N
Town	Byron
Viewer Elevation (ft msl)	685
Distance to Fence Line	288 ft
Direction of View	N
Date/Time	12/13/19 10:42 AM

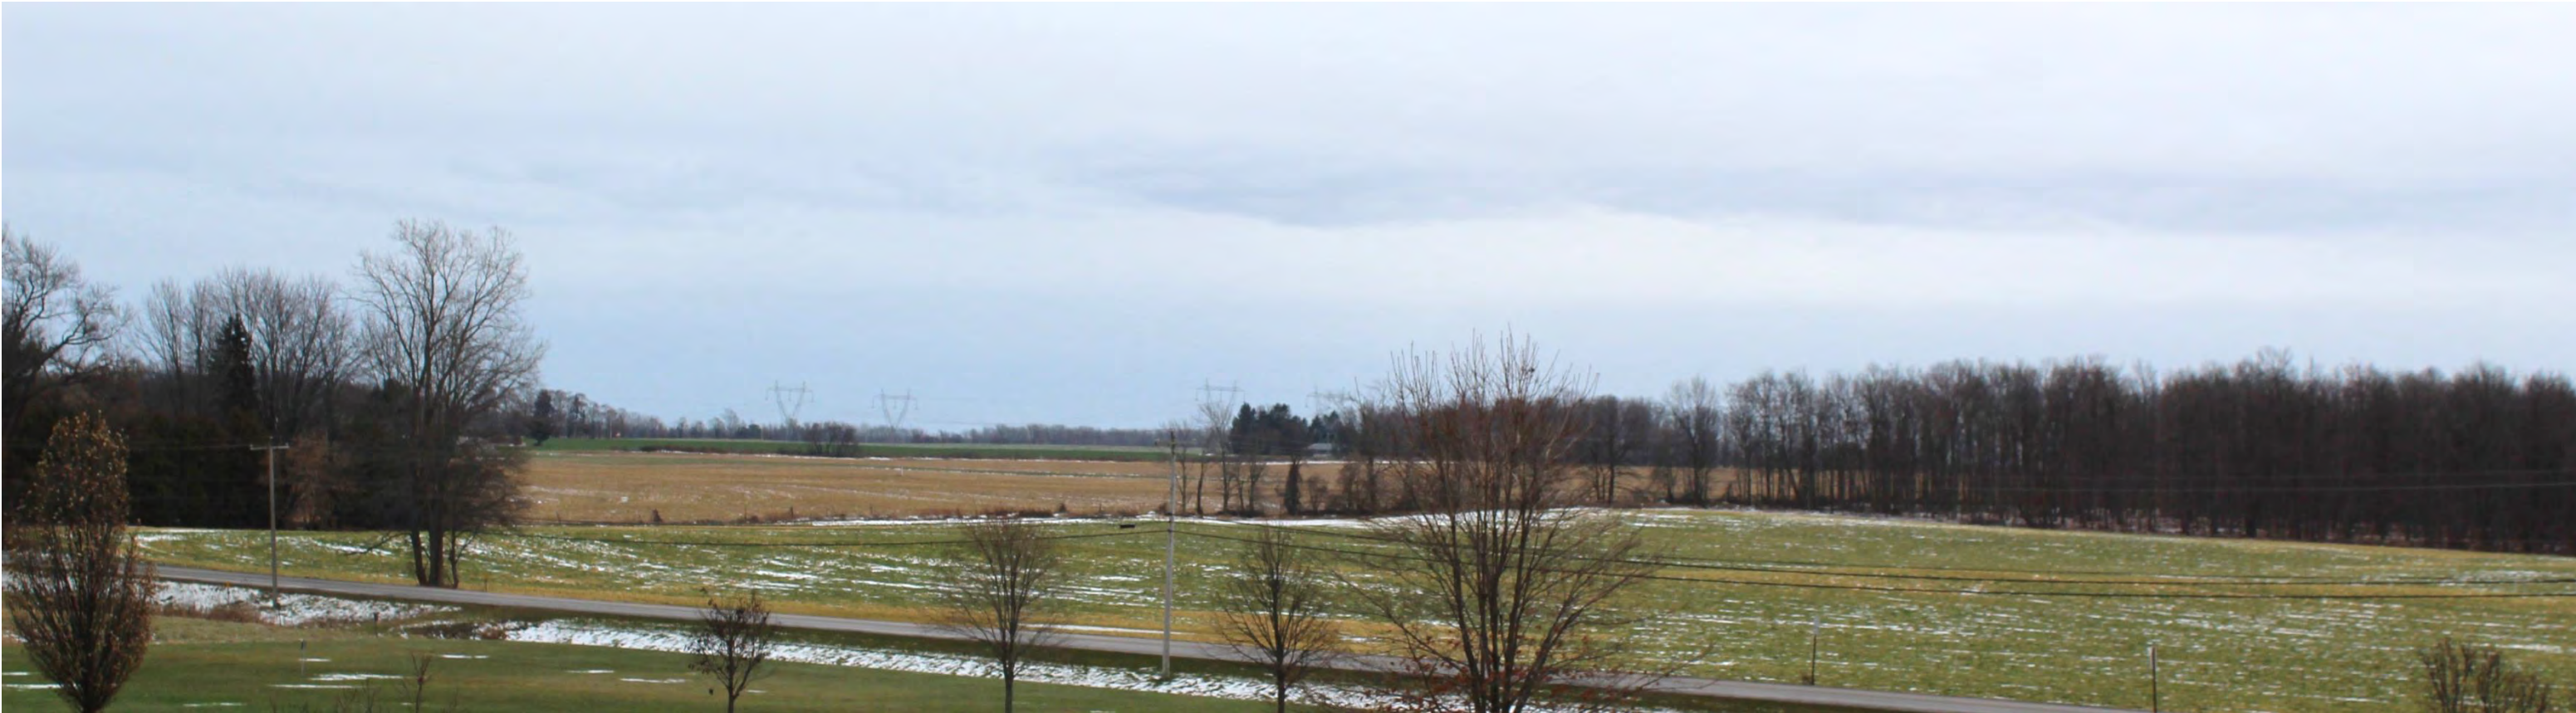
Existing Conditions

Viewpoint Coordinates in NY State Plane West	1288920.8 E 1122864.7 N
Town	Byron
Viewer Elevation (ft msl)	636
Distance to Fence Line	1327 ft
Direction of View	SE
Date/Time	12/13/19 10:22 AM

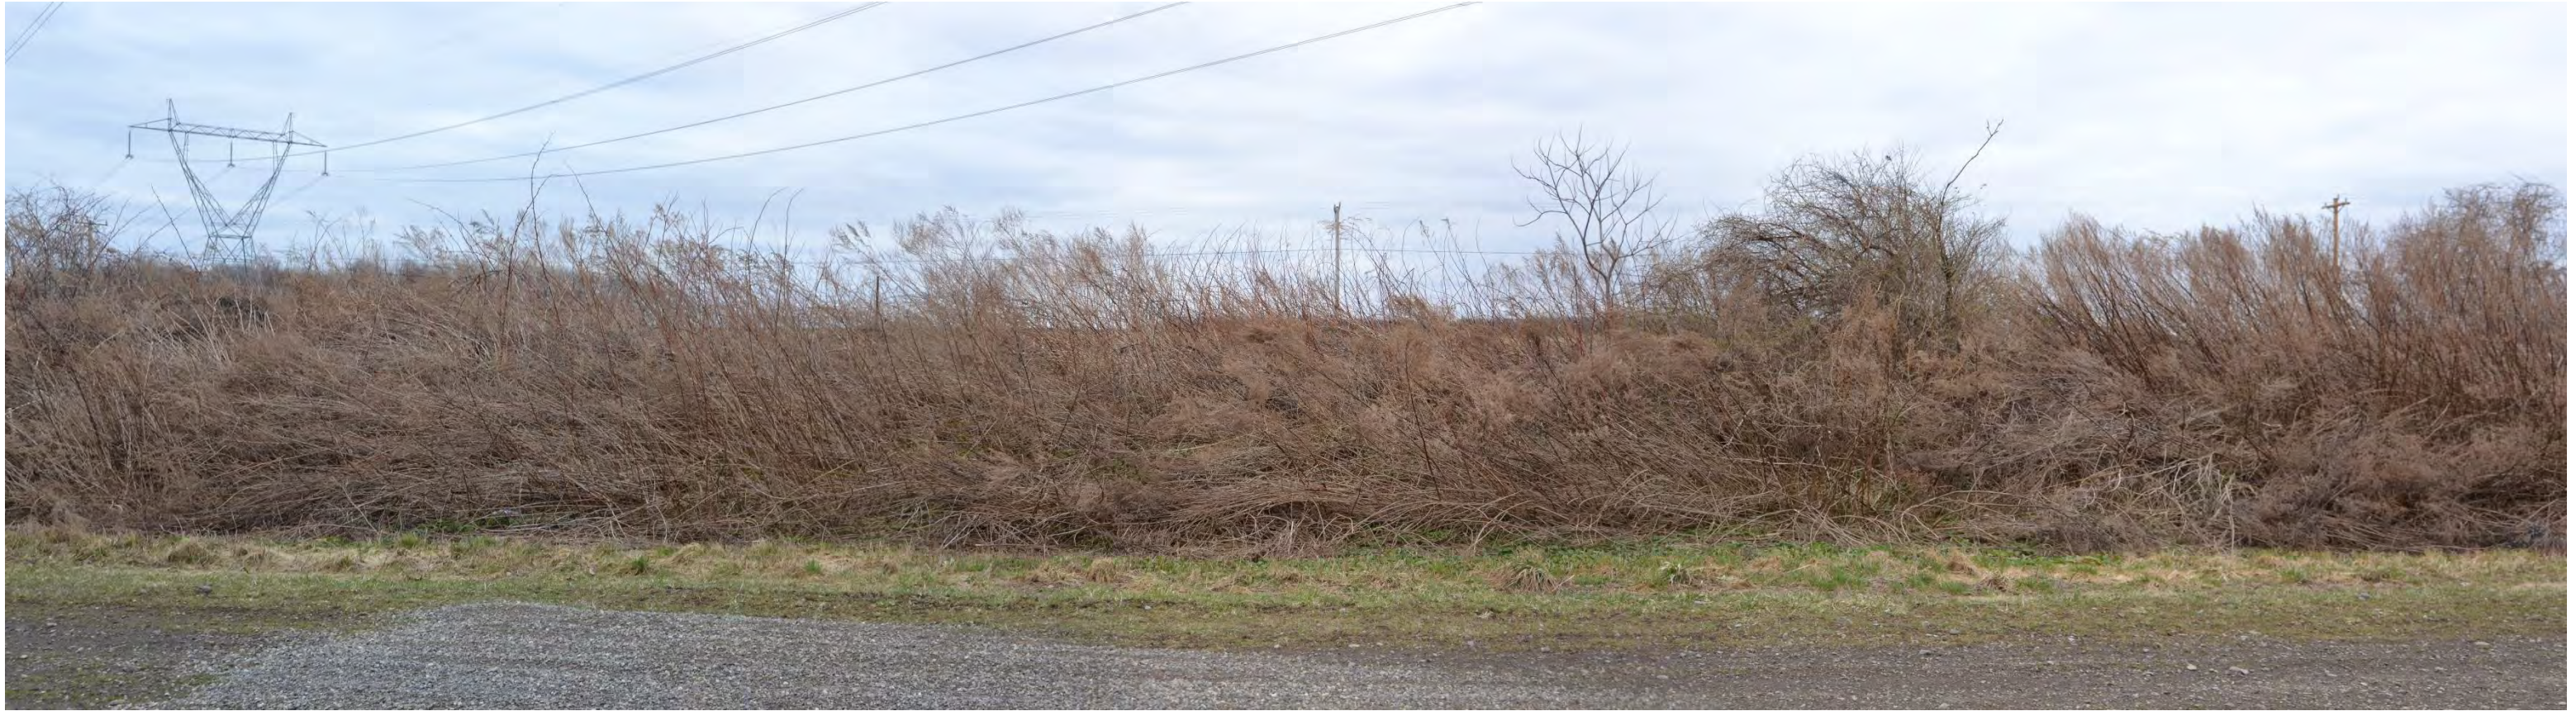
Existing Conditions

Viewpoint Coordinates in NY State Plane West	1279072.5 E 1123151.3 N
Town	Byron
Viewer Elevation (ft msl)	651
Distance to Fence Line	655 ft
Direction of View	S
Date/Time	3/24/20 10:01 AM

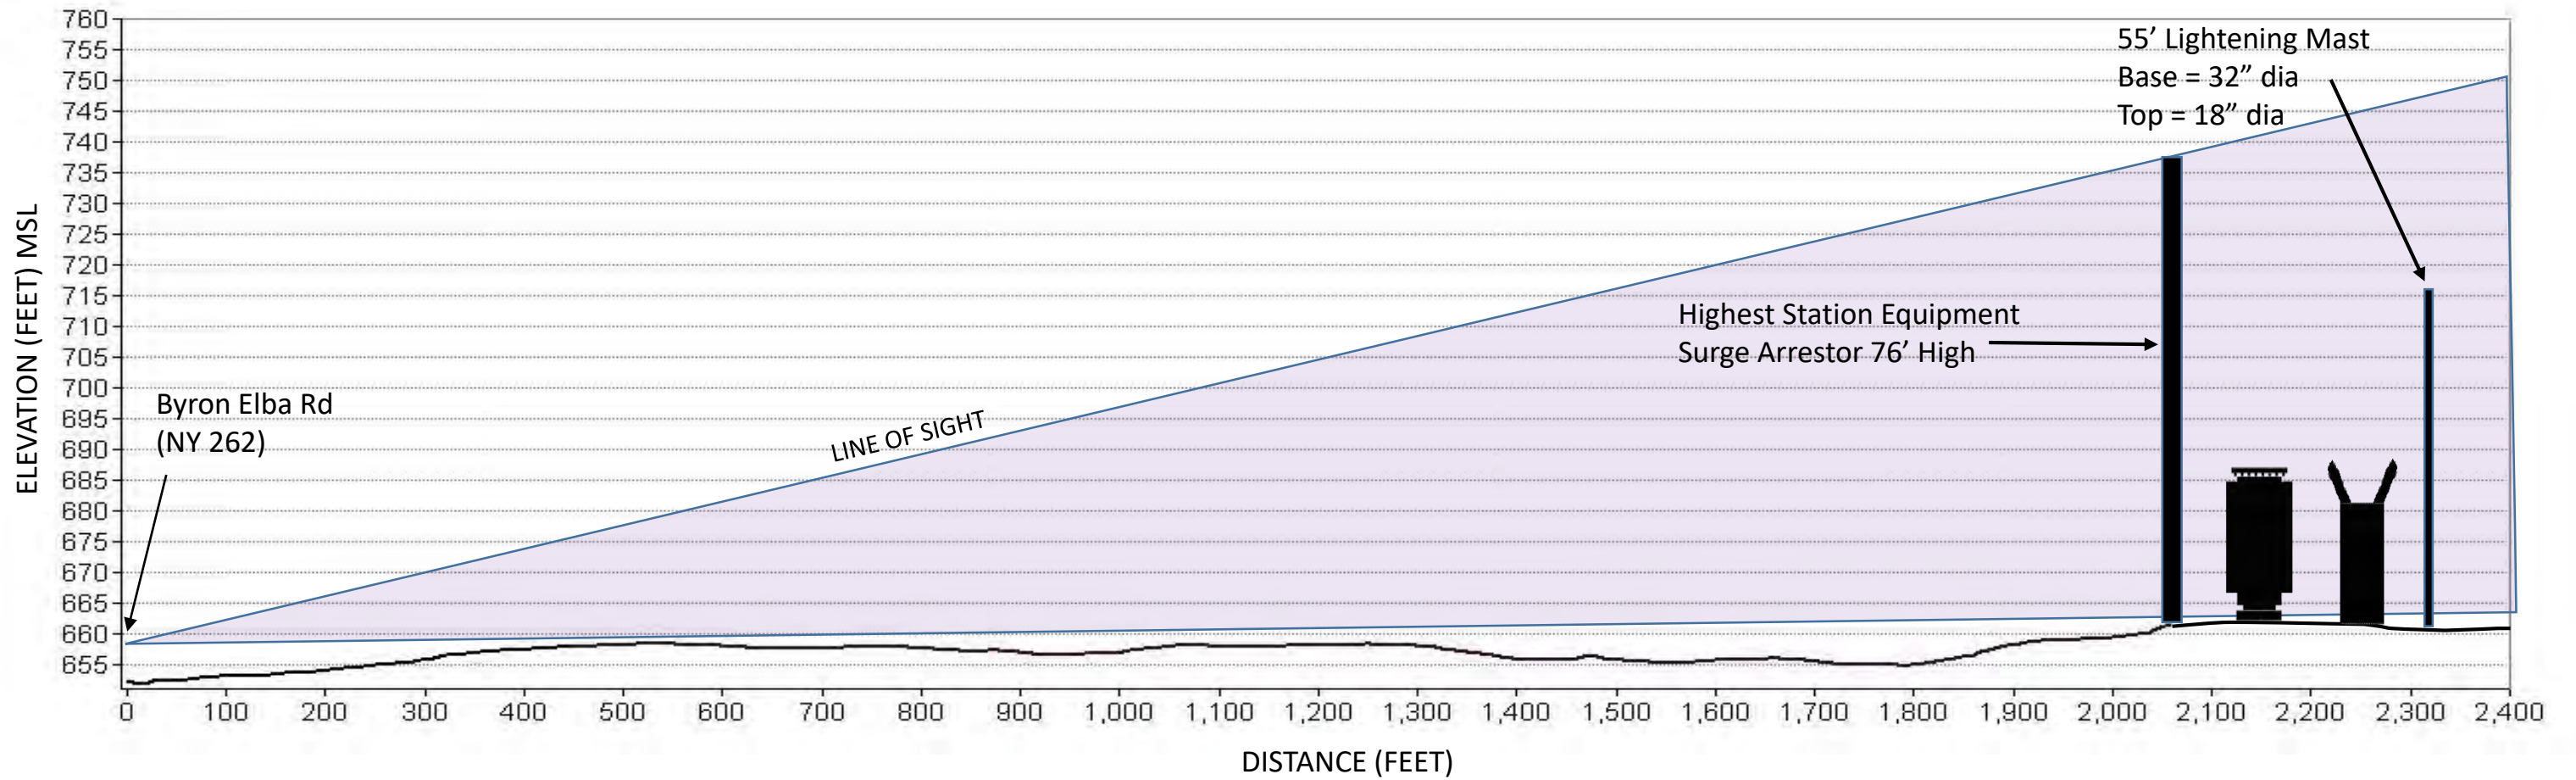
L1 - LINE OF SIGHT FROM – BYRON ELBA ROAD (NY 262) TO COLLECTION SUBSTATION

Viewpoint Coordinates in	1282961.6
NY State Plane East	1122766.1
Viewpoint Location	NY 262
Distance to Object	0.35 miles
Direction of View	S

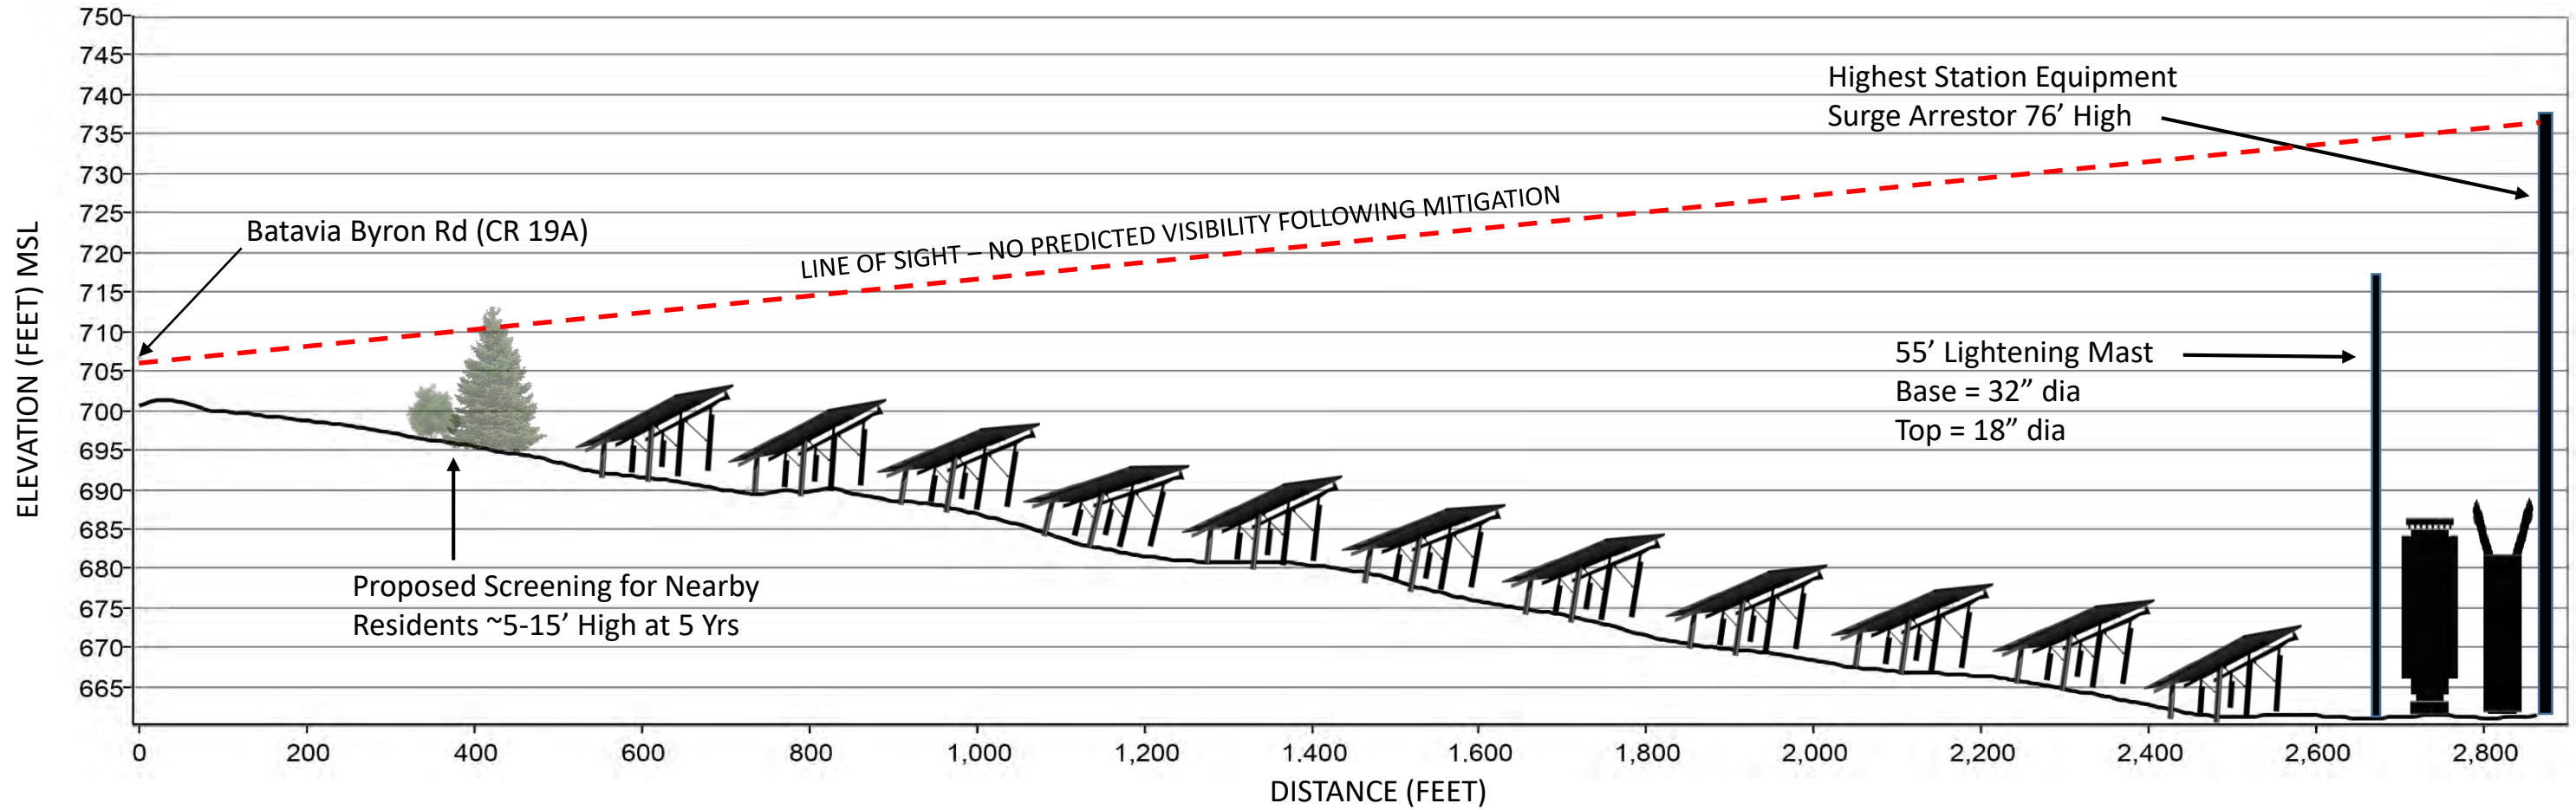
L2 - LINE OF SIGHT FROM – BATAVIA BYRON RD (CR 19A) TO COLLECTION SUBSTATION

Viewpoint Coordinates in	1280589.6
NY State Plane East	1119092.5
Viewpoint Location	CR 19A
Distance to Object	0.5 miles
Direction of View	NE
