Attachment N

Visual Impact Assessment - Revised Simulations

Viewpoint Coordinates in	1274684.7 E
NY State Plane West	1118167.6 N
Town	Byron
Viewer Elevation (ft msl)	689
Distance to Fence Line	293 ft
Direction of View	SE
Date/Time	12/13/19 11:15 AM
Excelsior Energy Center Byron, New York Visual Simulation of Project December 2020

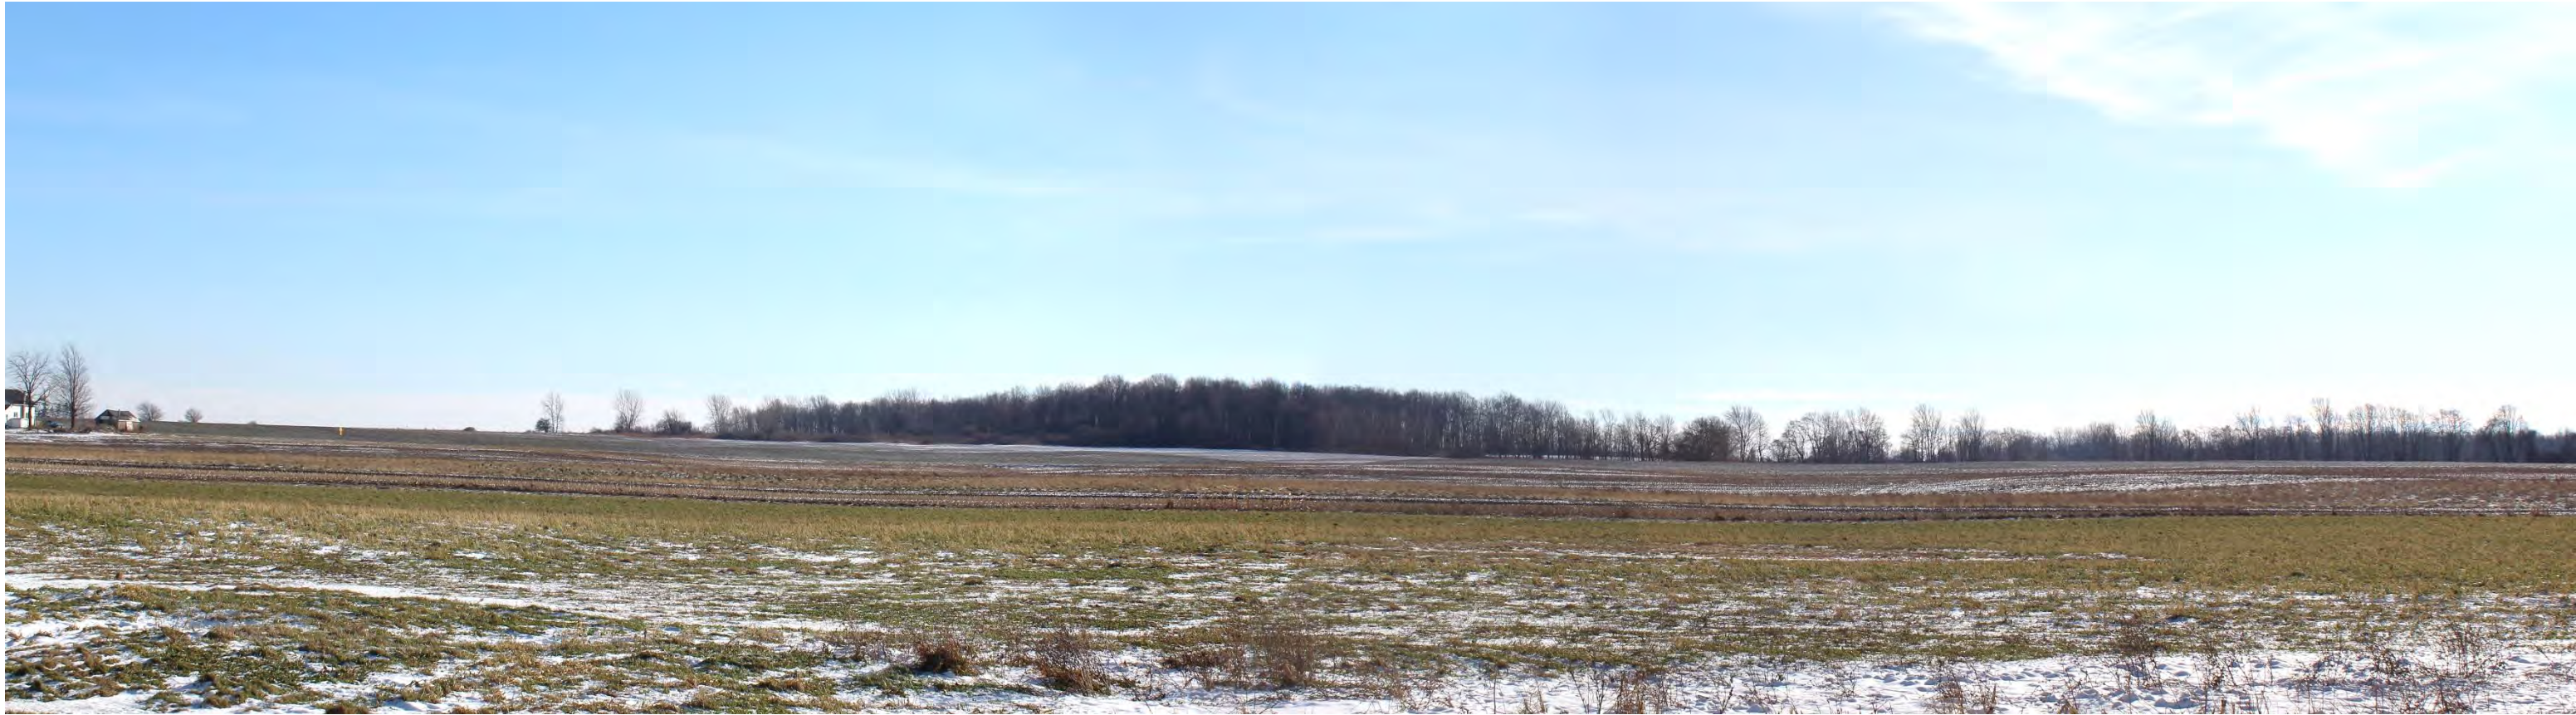
Existing Conditions

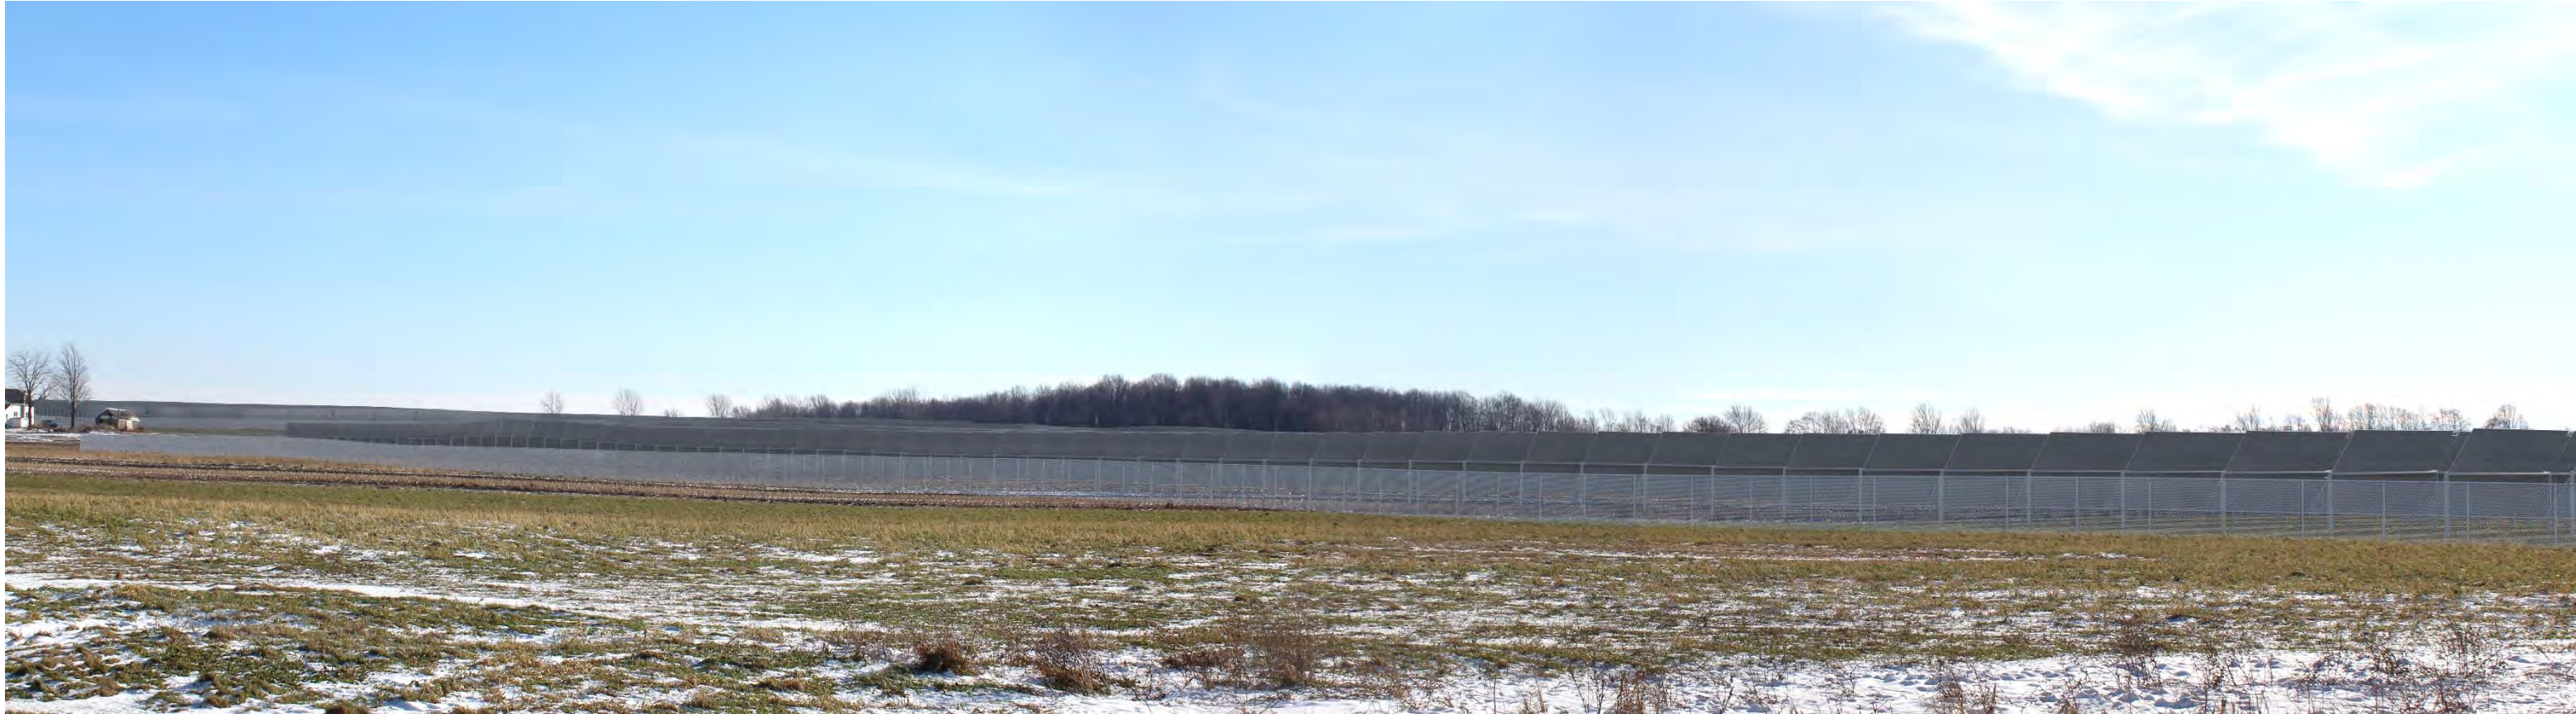
Simulation Proposed Conditions

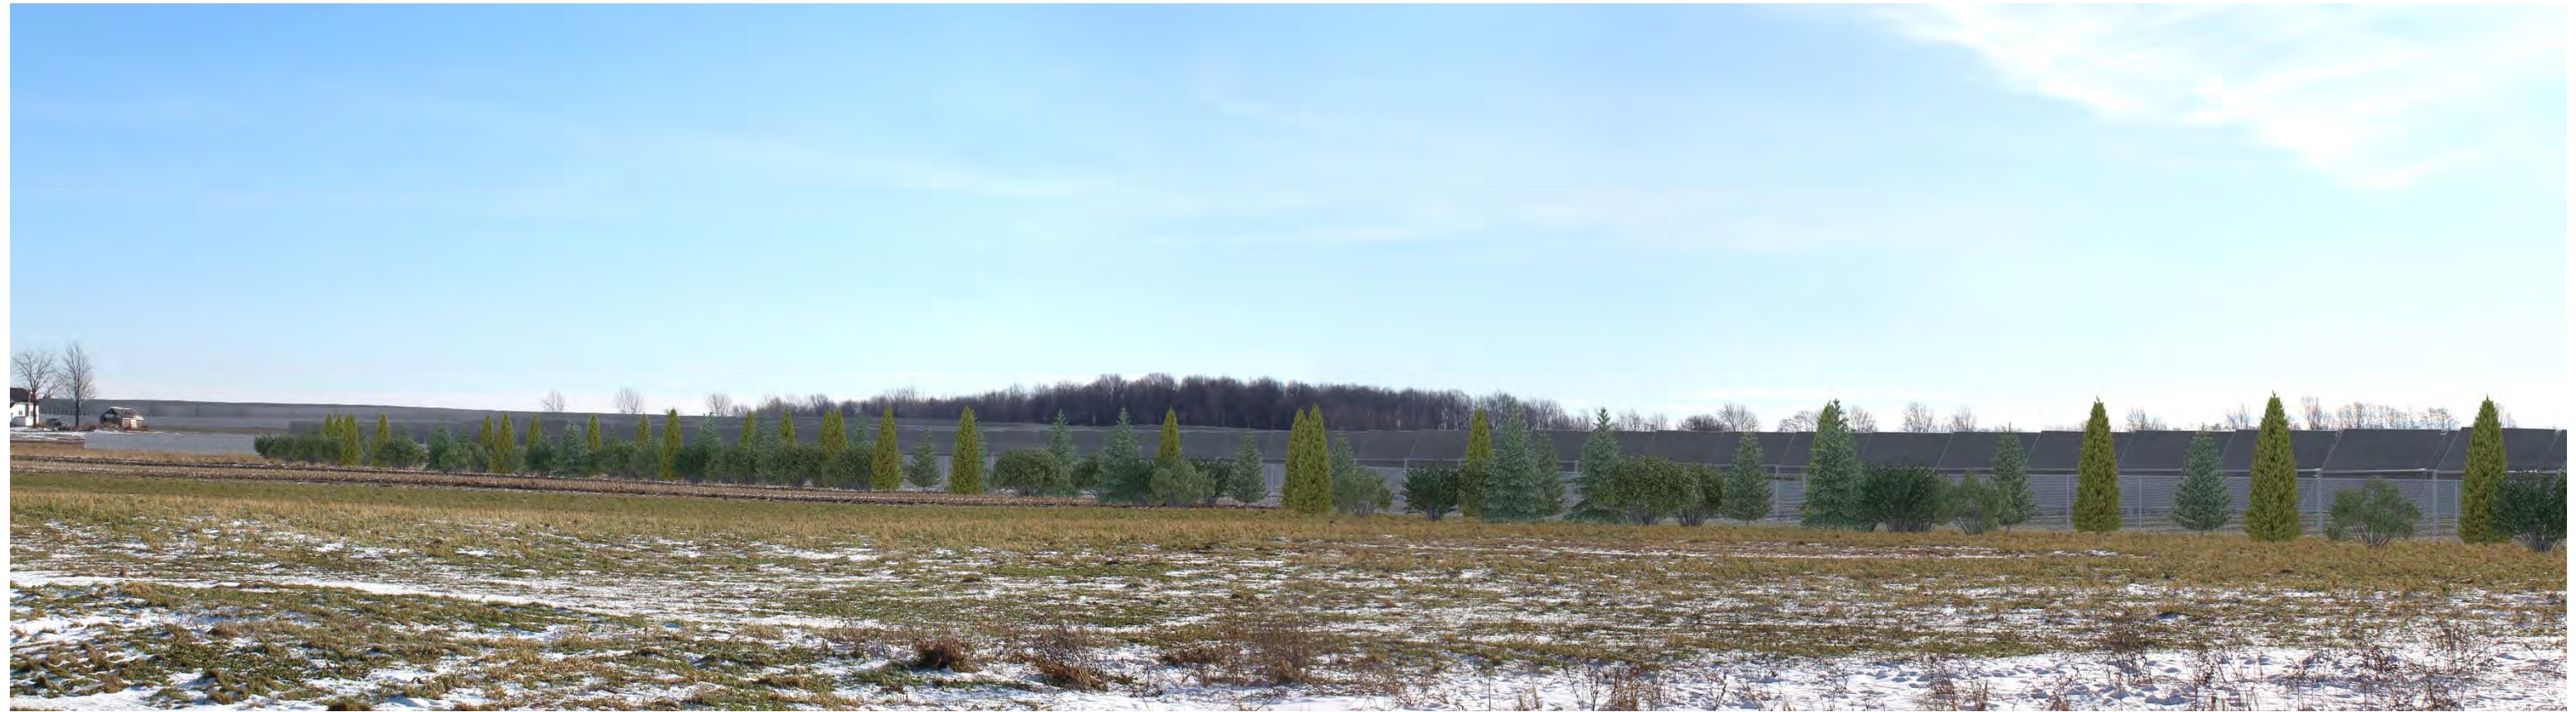
Simulation Mitigation at 5 years – Leaf On

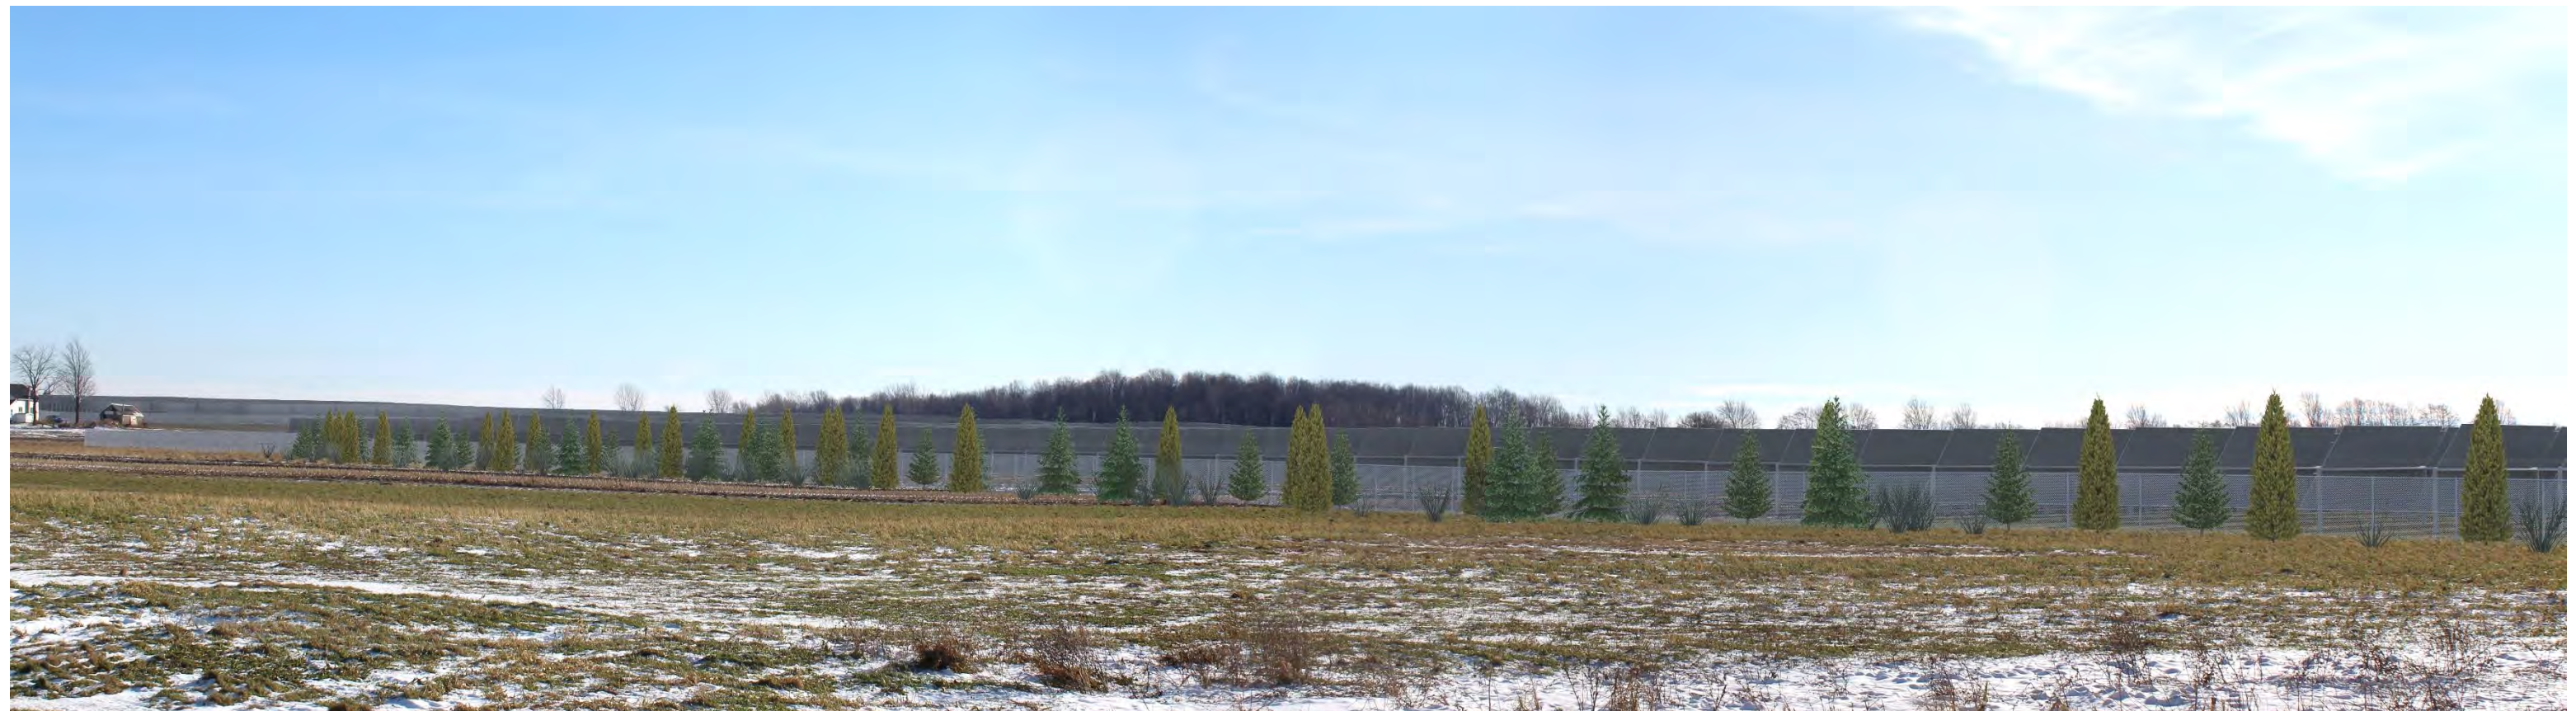
Simulation Mitigation at 5 years – Leaf Off

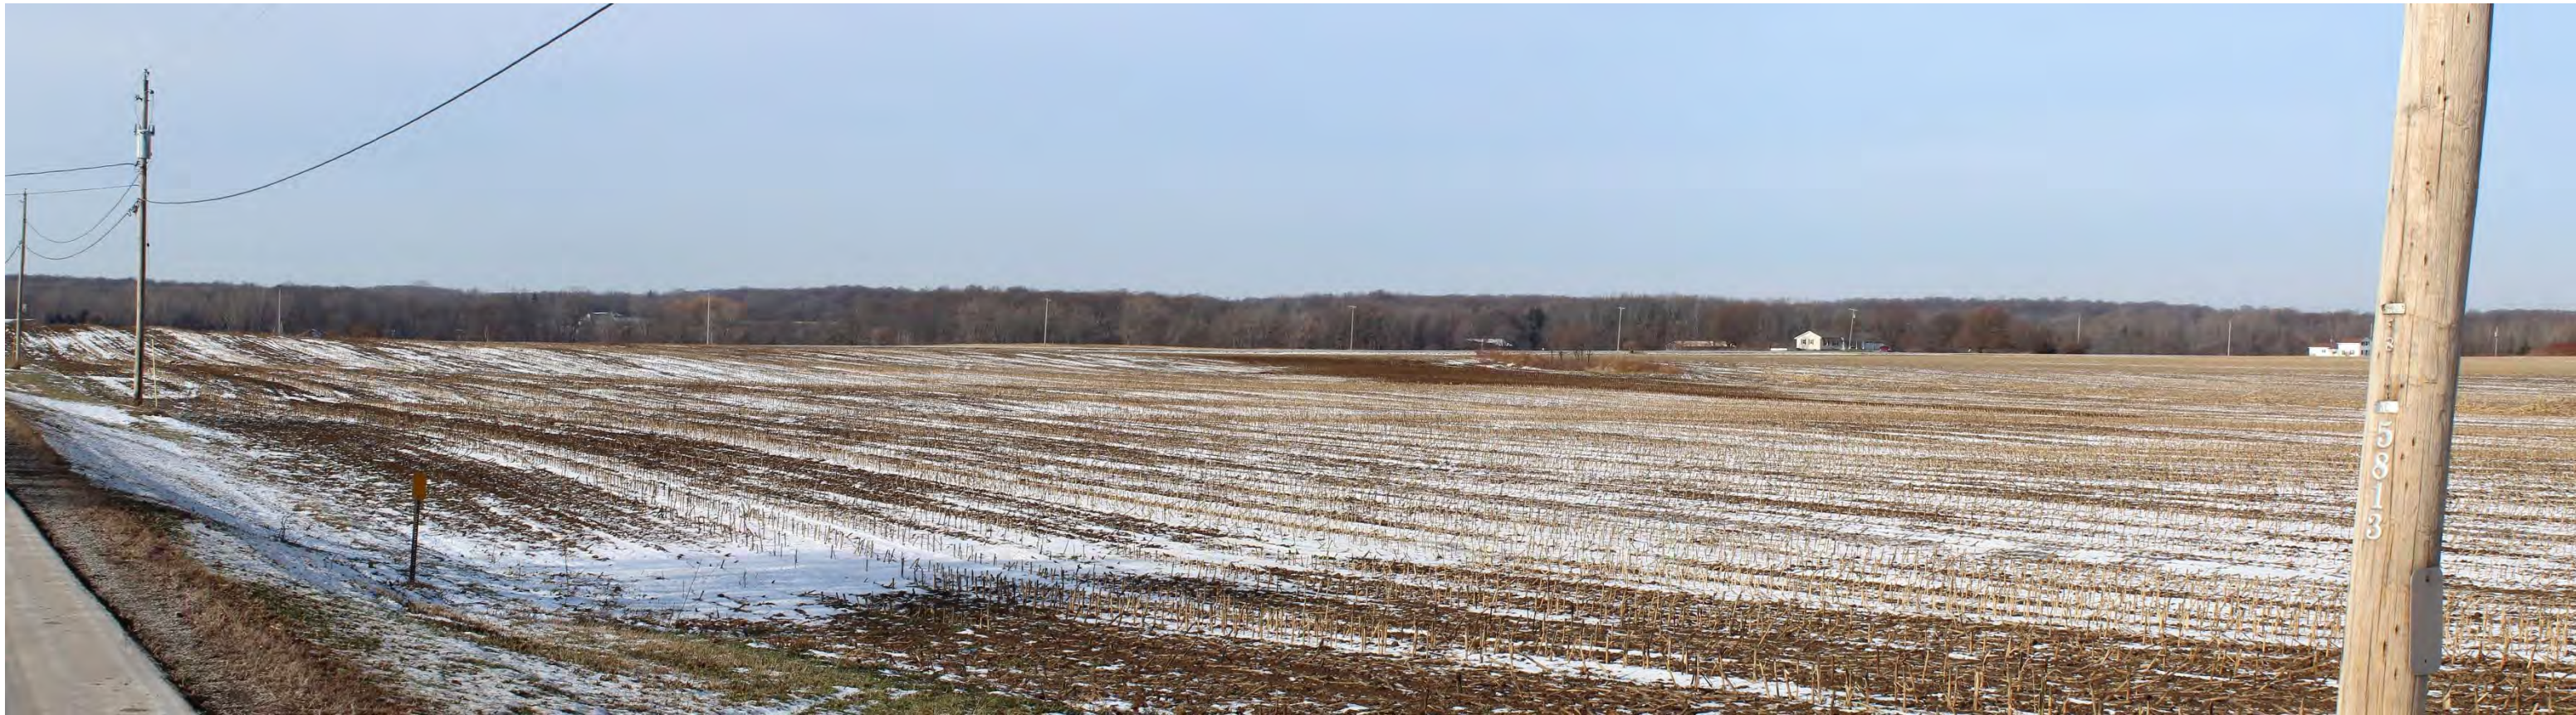
Existing Conditions

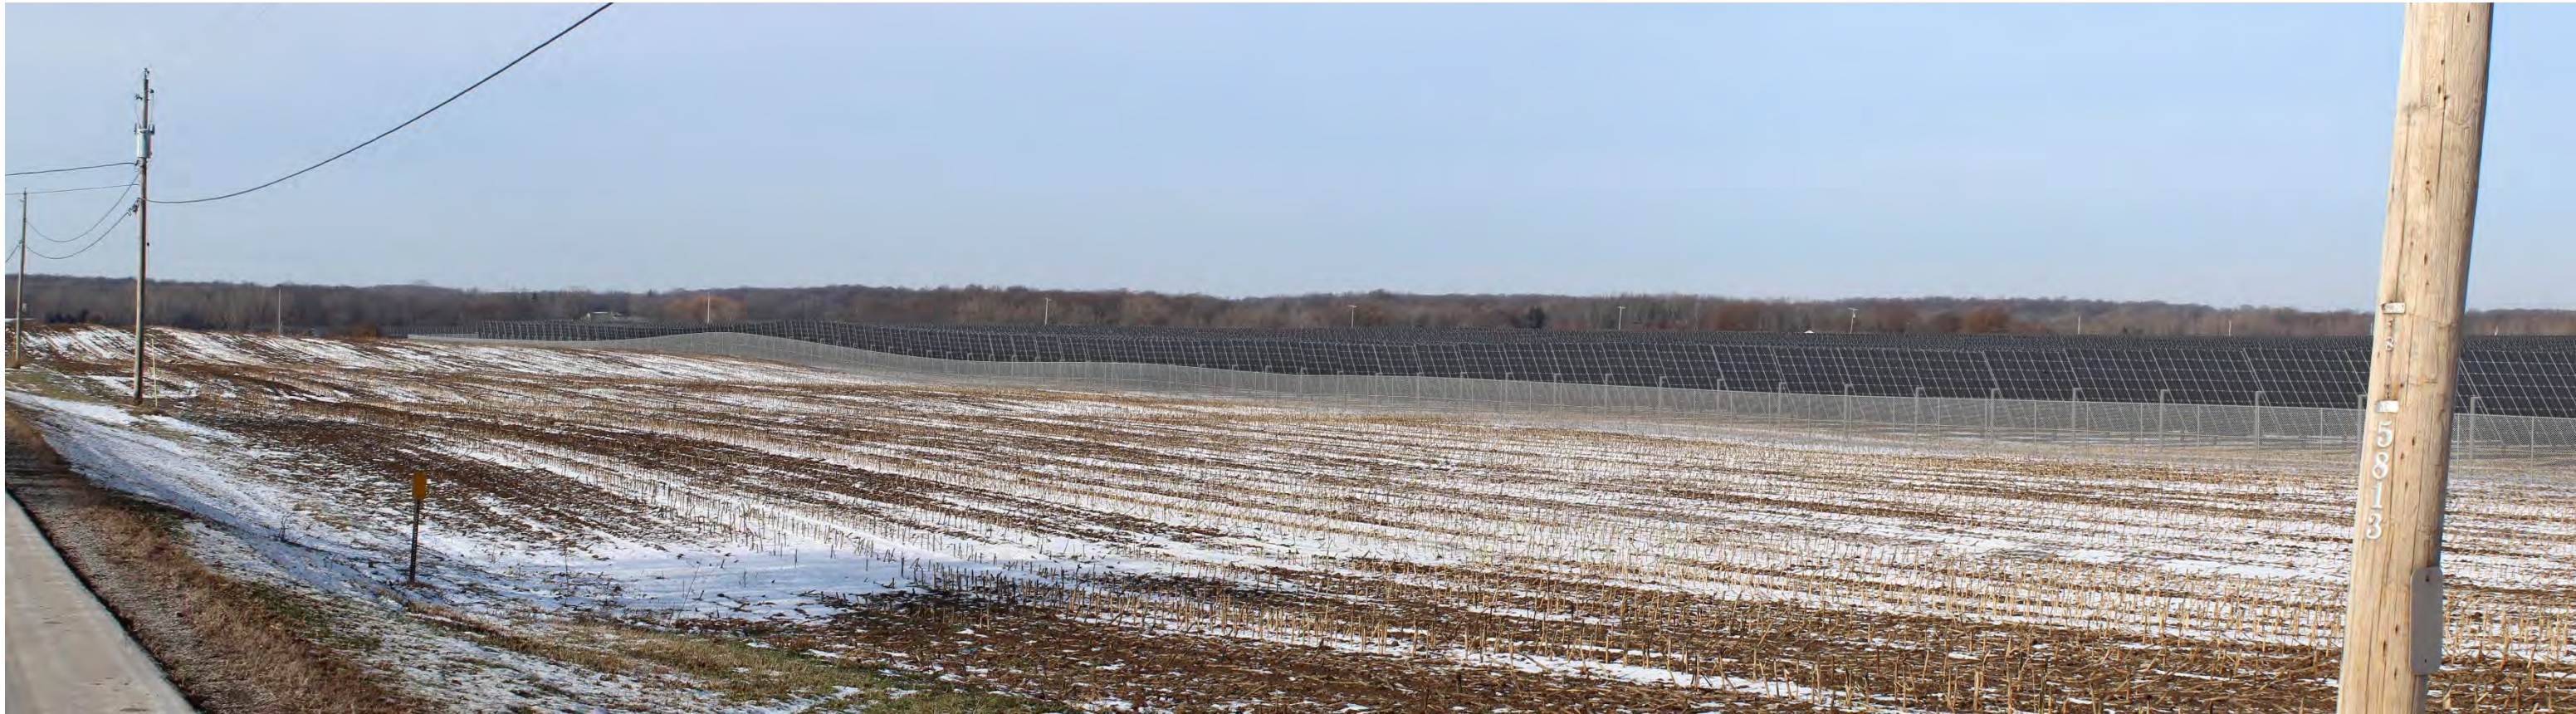
Simulation Proposed Conditions

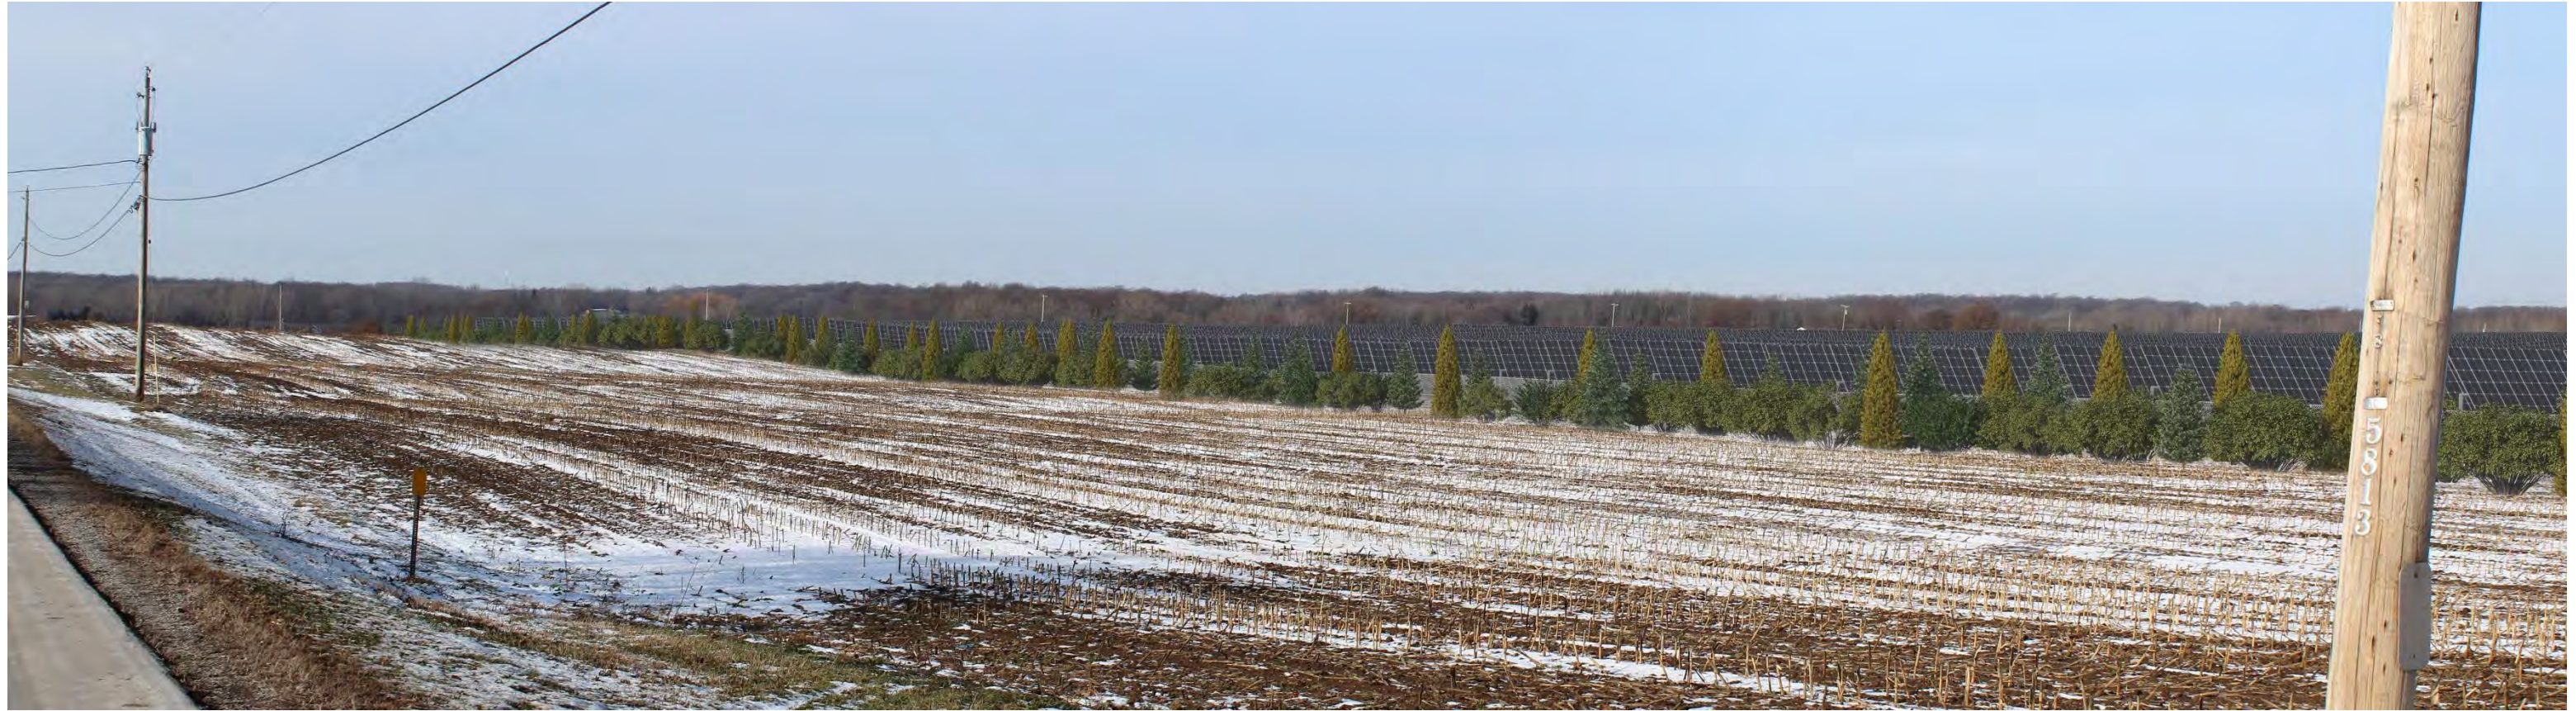
Simulation Mitigation at 5 years – Leaf On

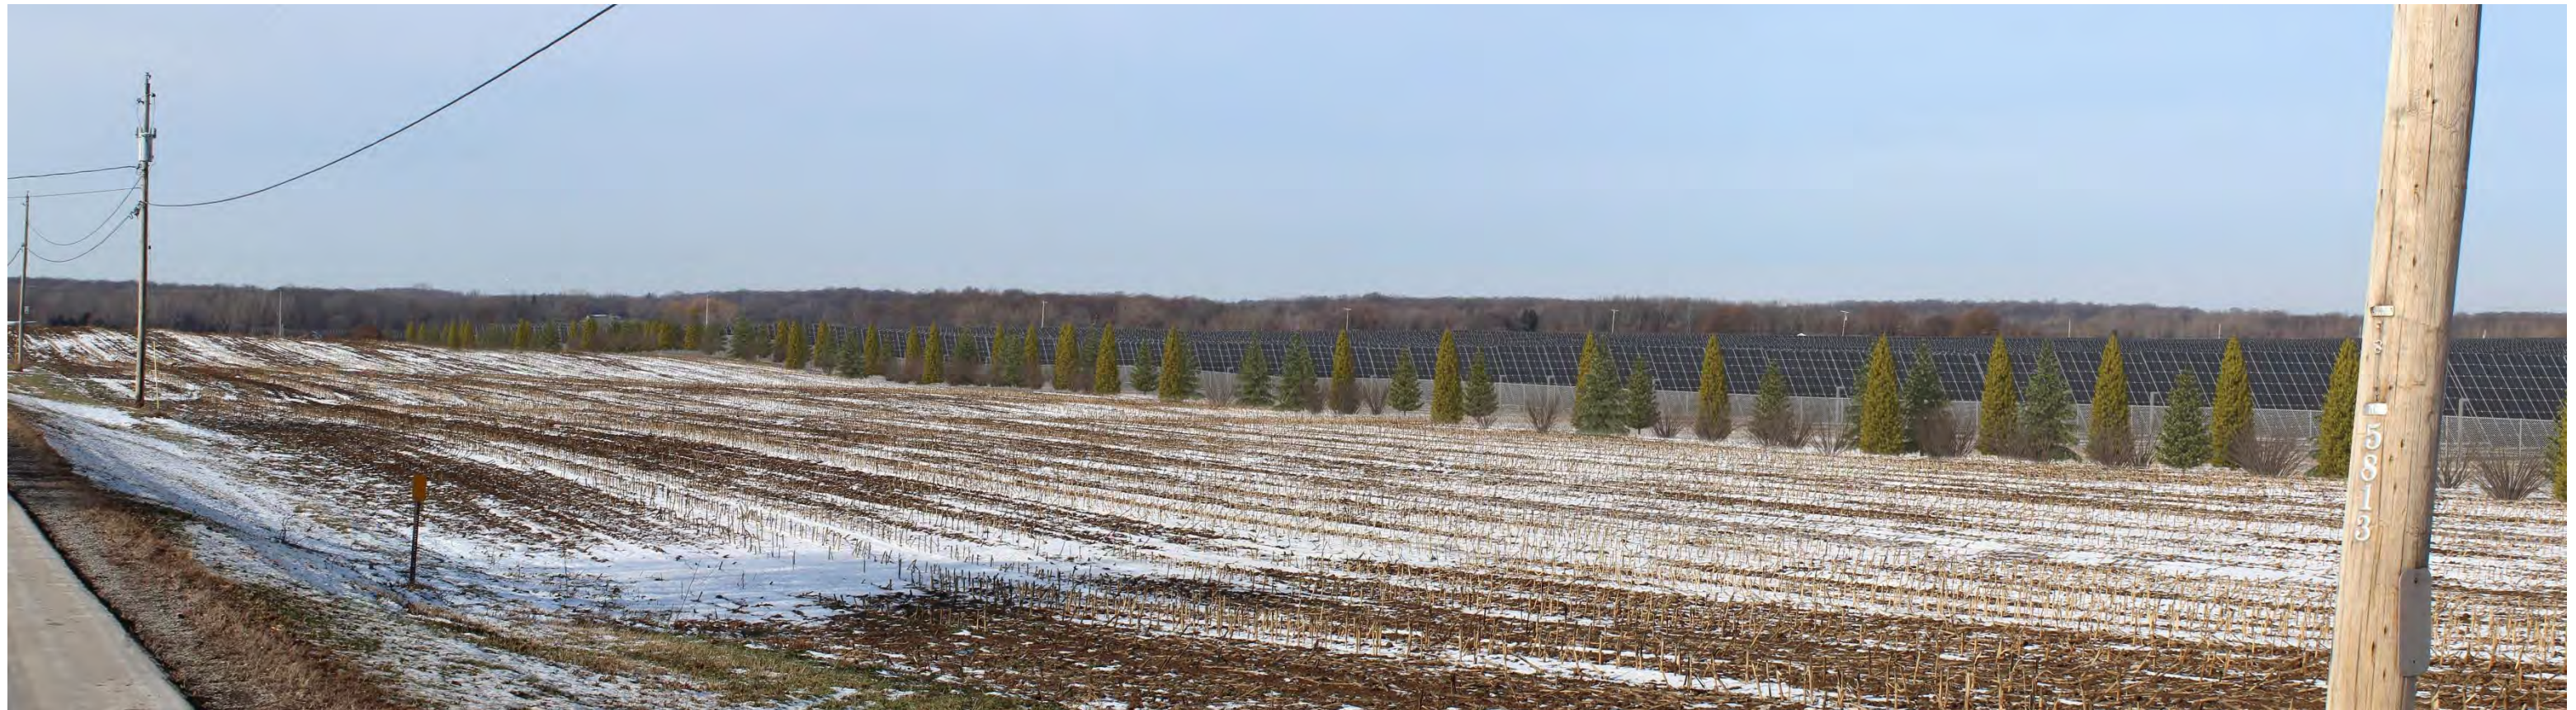
Simulation Mitigation at 5 years – Leaf Off

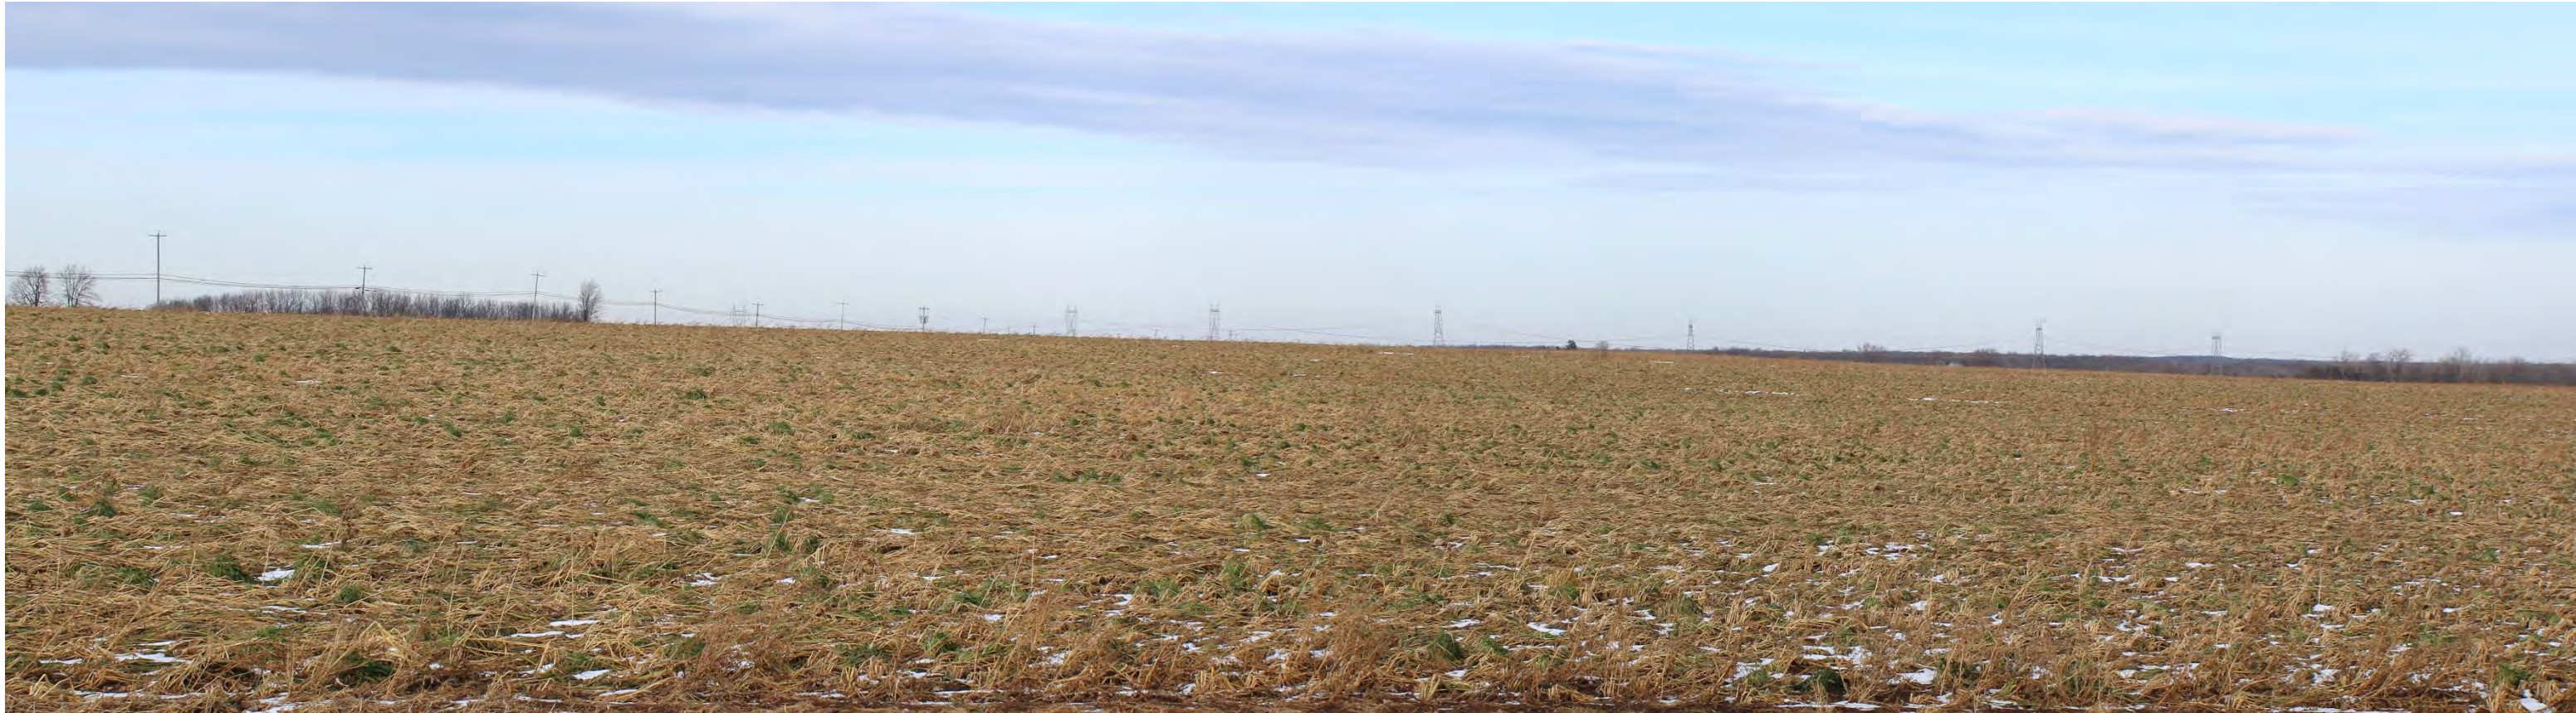
Existing Conditions

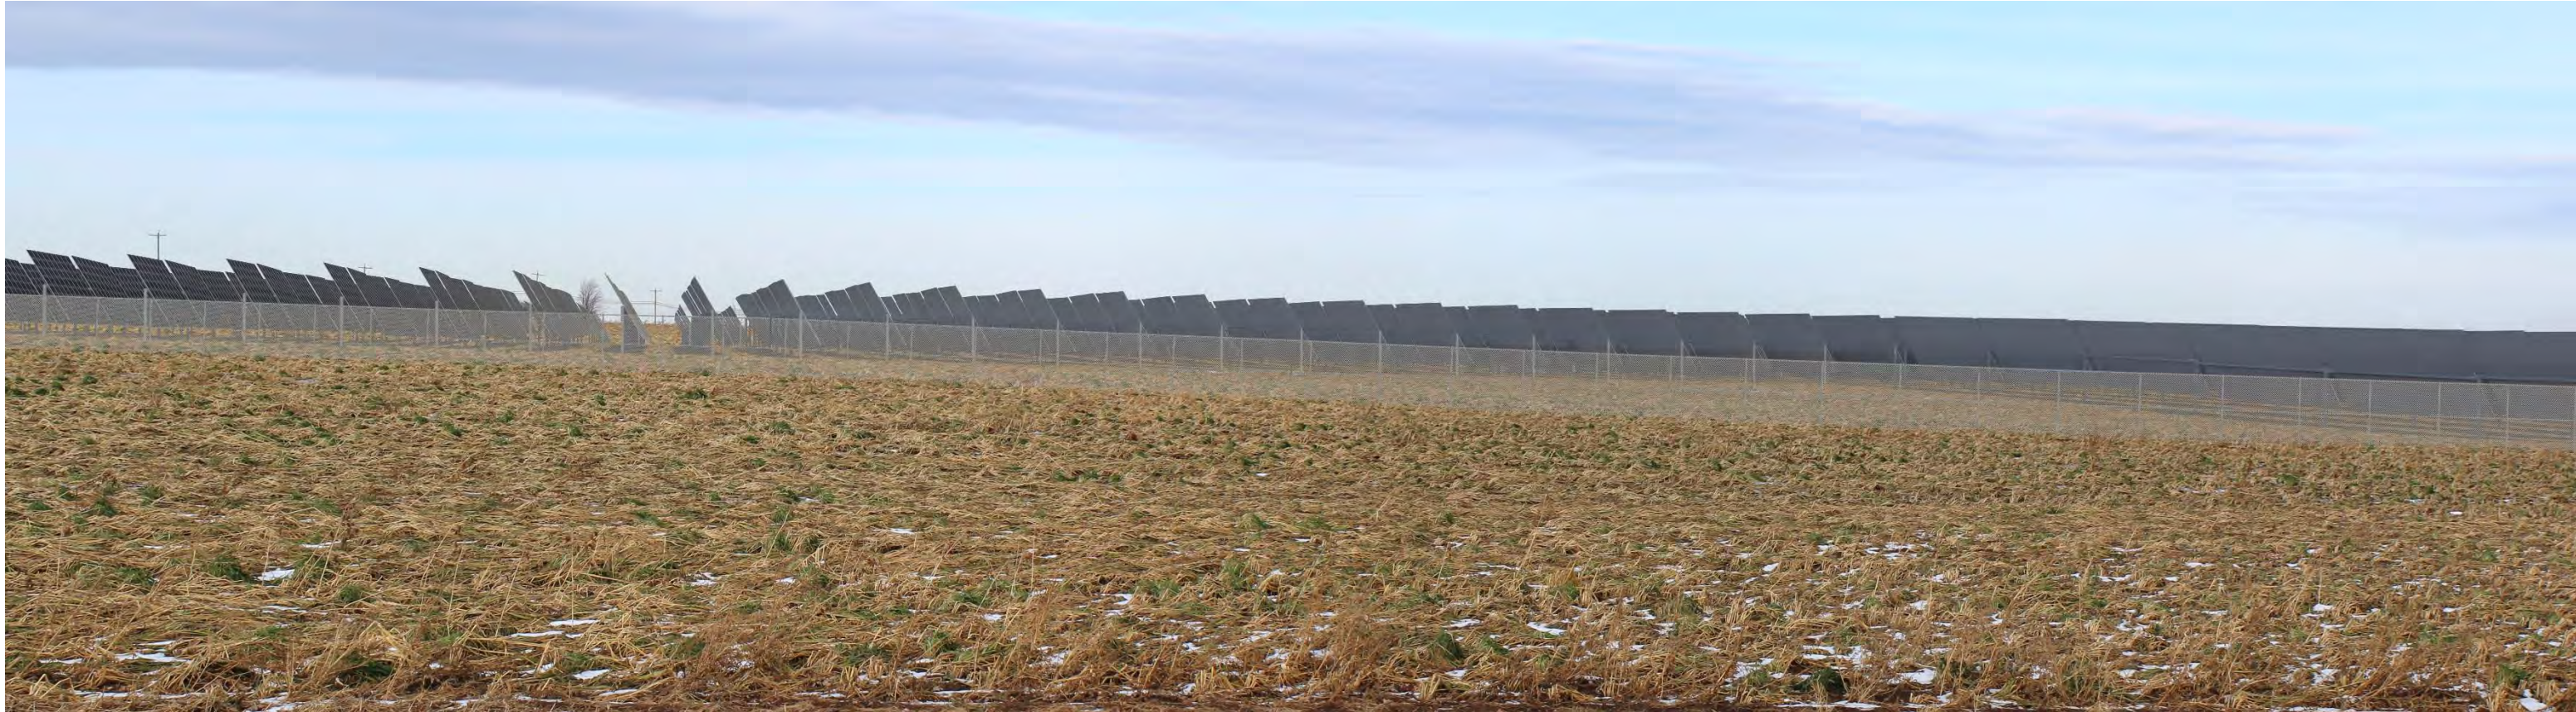
Simulation Proposed Conditions

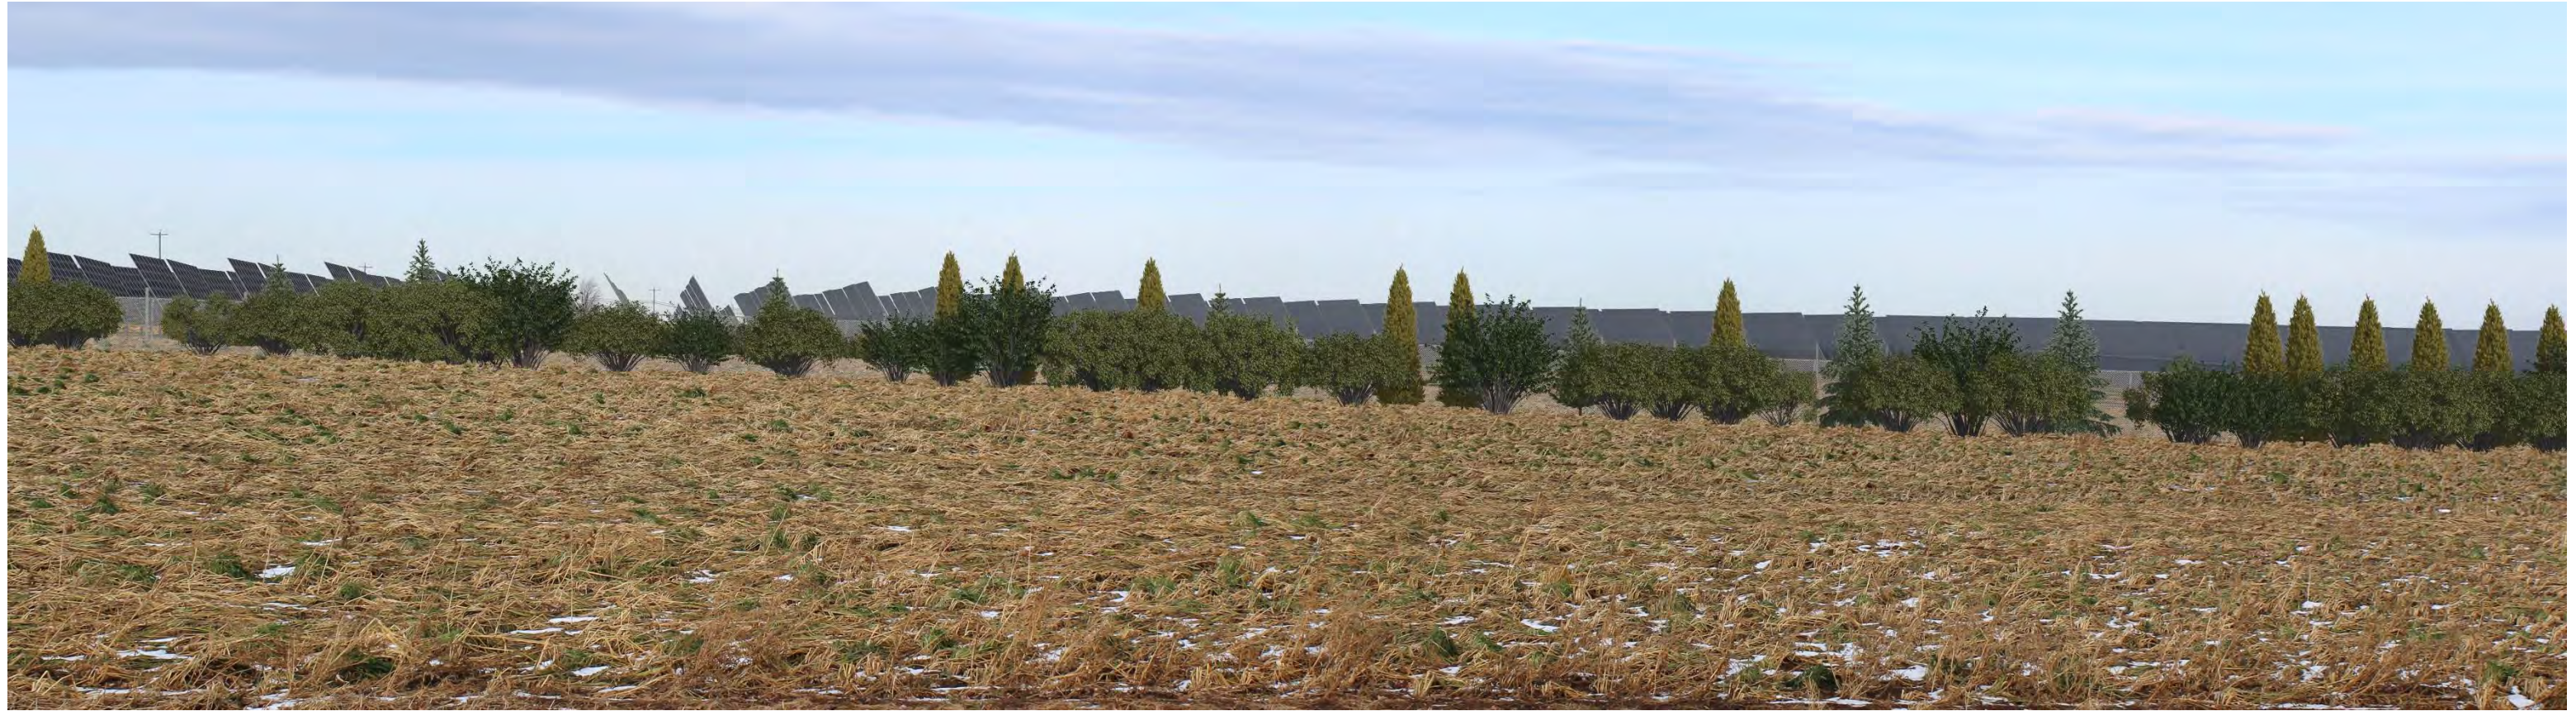
Simulation Mitigation at 5 years – Leaf On

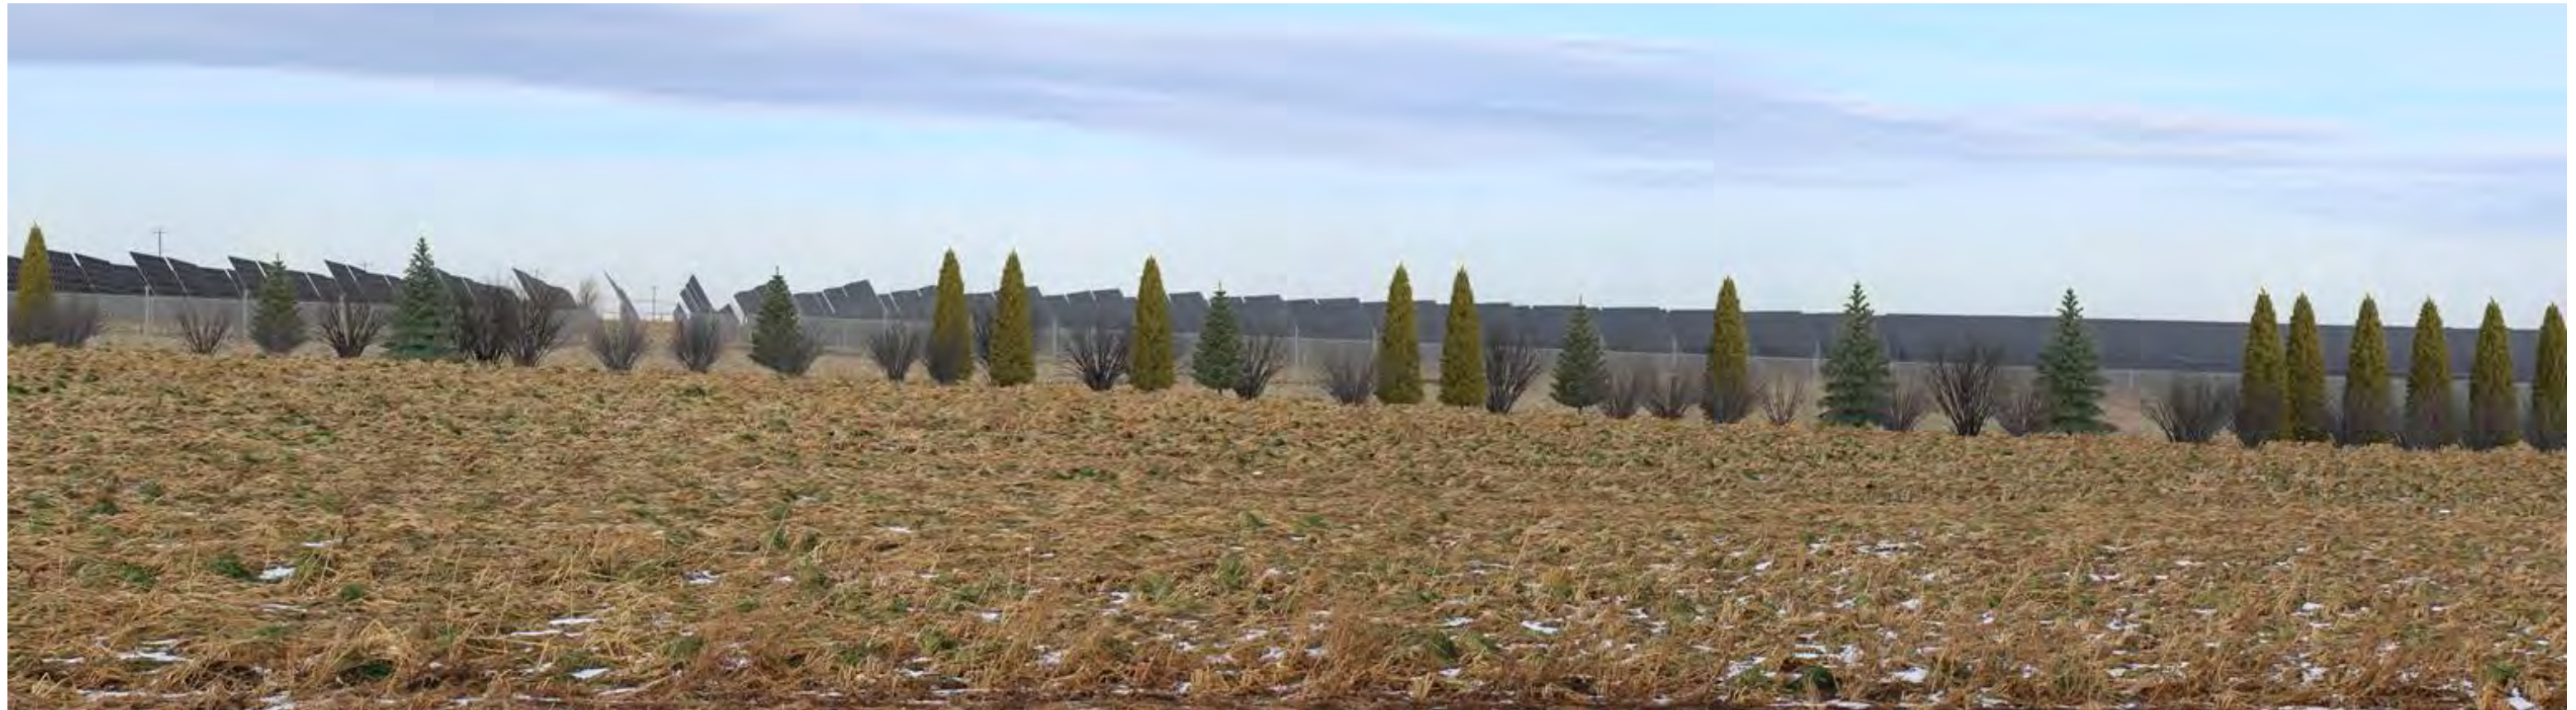
Simulation Mitigation at 5 years – Leaf Off
