Attachment N

Visual Impact Assessment - Revised Simulations

Viewpoint Coordinates in	1274684.7 E
NY State Plane West	1118167.6 N
Town	Byron
Viewer Elevation (ft msl)	689
Distance to Fence Line	293 ft
Direction of View	SE
Date/Time	12/13/19 11:15 AM
Excelsior Energy Center Byron, New York Visual Simulation of Project December 2020

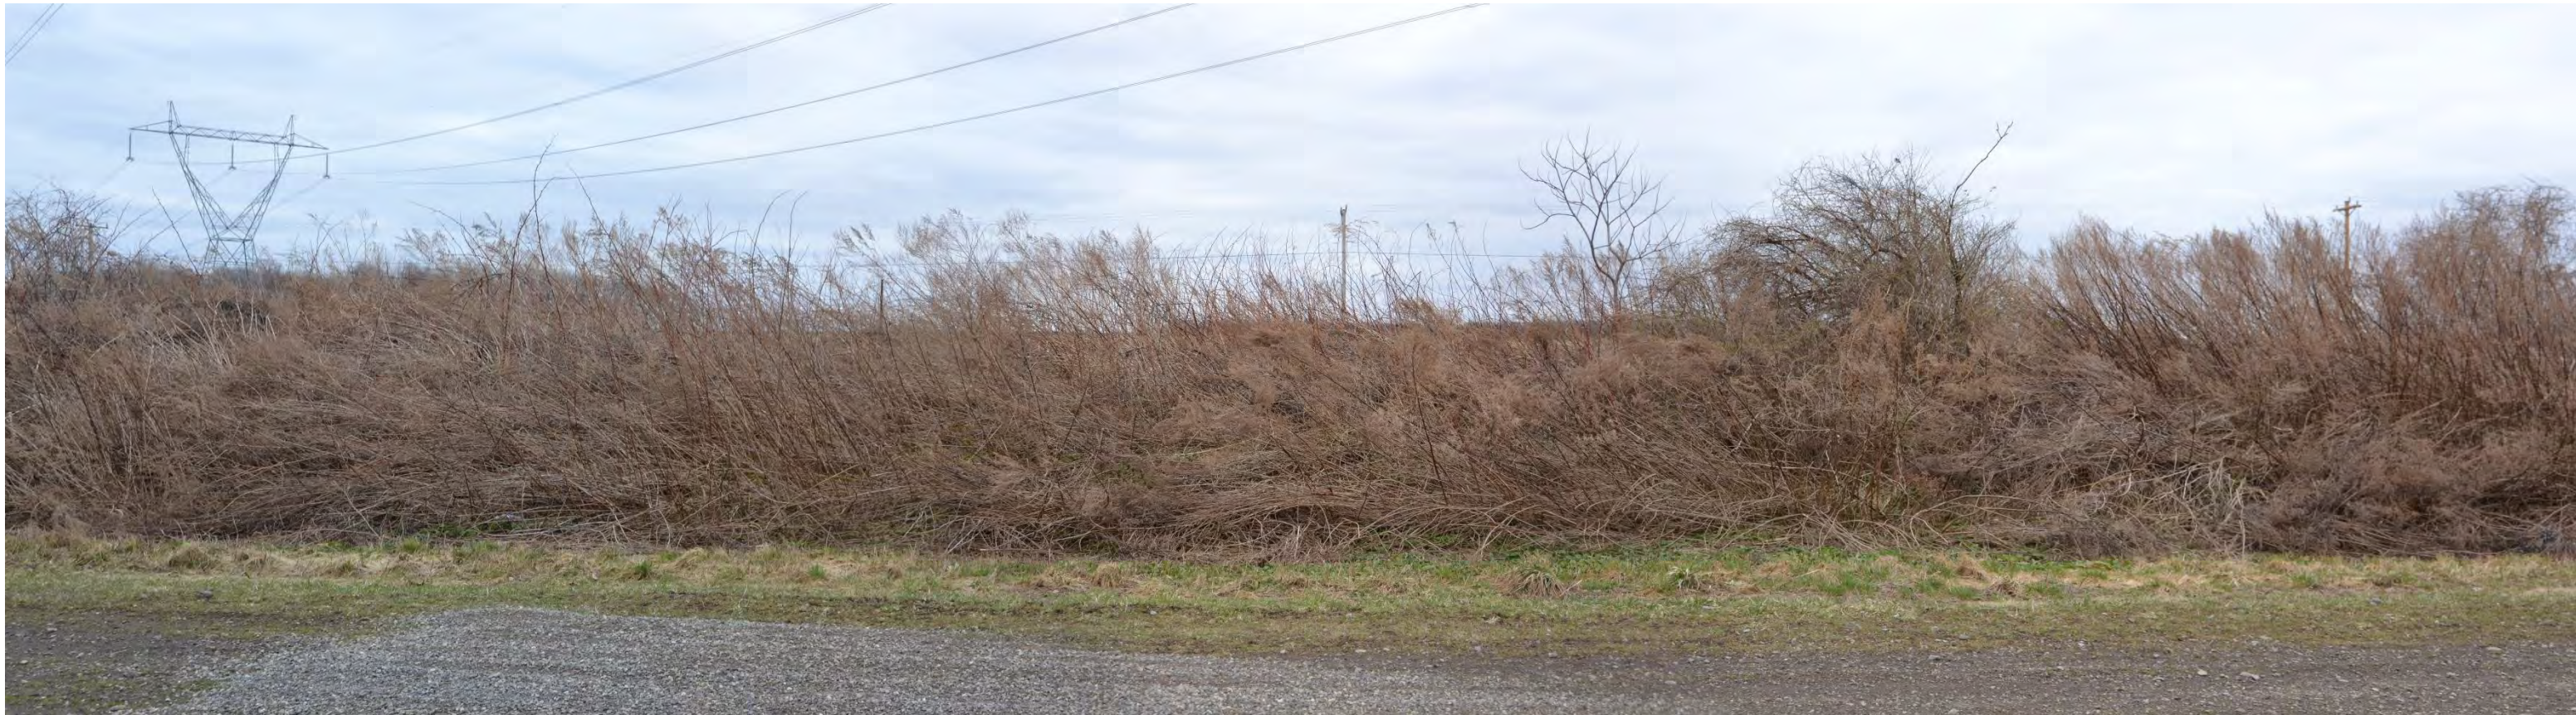
Existing Conditions

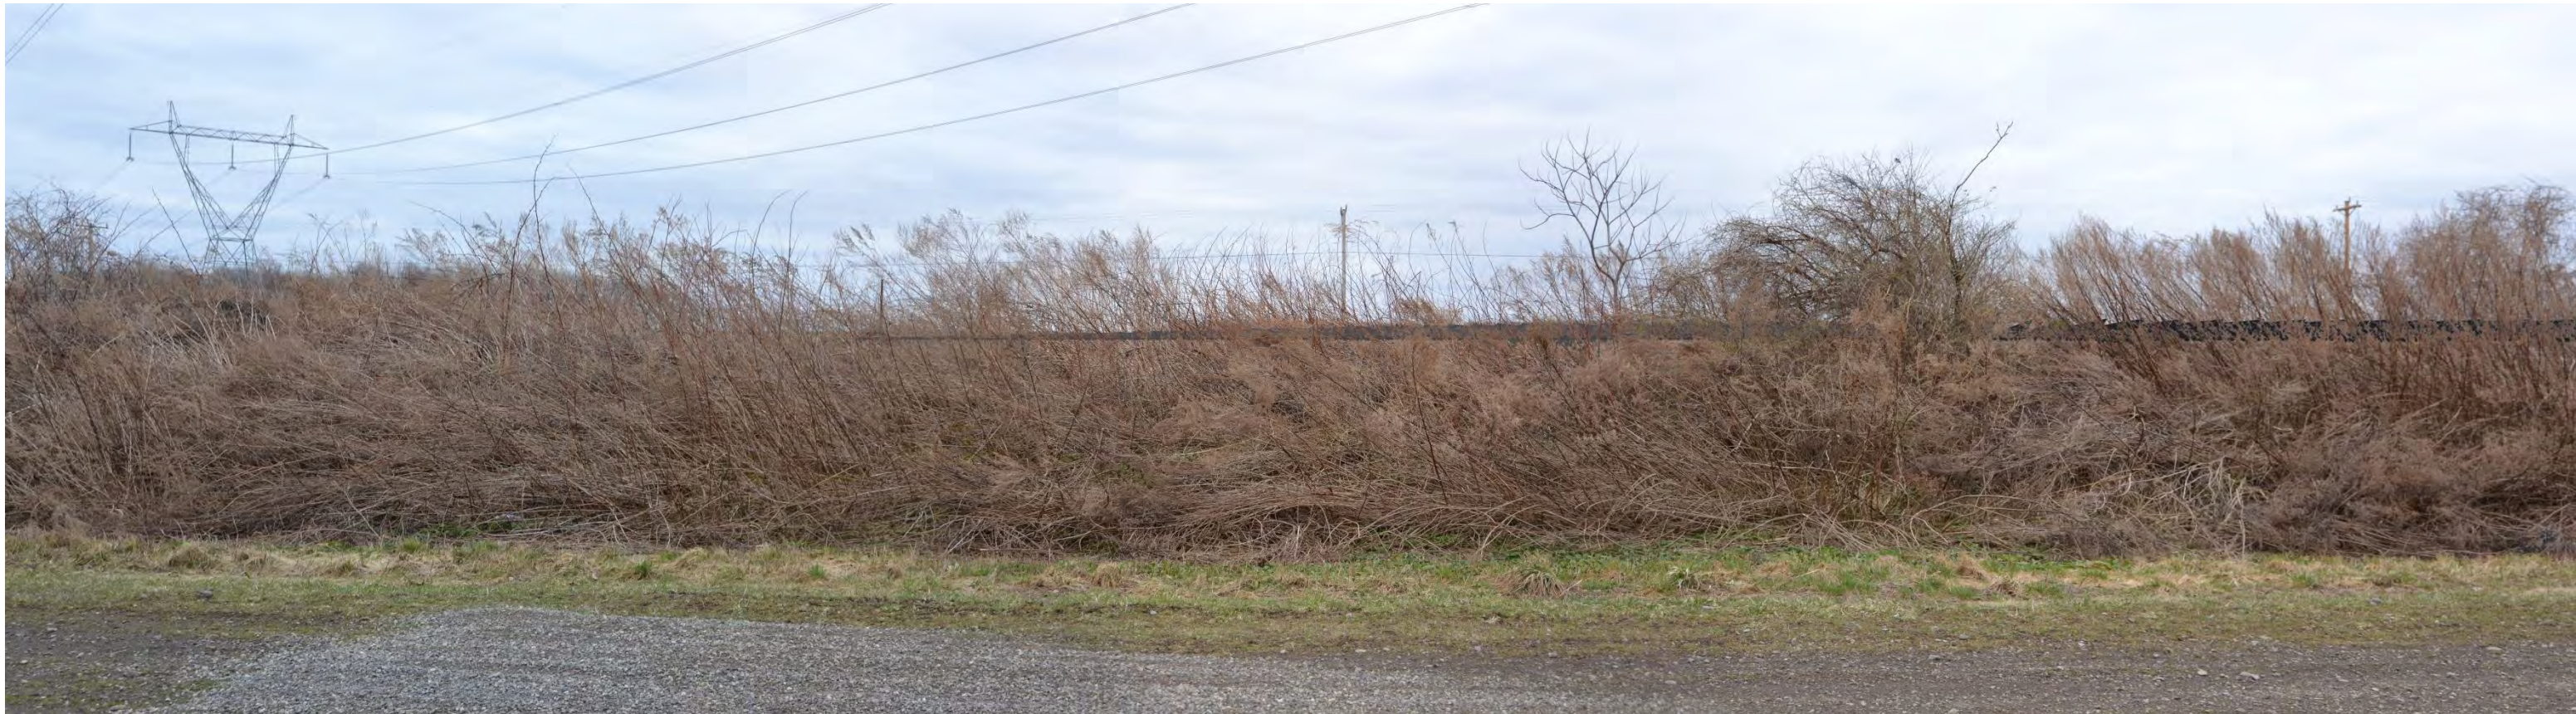
Simulation Proposed Conditions

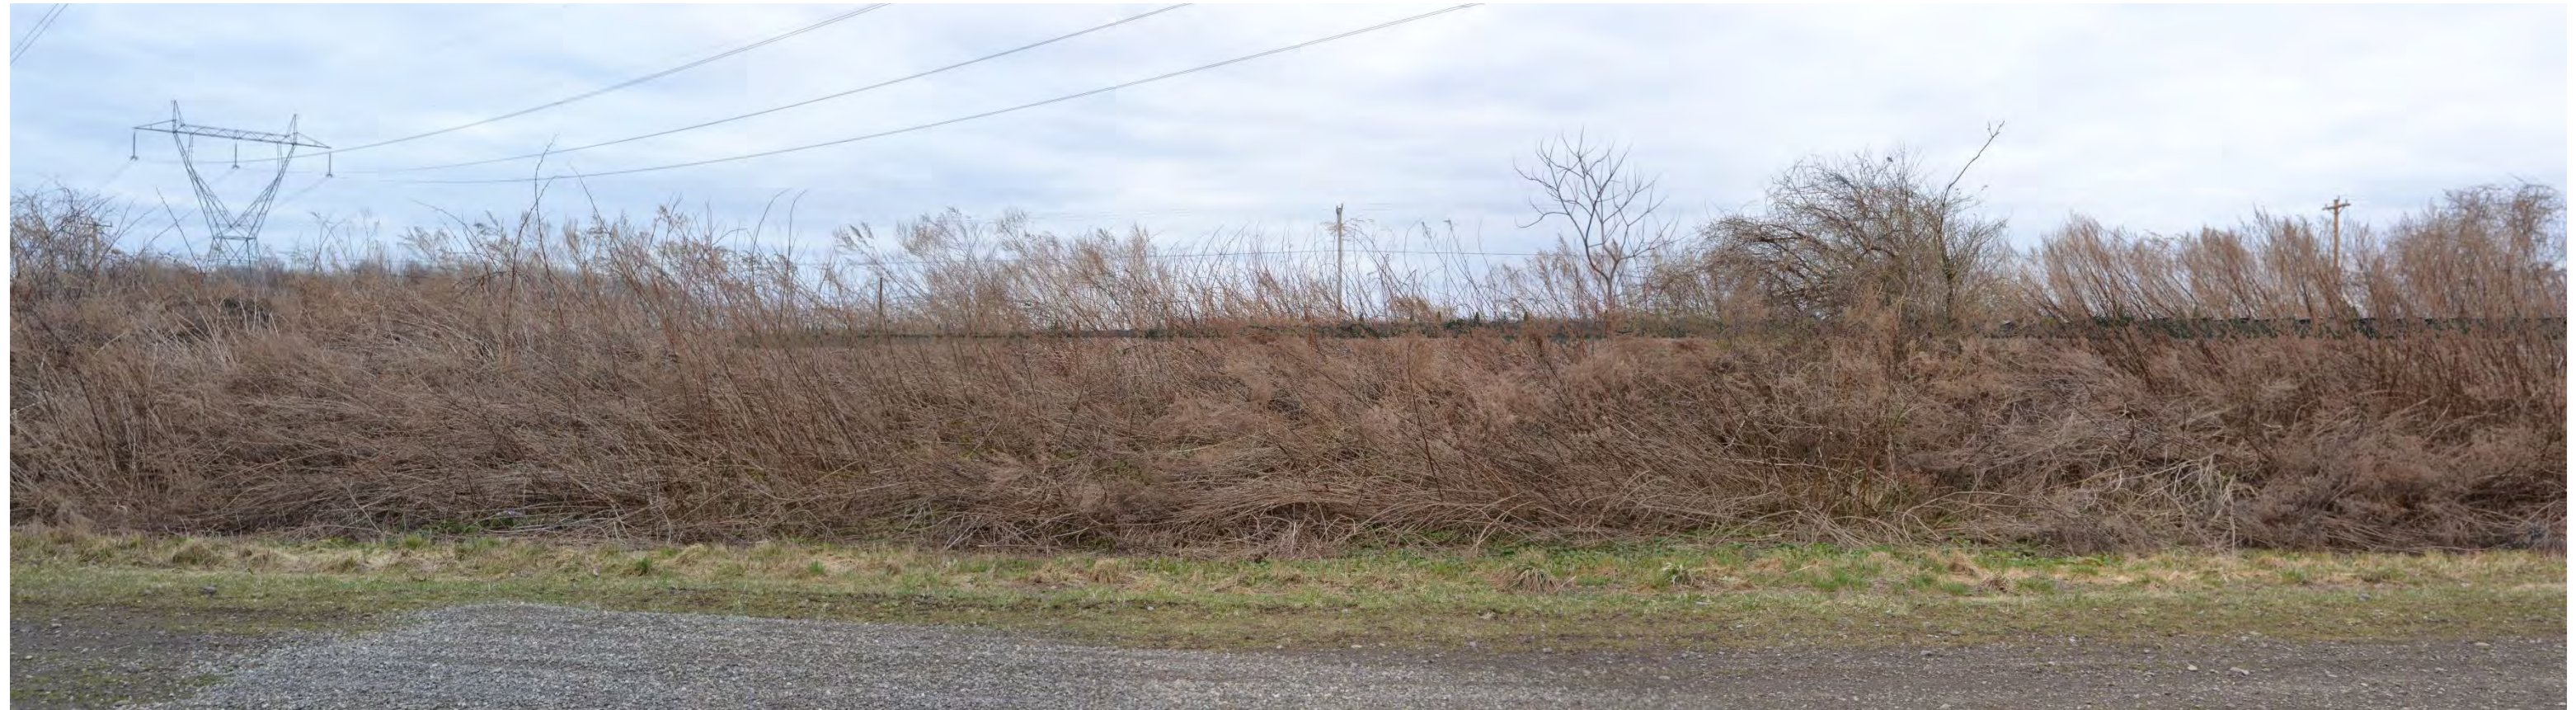
Simulation Mitigation at 5 years – Leaf On

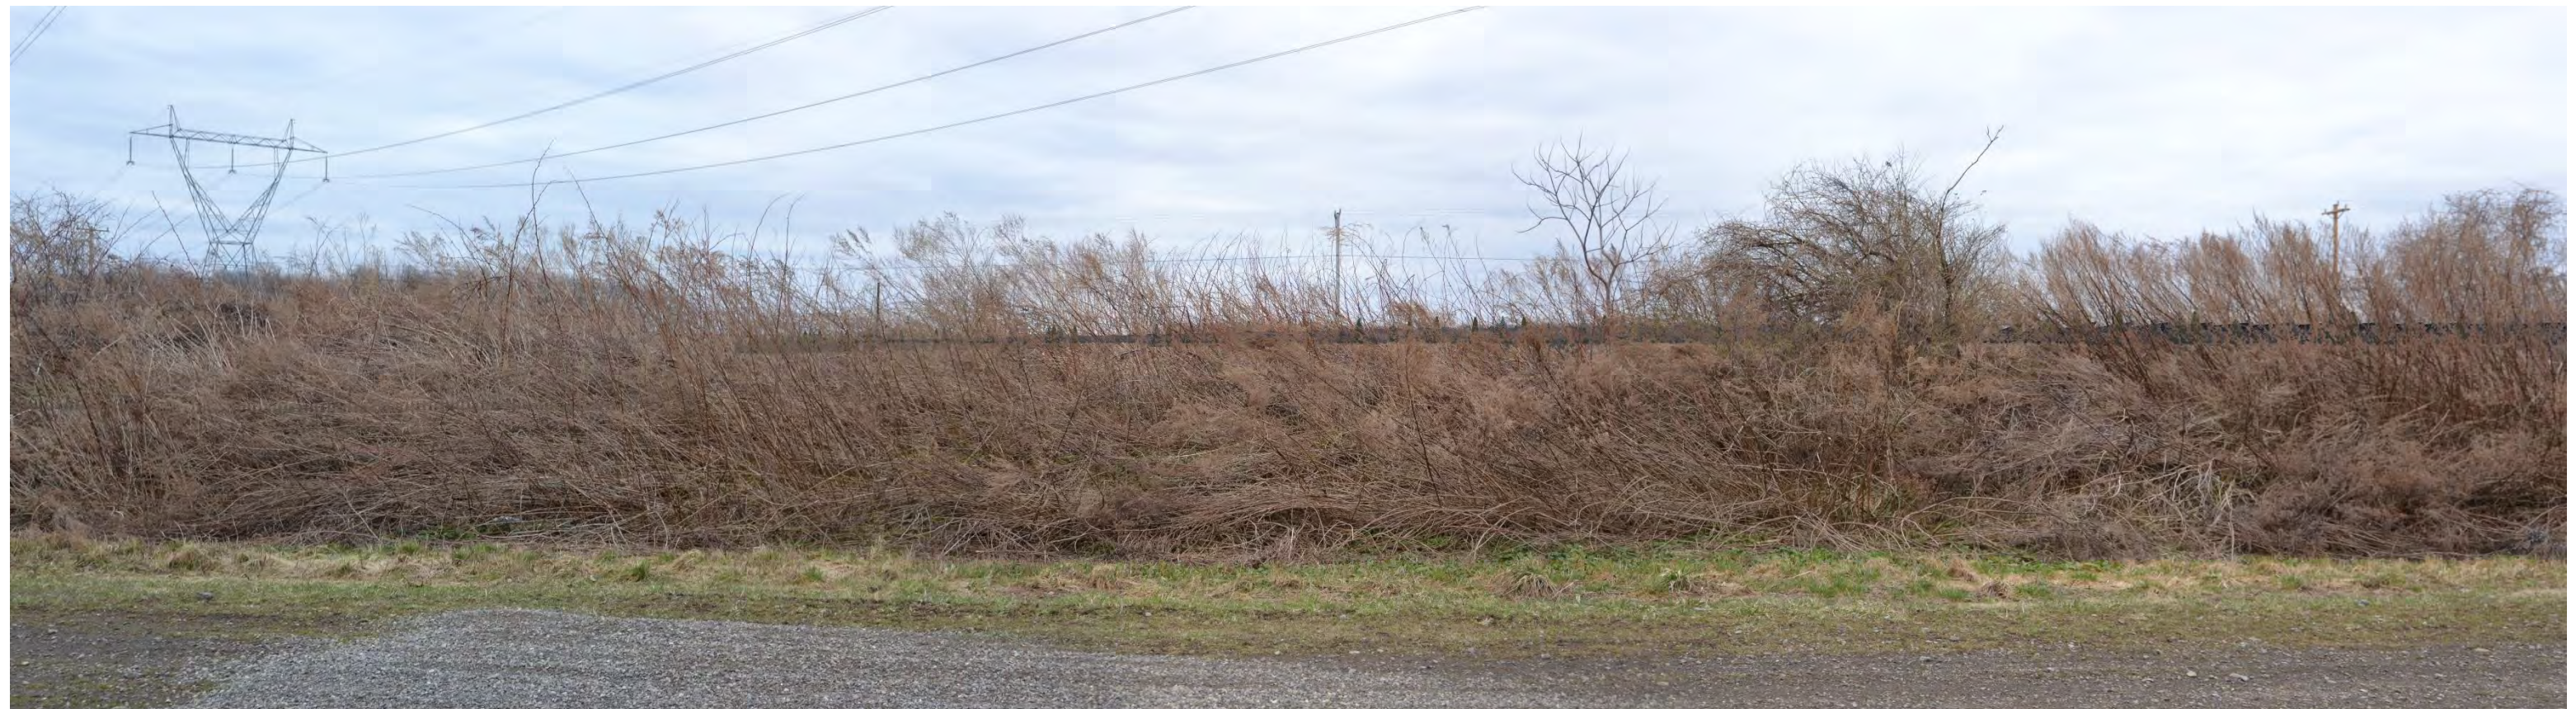
Simulation Mitigation at 5 years – Leaf Off

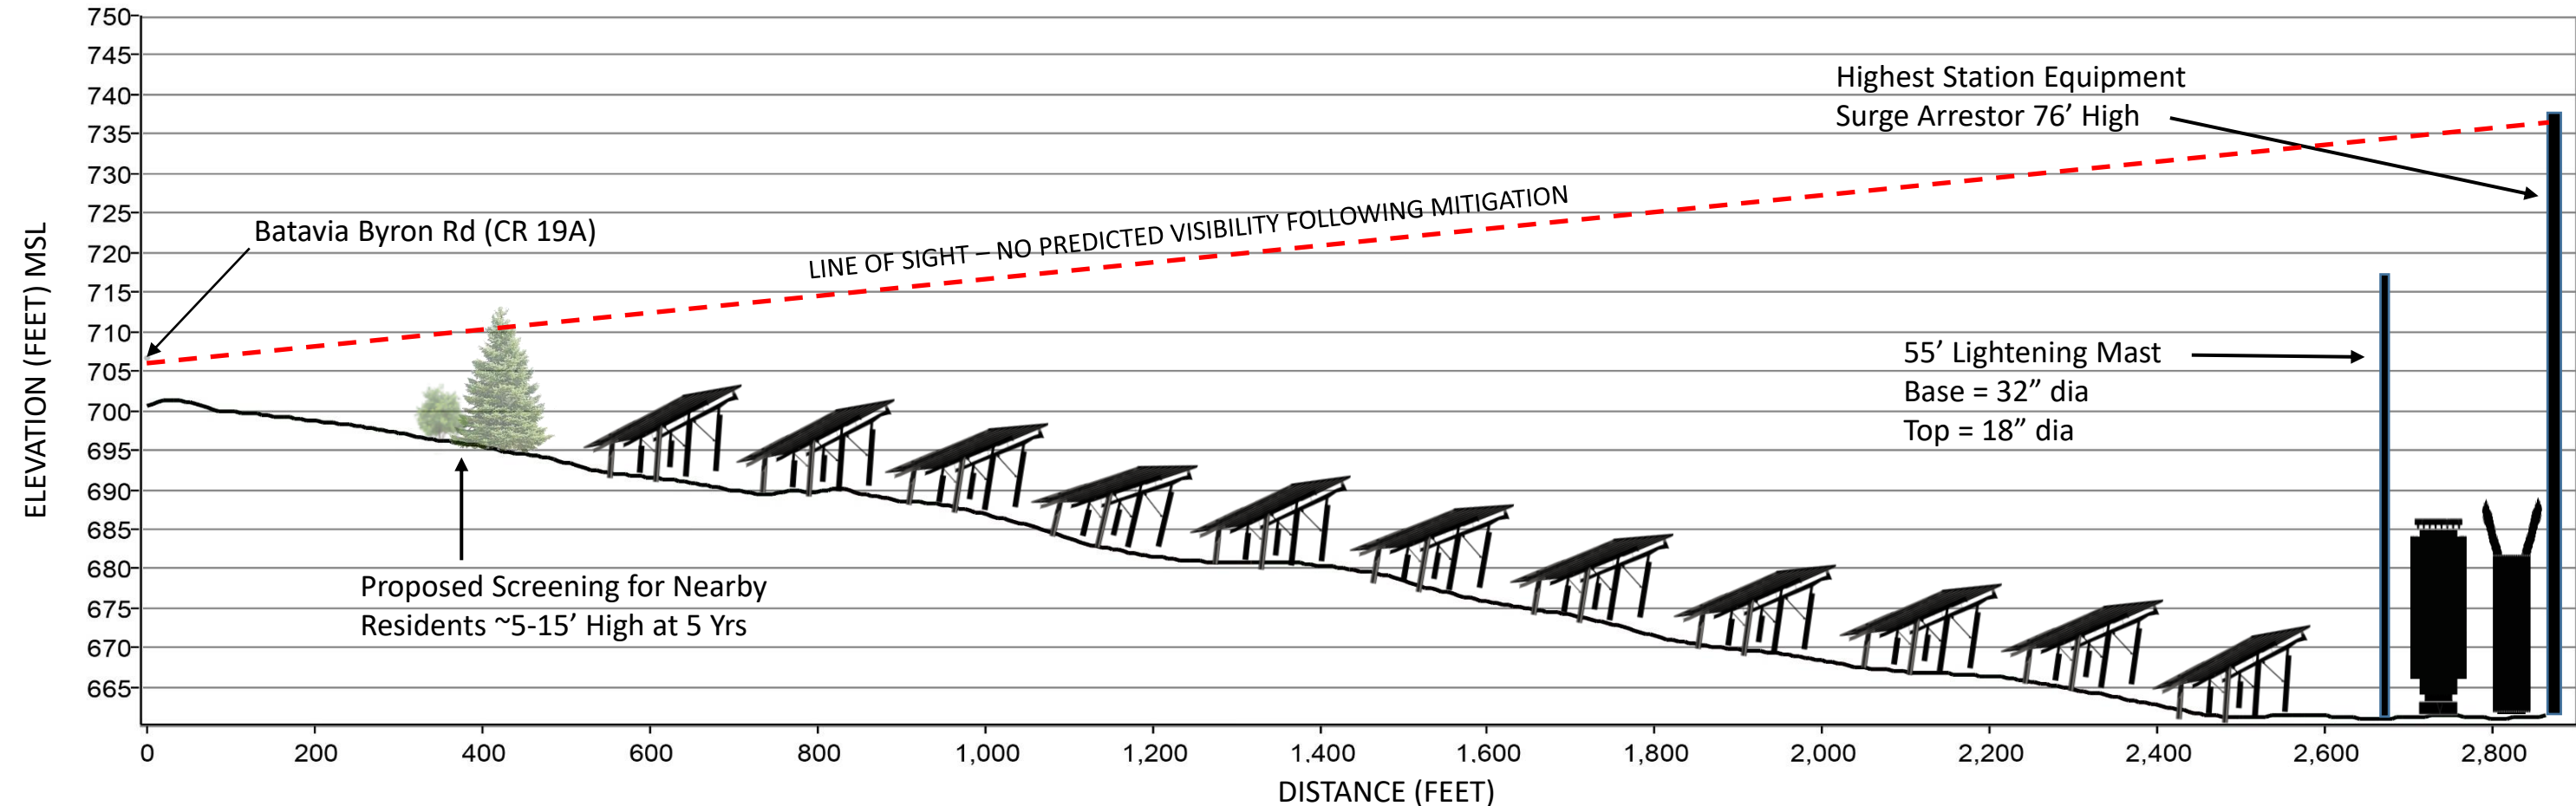
L2 - LINE OF SIGHT FROM – BATAVIA BYRON RD (CR 19A) TO COLLECTION SUBSTATION

Viewpoint Coordinates in	1280589.6
NY State Plane East	1119092.5
Viewpoint Location	CR 19A
Distance to Object	0.5 miles
Direction of View	NE
Excelsior Energy Center Byron, New York Line of Sight December 2020

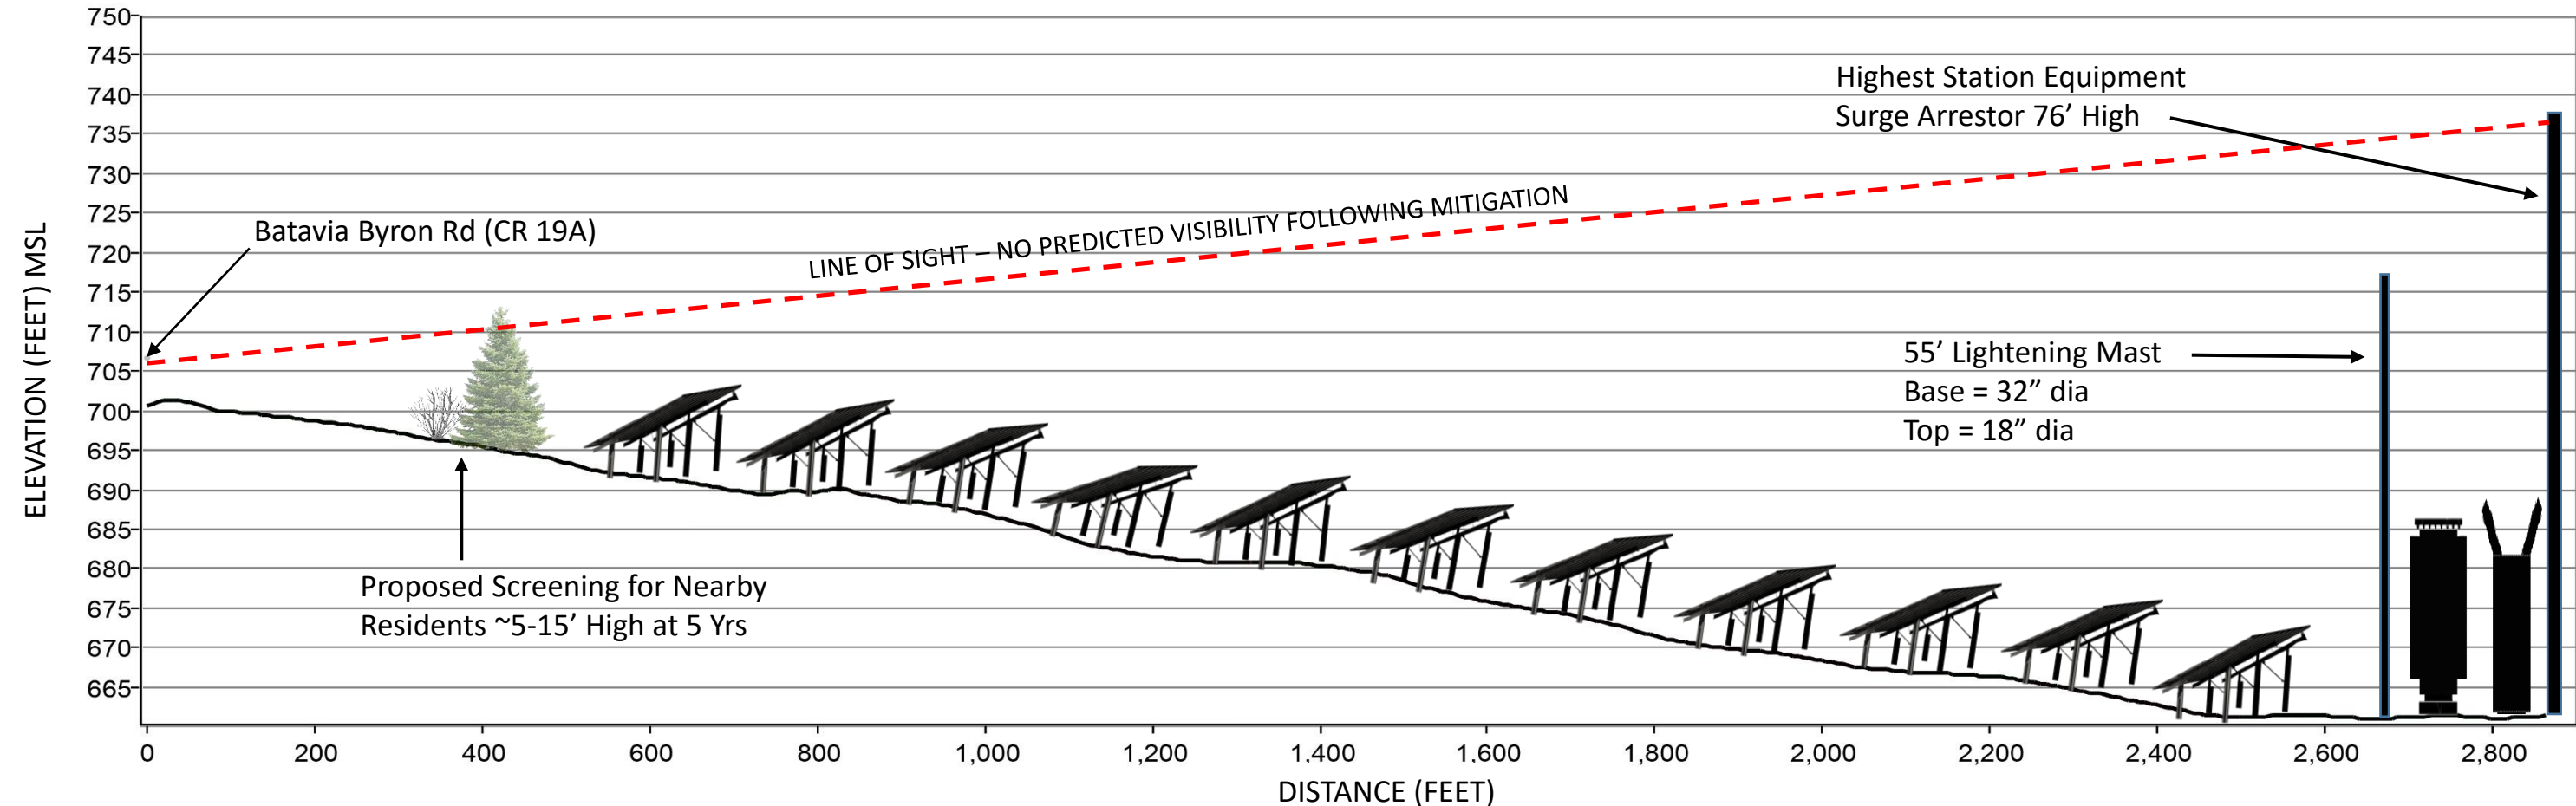
L2 - LINE OF SIGHT FROM – BATAVIA BYRON RD (CR 19A) TO COLLECTION SUBSTATION

Viewpoint Coordinates in	1280589.6
NY State Plane East	1119092.5
Viewpoint Location	CR 19A
Distance to Object	0.5 miles
Direction of View	NE
Excelsior Energy Center Byron, New York Line of Sight December 2020
