Memorandum

To: Excelsior Energy Center, LLC
From: TRC
Subject: Wetland and Stream Delineation Supplement
Excelsior Energy Center
Date: March 2025

On November 26 and December 3, 2024, TRC completed a supplemental delineation effort for the proposed Excelsior Energy Center, located in the Town of Byron, Genesee County, New York (Attachment A – Figure 1). This supplemental field effort covered portions of five tax parcels totaling approximately 4.5 acres (Survey Area). Four of these parcels were added after the original delineation effort was completed in 2019. One of the parcels had been included in the original delineation effort but one small portion of it was revisited in search of potential alternative access. The field team documented all wetlands and surface waters (including rivers, streams, ponds, lakes, etc.) regardless of jurisdictional status. This memorandum summarizes the results of the wetland and stream delineation conducted for the Survey Area.

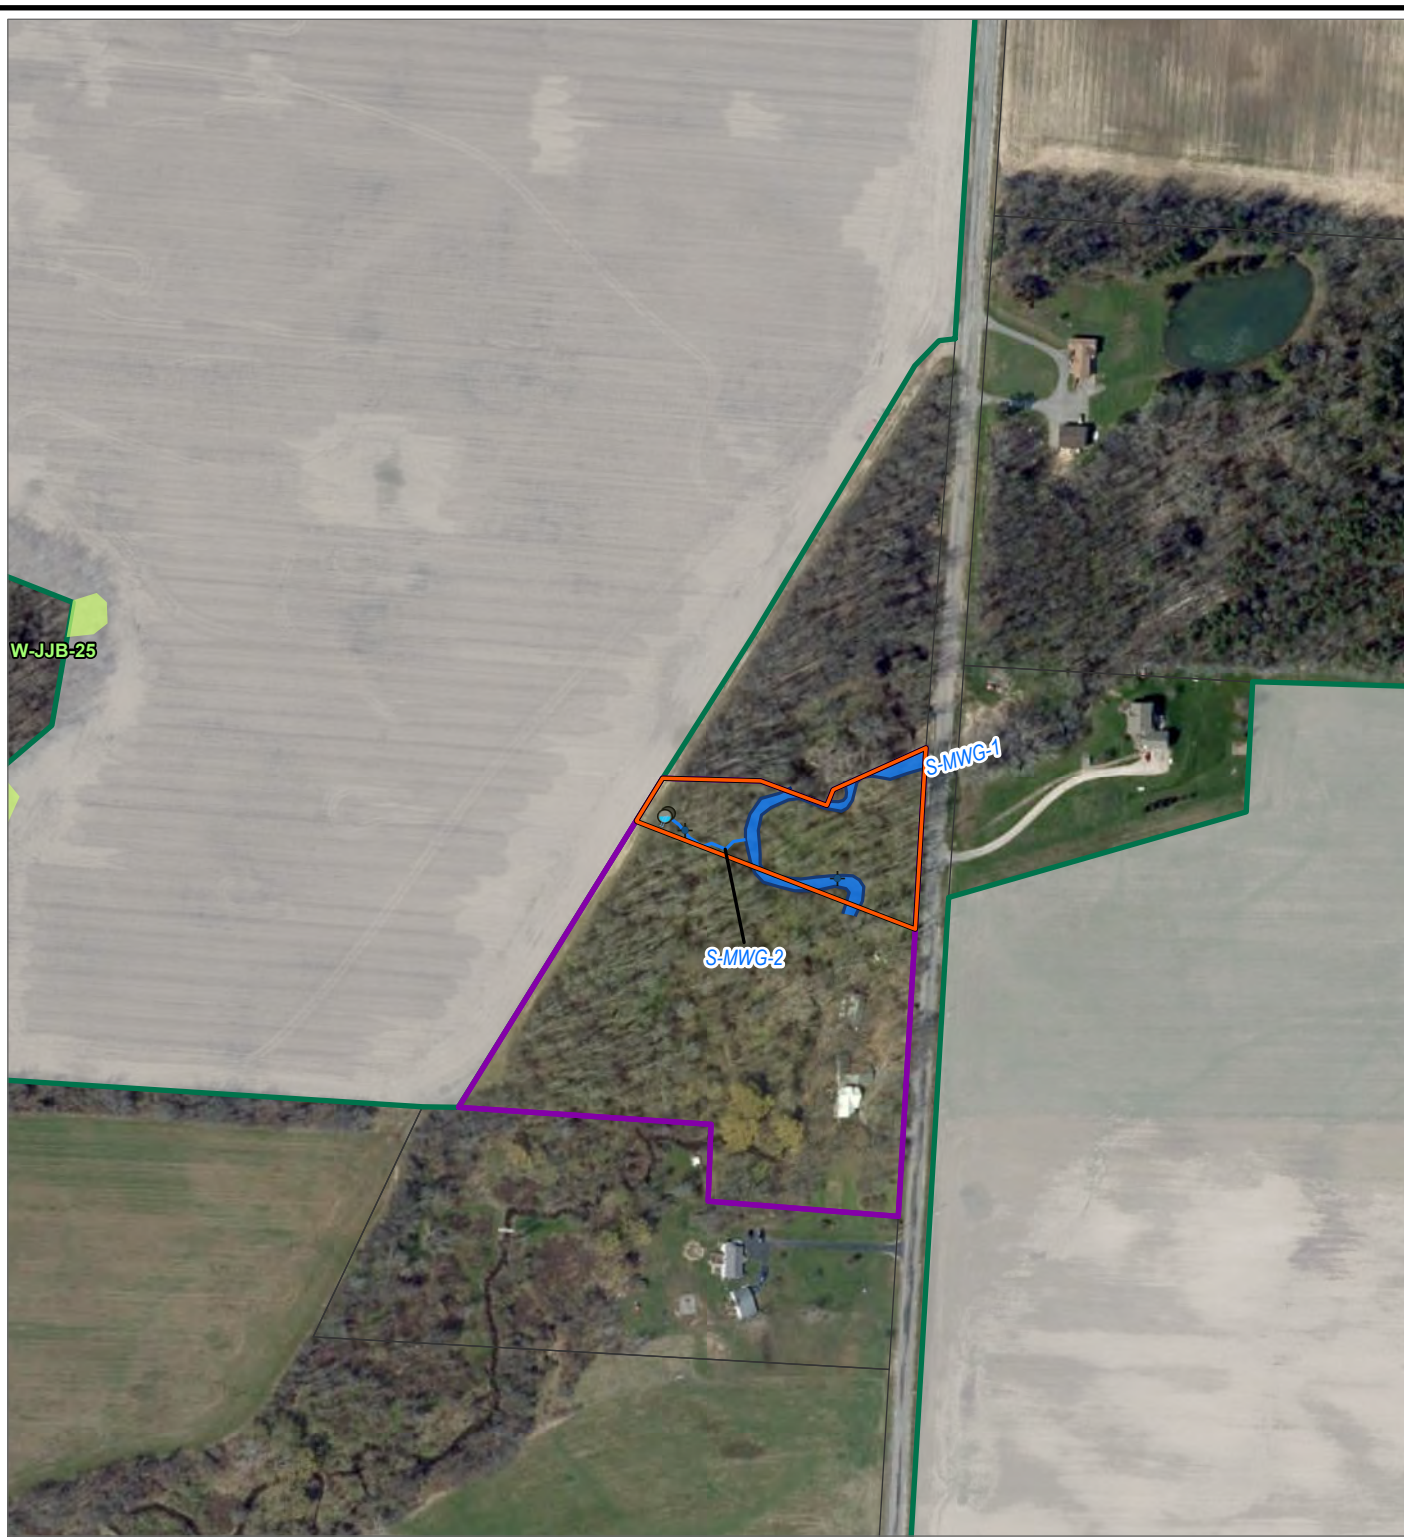
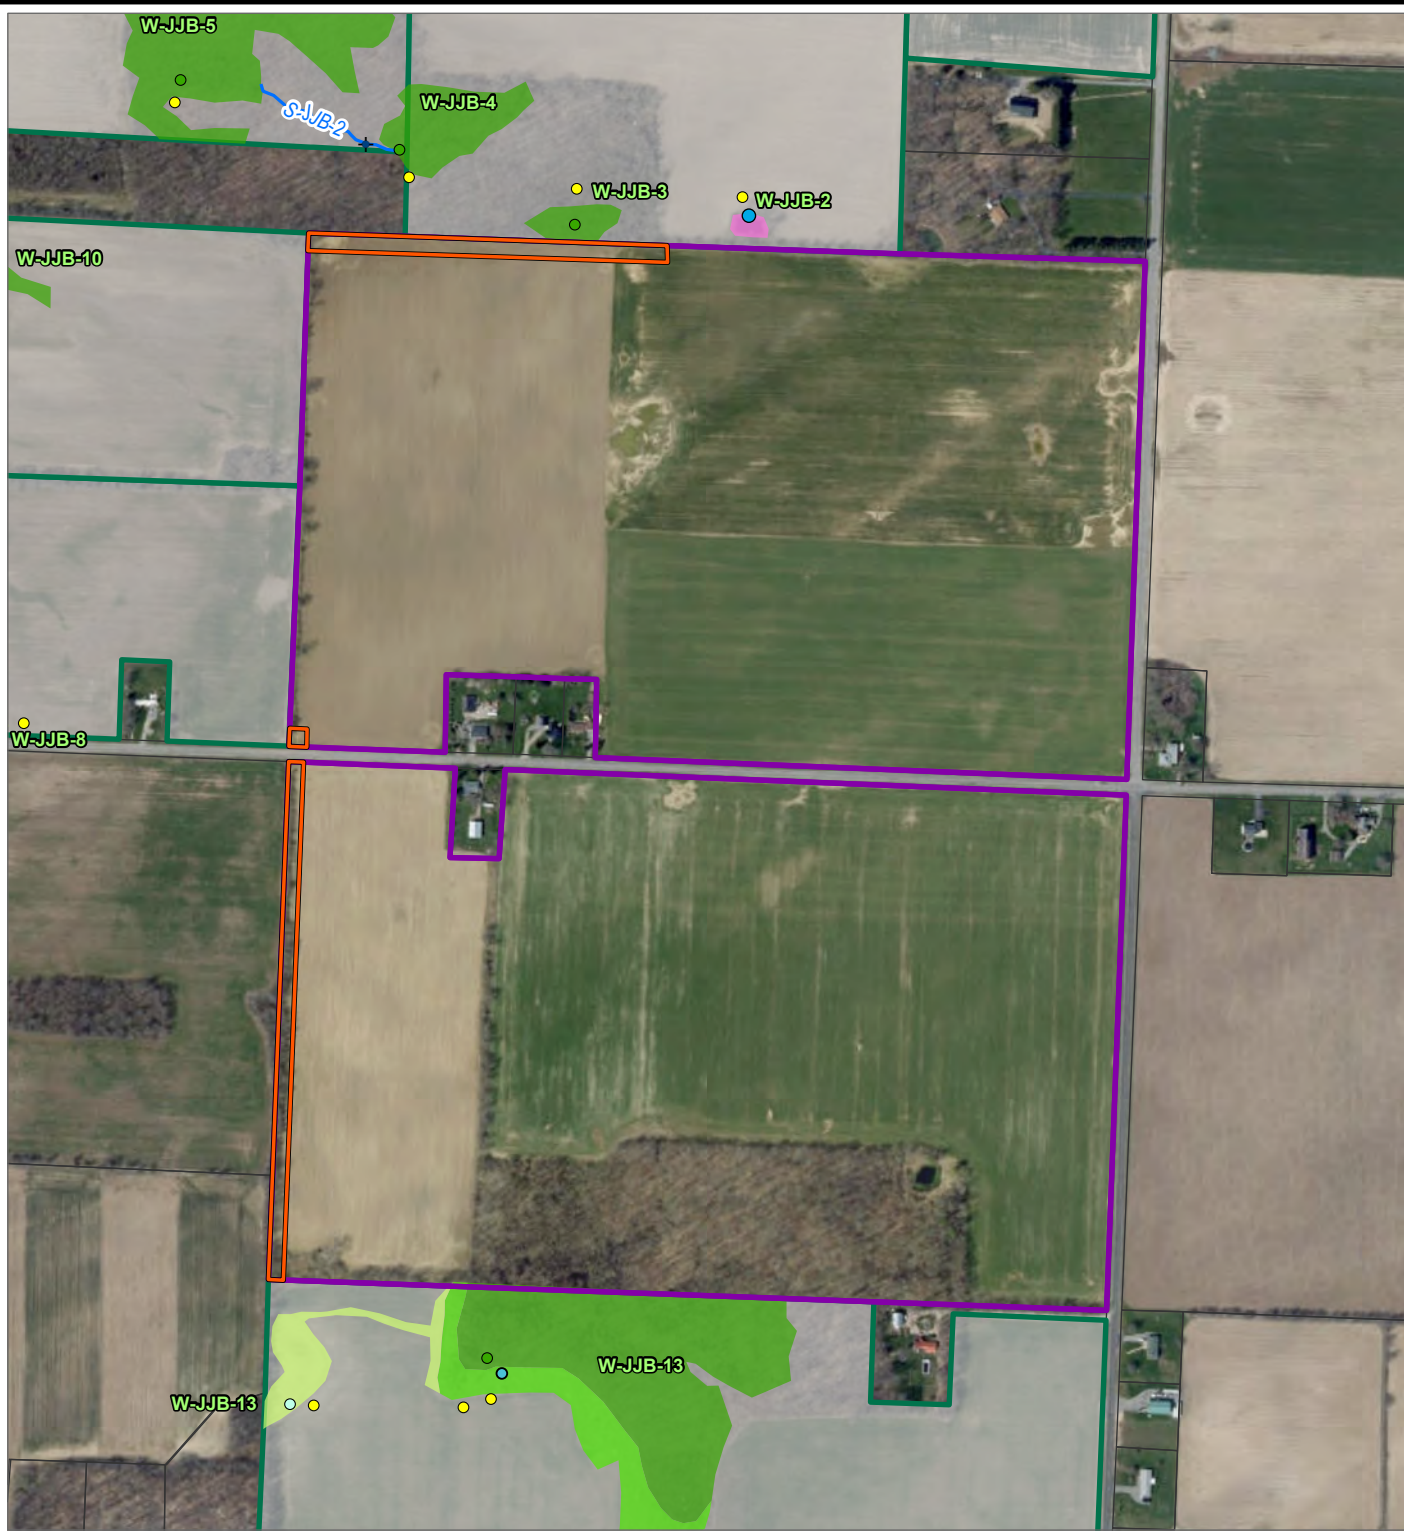
TRC scientists adjusted and extended the boundaries of one previously mapped wetland, W-IBP-1, which is classified as a combination of palustrine forested (PFO) and palustrine emergent (PEM). It was determined that two small upland areas warranted removal from the originally delineated wetland in one portion of the Survey Area, while a wetland extension was appropriate in another portion of the Survey Area to the northeast. TRC scientists also identified and delineated two new streams, S-MWG-1 (perennial), and S-MWG-2, (ephemeral), within the Survey Area. Two previously mapped streams were extended as well. Stream S-IBP-1, a perennial feature, and stream S-JJB-3, an intermittent feature, were both extended in the northern, central portion of the Survey Area (Figure 4 of Attachment A).

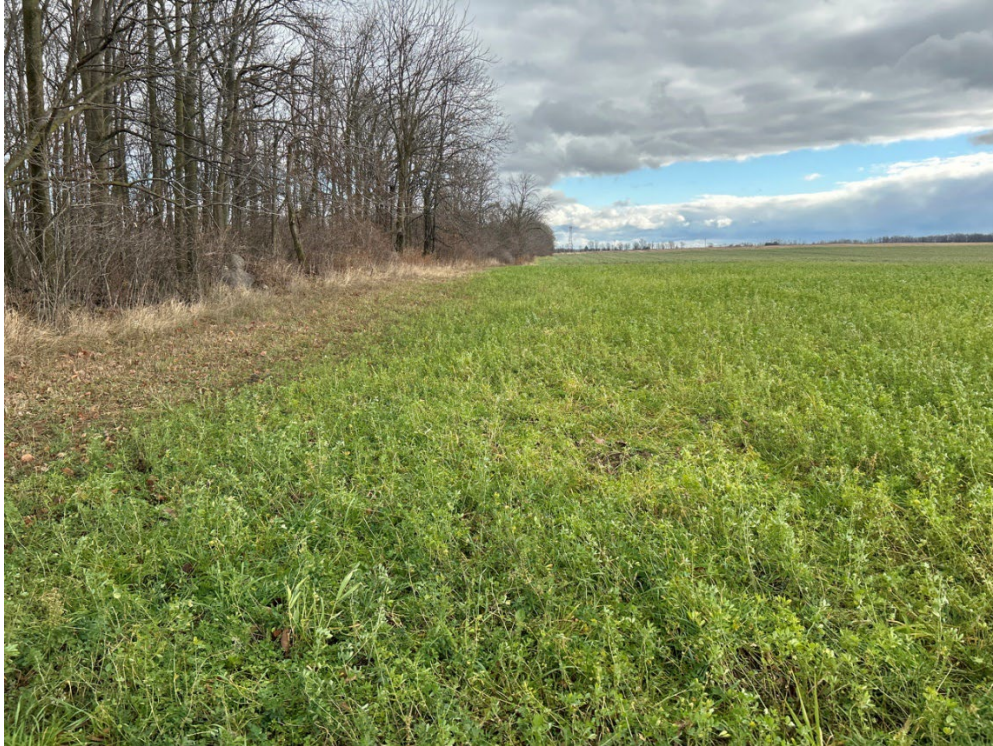
Photograph 1: Upland field in northeast portion of Survey Area, facing east, taken on 11/26/2024.

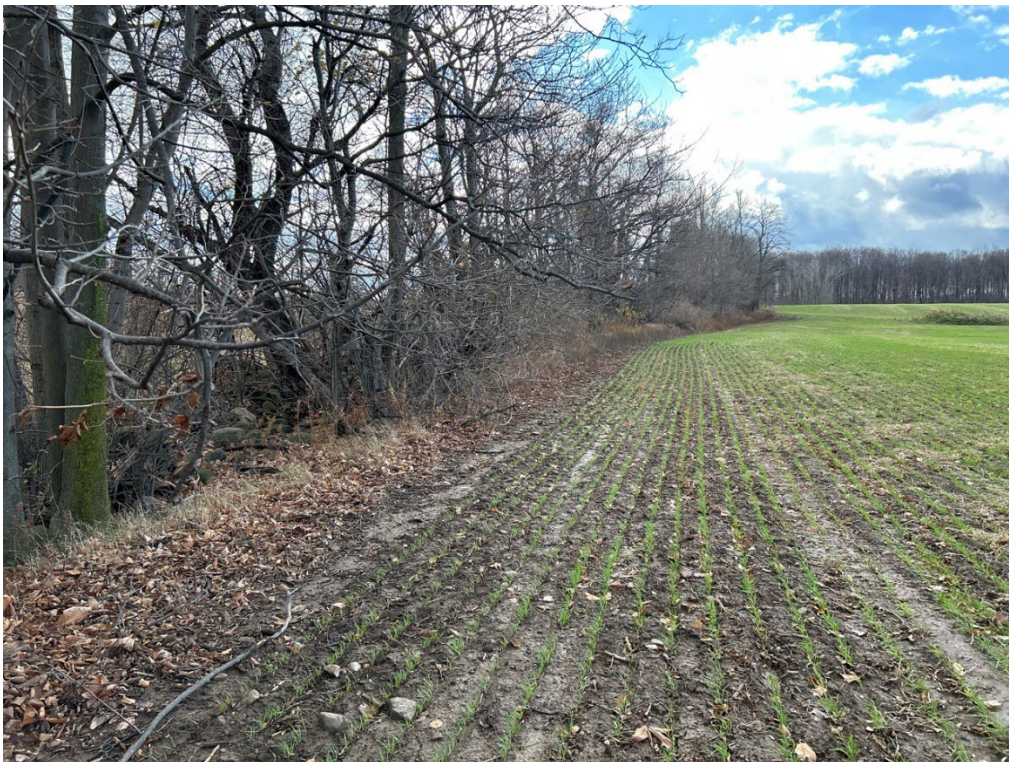
Photograph 2: Upland field in southeast portion of Survey Area, facing south, taken on 11/26/2024.

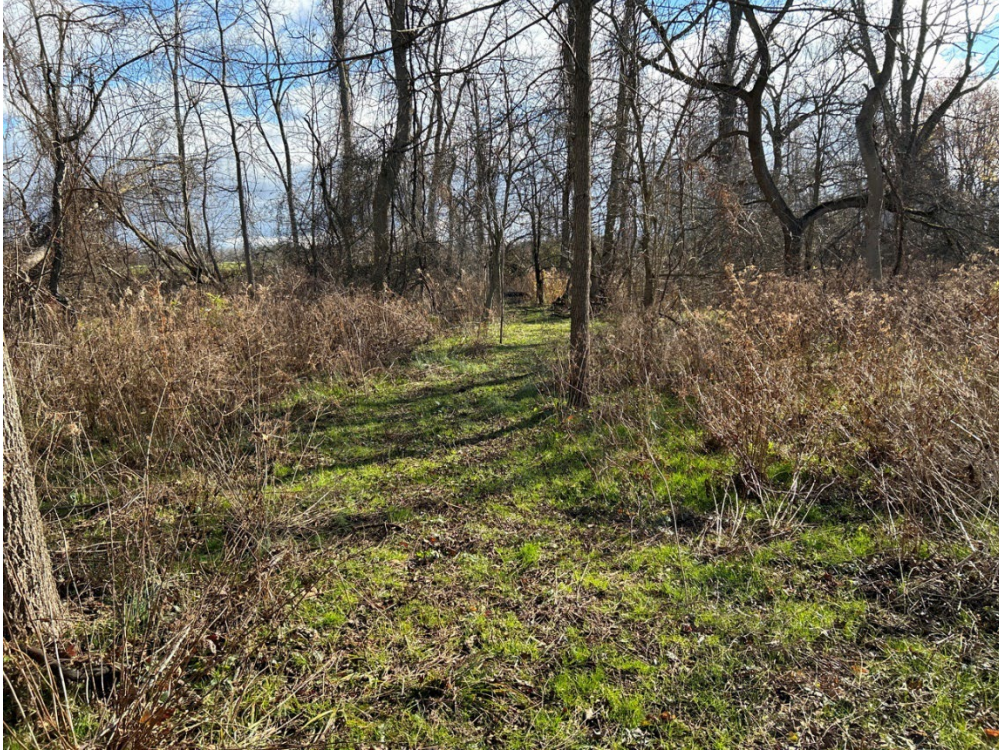
Photograph 3: Upland woods in southwest portion of Survey Area, facing southeast, taken on 11/26/2024.

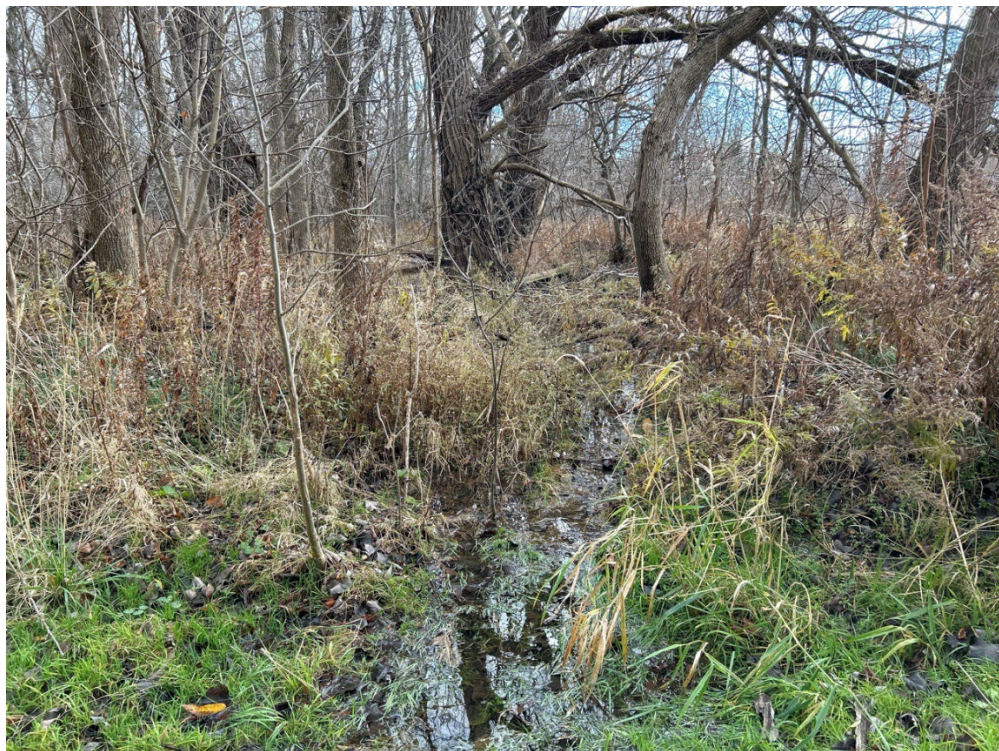
Wetland W-IBP-1, within this supplemental Survey Area, consists of 0.35 acre of PFO wetland, and 0.03 acre of PEM wetland, located in the central part of the Survey Area. It extends offsite on the north and northeast border of the Survey Area. Wetland W-IMP-1 is mapped as a NWI palustrine forested, temporary flooded broad-leaved deciduous wetland (PFO1A), and palustrine forested, seasonally flooded broad-leaved

deciduous wetland (PFO1C). Within the delineated PFO area, indicators of wetland hydrology include water-stained leaves (B9), saturation (A3), water marks (B1), sediment deposits (B2), oxidized rhizospheres on living roots (C3), drift deposits (B3), presence of reduced iron (C4), and sparsely vegetated concave surface (B8). Dominant vegetation includes black willow, eastern skunk cabbage, riverbank grape, and spotted touch-me-not (*Impatiens capensis*). The hydric soil indicator was redox dark surface (F6), with a silty clay loam texture. Within the PEM portion of the wetland, indicators of wetland hydrology include oxidized rhizospheres on living roots (C3). The dominate vegetation includes reed canary grass. The hydric soil indicator observed was a depleted matrix (F3), with a silty clay texture.

Photograph 4: PFO wetland W-IBP-01, facing southeast, taken on 11/26/2024.

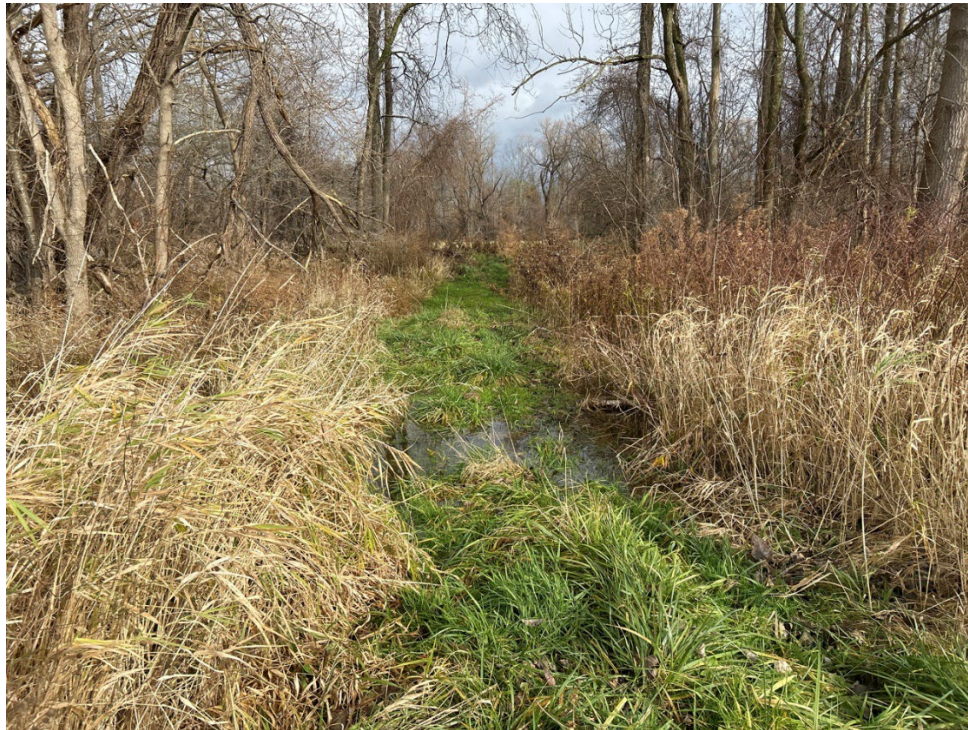
Photograph 5: PEM/PFO wetland W-IBP-01, facing north, taken on 11/26/2024.

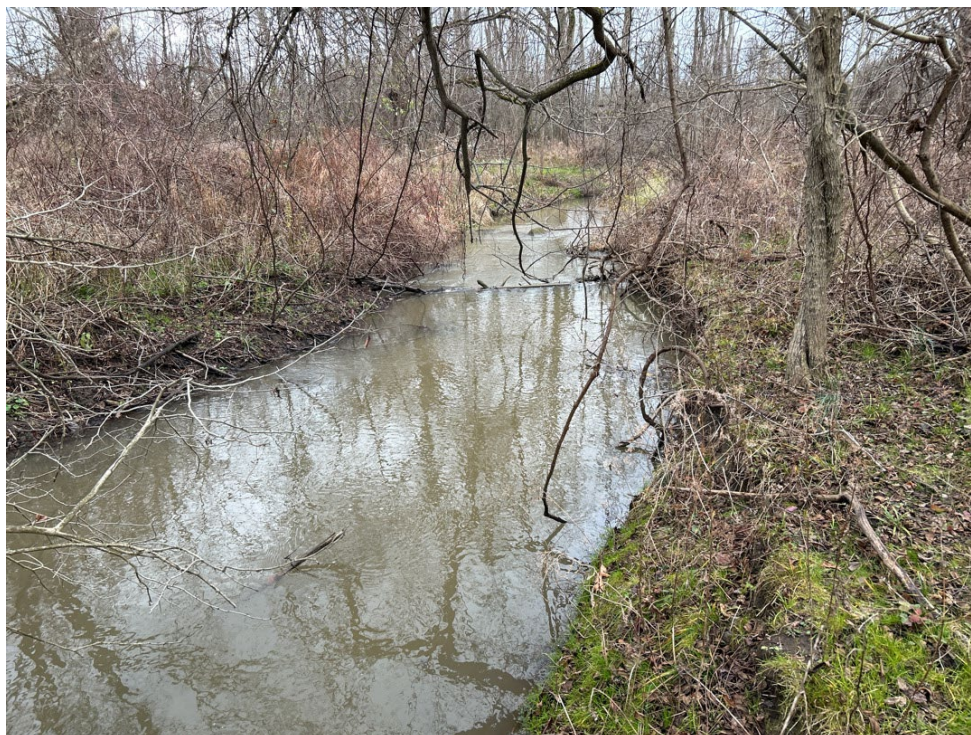
Stream S-MWG-1 is an approximately 20-foot-wide, 6 to 12-inches-deep, perennial stream with two-foot-high banks. Approximately 178 linear feet were delineated within the Survey Area. The streambed consists of silt/clay and cobble/gravel substrate. The stream originates from offsite to the south and flows northeast/north offsite. The stream is a known tributary to a named WOTUS, Genesee River, and corresponds to a mapped NWI riverine lower perennial unconsolidated feature (R2UBH) and a Class C unprotected NYSDEC mapped stream feature, Bigelow Creek.

Photograph 6: Downstream of perennial stream S-MWG-1, facing west, taken on 11/26/2024.

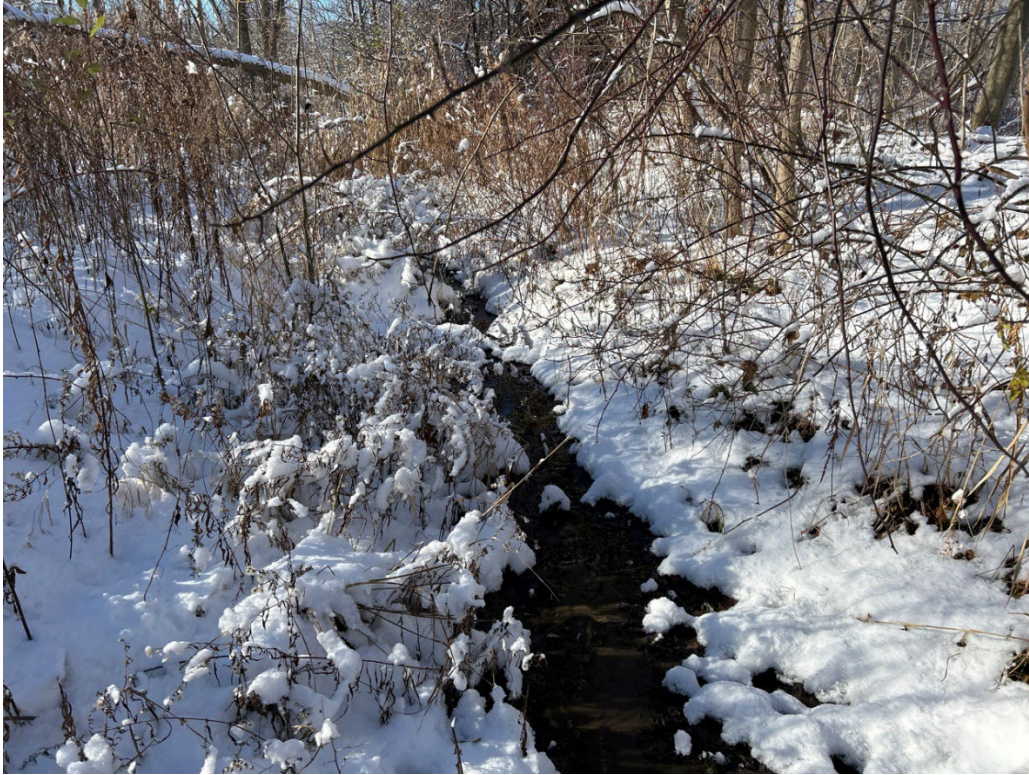
Stream S-JJB-3 is an approximately 4-foot-wide, 0 to 6-inches-deep, intermittent drainage ditch with approximately 3-foot-high banks. Approximately 204 linear feet were delineated within the Survey Area. The streambed consists of silt/clay substrate. The stream originates offsite to the east at a culvert which conveys flow beneath Route 237 and flows west/southwest into stream S-IBP-1. The stream corresponds to a mapped NWI riverine intermittent streambed feature (R4SBA) and flows into a Class C unprotected NYSDEC mapped stream feature, Black Creek (S-IBP-1).

Photograph 7: Downstream of intermittent stream S-JJB-3, facing southwest, taken on 12/3/2024.

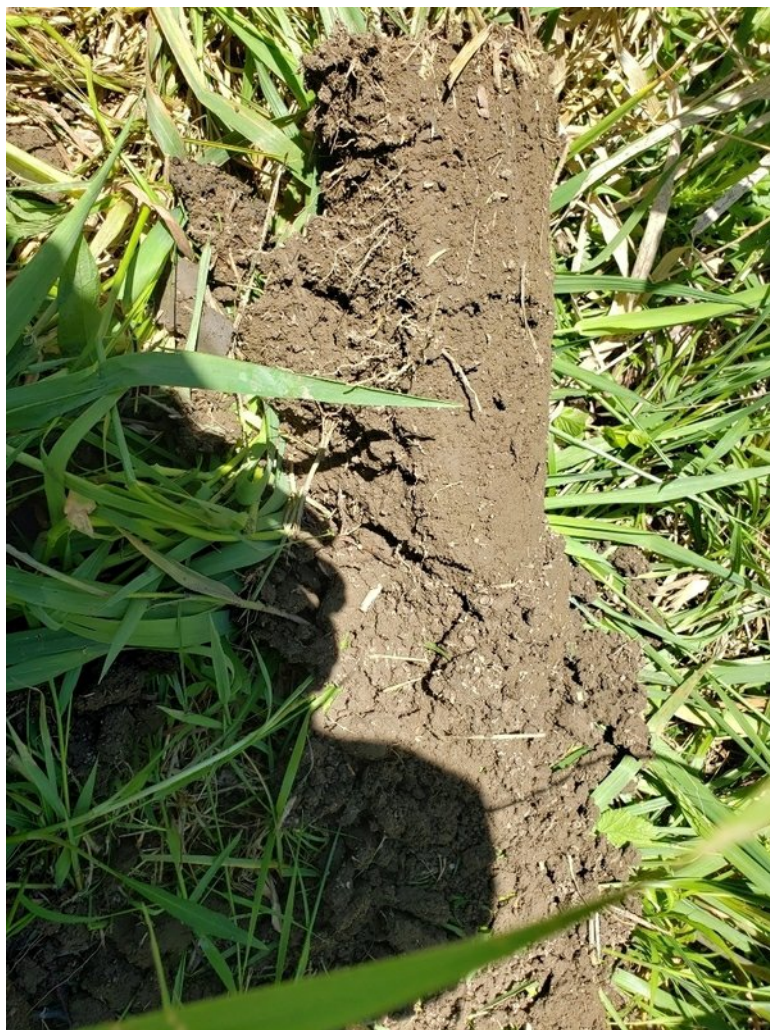
Soil Photos

Project/Site: Excelsior City/County: Byron, Genesee County Sampling Date: 2020-June-01
 Applicant/Owner: NextEra State: New York Sampling Point: W-IBP-01; UPL-1
 Investigator(s): Isaac Pallant, Casey Pearce Section, Township, Range: _____
 Landform (hillslope, terrace, etc.): Flat Local relief (concave, convex, none): Flat Slope (%): 0-1
 Subregion (LRR or MLRA): LRR R Lat: 43.0692347 Long: -78.0664124 Datum: WGS84
 Soil Map Unit Name: Fredon gravelly loam, 0 to 3 percent slopes NWI classification: None
 Are climatic/hydrologic conditions on the site typical for this time of year? Yes ☒ No ☐ (If no, explain in Remarks.)
 Are Vegetation ☐ Soil ☐ or Hydrology ☐ significantly disturbed? Are "Normal Circumstances" present? Yes ☒ No ☐
 Are Vegetation ☐ Soil ☐ or Hydrology ☐ naturally problematic? (If needed, explain any answers in Remarks.)

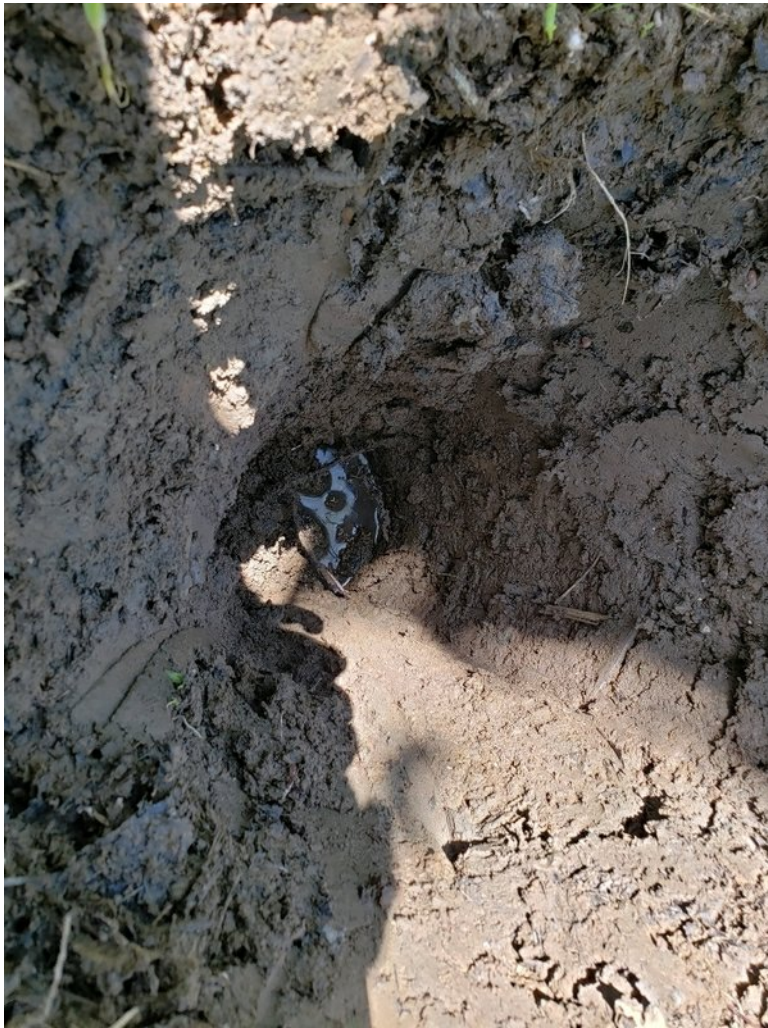
Hydrology Photos

Wetland Hydrology Indicators:											
Primary Indicators (minimum of one is required; check all that apply)		Secondary Indicators (minimum of two required)									
<input type="checkbox"/> Surface Water (A1)	<input checked="" type="checkbox"/> Water-Stained Leaves (B9)	<input checked="" type="checkbox"/> Surface Soil Cracks (B6)									
<input type="checkbox"/> High Water Table (A2)	<input type="checkbox"/> Aquatic Fauna (B13)	<input checked="" type="checkbox"/> Drainage Patterns (B10)									
<input checked="" type="checkbox"/> Saturation (A3)	<input type="checkbox"/> Marl Deposits (B15)	<input checked="" type="checkbox"/> Moss Trim Lines (B16)									
<input checked="" type="checkbox"/> Water Marks (B1)	<input type="checkbox"/> Hydrogen Sulfide Odor (C1)	<input type="checkbox"/> Dry-Season Water Table (C2)									
<input checked="" type="checkbox"/> Sediment Deposits (B2)	<input checked="" type="checkbox"/> Oxidized Rhizospheres on Living Roots (C3)	<input type="checkbox"/> Crayfish Burrows (C8)									
<input checked="" type="checkbox"/> Drift Deposits (B3)	<input checked="" type="checkbox"/> Presence of Reduced Iron (C4)	<input type="checkbox"/> Saturation Visible on Aerial Imagery (C9)									
<input type="checkbox"/> Algal Mat or Crust (B4)	<input type="checkbox"/> Recent Iron Reduction in Tilled Soils (C6)	<input type="checkbox"/> Stunted or Stressed Plants (D1)									
<input type="checkbox"/> Iron Deposits (B5)	<input type="checkbox"/> Thin Muck Surface (C7)	<input checked="" type="checkbox"/> Geomorphic Position (D2)									
<input type="checkbox"/> Inundation Visible on Aerial Imagery (B7)	<input type="checkbox"/> Other (Explain in Remarks)	<input type="checkbox"/> Shallow Aquitard (D3)									
<input checked="" type="checkbox"/> Sparsely Vegetated Concave Surface (B8)		<input type="checkbox"/> Microtopographic Relief (D4)									
		<input checked="" type="checkbox"/> FAC-Neutral Test (D5)									
Field Observations:											
Surface Water Present?	Yes ____ No <input checked="" type="checkbox"/>

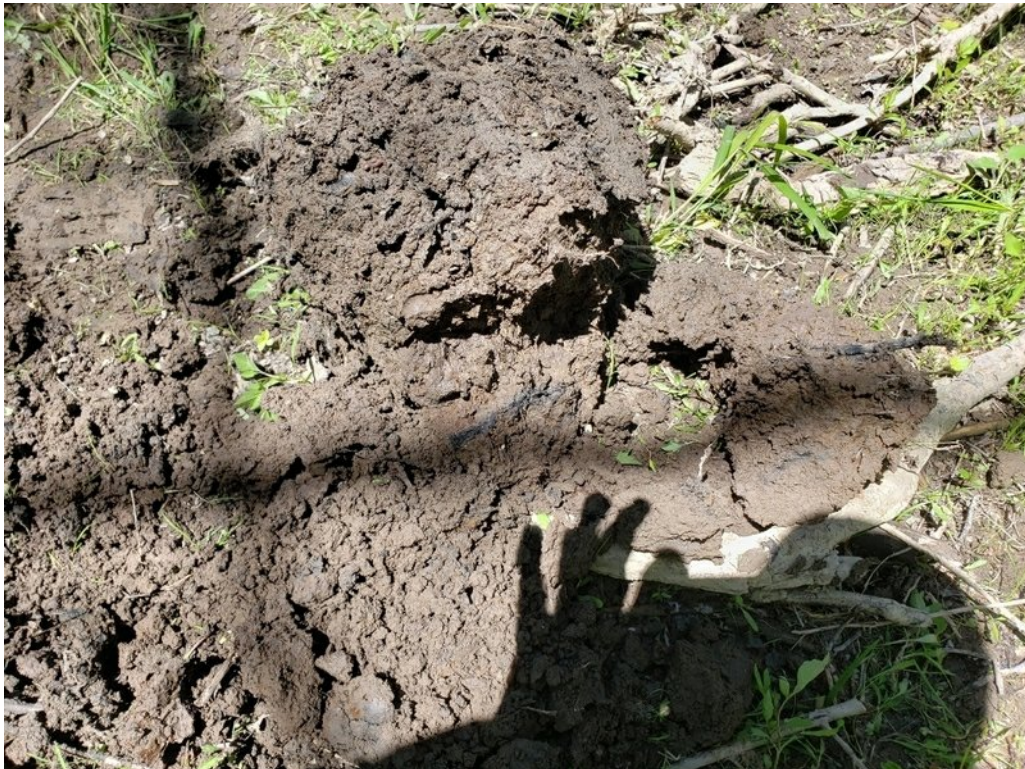
Soil Photos

Project/Site: Excelsior City/County: Byron, Genesee County Sampling Date: 2020-June-01
 Applicant/Owner: NextEra State: New York Sampling Point: W-IBP-01; PFO-1
 Investigator(s): Isaac Pallant, Casey Pearce Section, Township, Range: _____
 Landform (hillslope, terrace, etc.): Flood Plain Local relief (concave, convex, none): Flat Slope (%): 0-1
 Subregion (LRR or MLRA): LRR R Lat: 43.0696578 Long: -78.0662023 Datum: WGS84
 Soil Map Unit Name: Wakeville silt loam NWI classification: None
 Are climatic/hydrologic conditions on the site typical for this time of year? Yes ☒ No ____ (If no, explain in Remarks.)
 Are Vegetation ____, Soil ____, or Hydrology ____ significantly disturbed? Are "Normal Circumstances" present? Yes ☒ No ____
 Are Vegetation ____, Soil ____, or Hydrology ____ naturally problematic? (If needed, explain any answers in Remarks.)

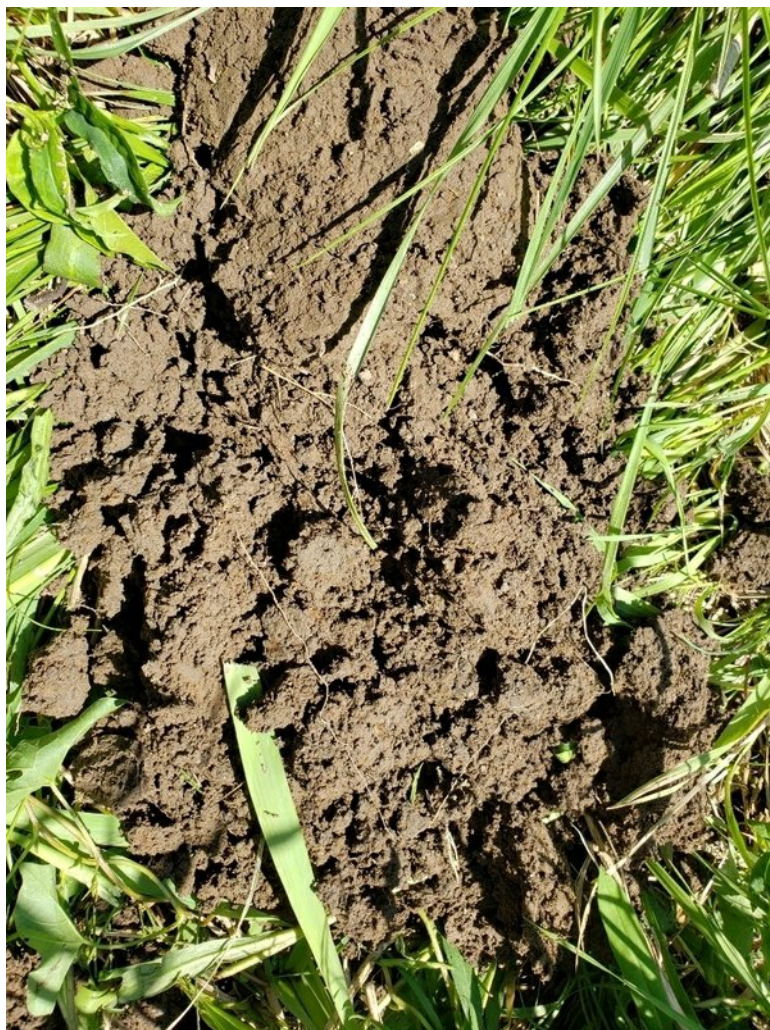
Soil Photos

Project/Site: Excelsior City/County: Byron, Genesee County Sampling Date: 2020-June-01
 Applicant/Owner: NextEra State: New York Sampling Point: W-IBP-01; PEM-2
 Investigator(s): Isaac Pallant, Casey Pearce Section, Township, Range: _____
 Landform (hillslope, terrace, etc.): Flat Local relief (concave, convex, none): Flat Slope (%): 0-1
 Subregion (LRR or MLRA): LRR R Lat: 43.0678977 Long: -78.0673683 Datum: WGS84
 Soil Map Unit Name: Wakeville silt loam NWI classification: None
 Are climatic/hydrologic conditions on the site typical for this time of year? Yes ☒ No ____ (If no, explain in Remarks.)
 Are Vegetation ____, Soil ____, or Hydrology ____ significantly disturbed? Are "Normal Circumstances" present? Yes ☒ No ____
 Are Vegetation ____, Soil ____, or Hydrology ____ naturally problematic? (If needed, explain any answers in Remarks.)
