Historic Architectural Resources Survey and Effects Report

Excelsior Energy Center Project
Town of Byron, Genesee County,
New York

SHPO Project Review Number:
19PR03747

September 2020

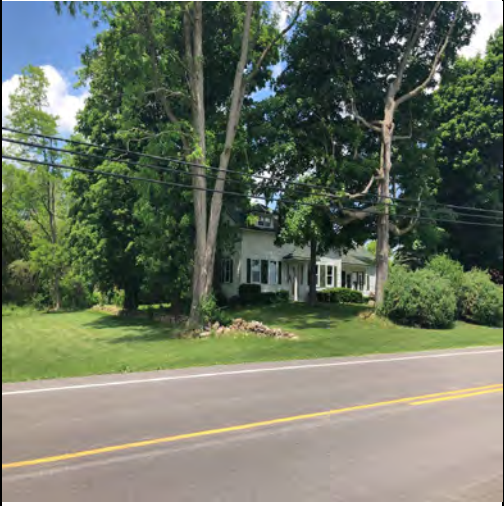
Address: 7294 Byron Holley Road, Byron	Construction Date: ca. 1875	Proposed Eligibility: Not Eligible

Property Name: Farm USN: Pending Description: The two-story, frame vernacular style residence features a side gable roof and an irregular plan due to additions, and is comprised of a five-bay wide primary mass, and two northern extensions. The façade includes a central single-leaf door with sidelights under a hipped roof entry porch, flanked by 1/1 double-hung sash windows with false shutters. Two hipped-roof dormers each include paired 1/1 sash windows. Windows on the south elevation are likewise 1/1 sashes with false shutters. The northern additions are both one-story, with the one adjacent to the primary mass featuring an enclosed front porch on the façade and a brick exterior end chimney. The second extension is a two-bay garage. The property includes a frame gambrel roof barn, built circa 1970, and a frame two-bay detached garage, built circa 2002, both located north of the house.

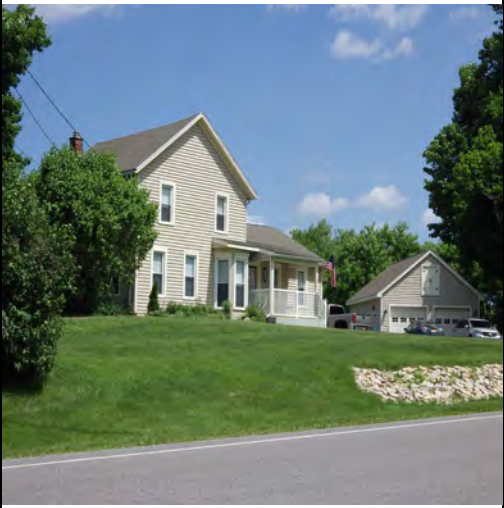
Address: 7796 Byron Road, Stafford	Construction Date: ca. 1900	Proposed Eligibility: Not Eligible

Property Name: House USN: Pending Description: This is a circa-1900, two-story, gable front and wing dwelling covered with vinyl siding. It features one exterior brick chimney on the southwest elevation and an altered front porch. Fenestration is synthetic 1/1 sashes. The façade (southeast elevation) includes a bay window projection on the first story, adjacent to the partial-width, altered front porch. A shed-roof addition is present on the northeast end, with a secondary entrance, connecting to an attached one-bay garage. A two-bay gable-front detached garage with hayloft doors is located east of the dwelling, built circa 2007.

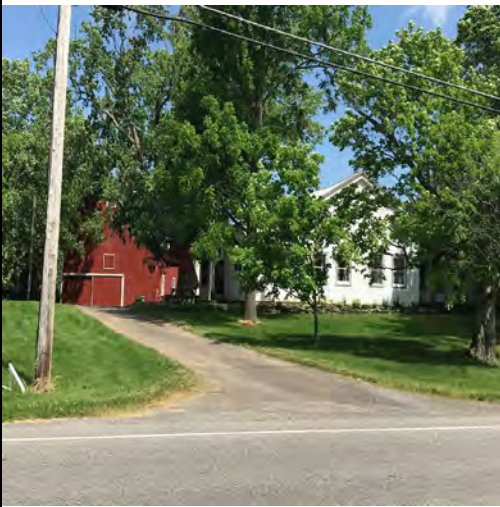
Address: 7862 Byron Road, Stafford	Construction Date: ca. 1825	Proposed Eligibility: Not Eligible

Property Name: Farm USN: Pending Description: This is a circa-1825, two-story gable front and wing dwelling covered with synthetic siding. The four-bay forward-facing gable end (southeast elevation) shows evidence of a now removed wide cornice, indicating the dwelling originally was built in the Greek Revival style. The wing features a wrap-around open porch with wrought-iron posts and railings, a single-leaf entry, and two flanking 1/1 sash windows. The gable end likewise features 1/1 sashes, replacements, four on the first story and two on the second story. An interior brick chimney is located at the junction of the gable front and wing sections. A one-bay addition with side-gable roof is present at the southwest end of the dwelling, with a casement window on the façade and a set-back secondary entrance. The property includes a circa 1900 two-story frame gambrel-roof barn, a detached garage, and a silo. The outbuildings are largely not visible from public right-of-way due to vegetation.

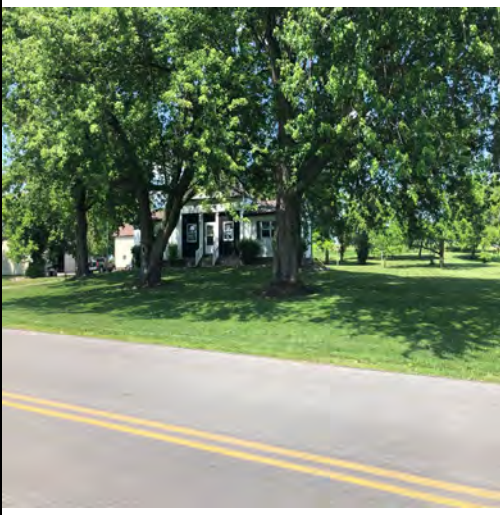
Address: 7912 Caswell Road, Stafford	Construction Date: ca. 1815	Proposed Eligibility: Not Eligible

Property Name: House USN: Pending Description: This is a circa-1815 Early Classical Revival style residence composed of a central front-gable section one-and-one-half stories in height flanked by one-story side gable wings. The integral porch on the central section has been enclosed and altered with new fenestration and siding materials. A modern octagonal window is in the pediment, also altered with vinyl siding. Each wing includes paired 1/1 vinyl sash windows with inoperable shutters. A rear ell extends from the south wing. The property includes two circa-1890 frame barns with gable roofs and replacement cladding and windows. The barns are located to the south of the house.

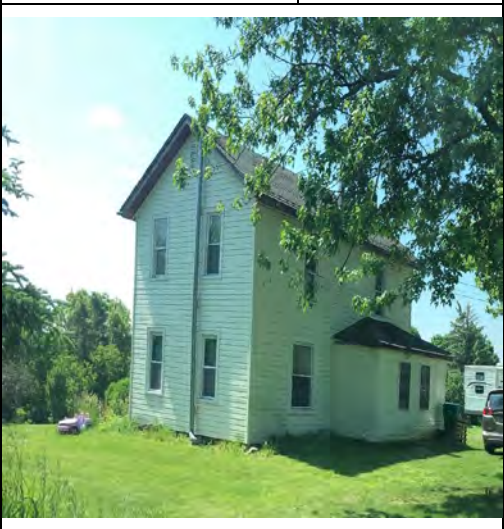
Address: 8021 Caswell Road, Stafford	Construction Date: ca. 1890	Proposed Eligibility: Not Eligible

Property Name: House USN: Pending Description: This is a circa 1890, two-story frame dwelling with a side-gable roof covered with asphalt shingles, and exterior vinyl siding. A partial-width front porch has been enclosed. Fenestration throughout is vinyl 1/1 sashes. An exterior cinderblock flue is present on the northeast gable end. The house has a one-story rear ell.
Address: 8026 Caswell Road, Stafford	Construction Date: ca. 1965	Proposed Eligibility: Not Eligible

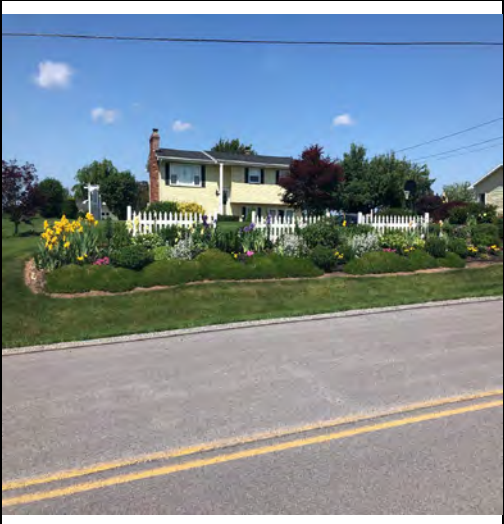
Property Name: House USN: Pending Description: This is a circa-1965, split-level, frame house built in the Colonial Revival/Ranch style. The two-story house features a side gable roof covered with asphalt shingles, one exterior brick chimney, and vinyl siding. The façade (east elevation) features a slightly overhanging second story, a single-leaf door, and one slender column. Fenestration includes picture windows and 1/1 sashes, all with inoperable shutters. A frame garage with side gable roof and matching siding and fenestration, built circa 1985, is located just northeast of the house.

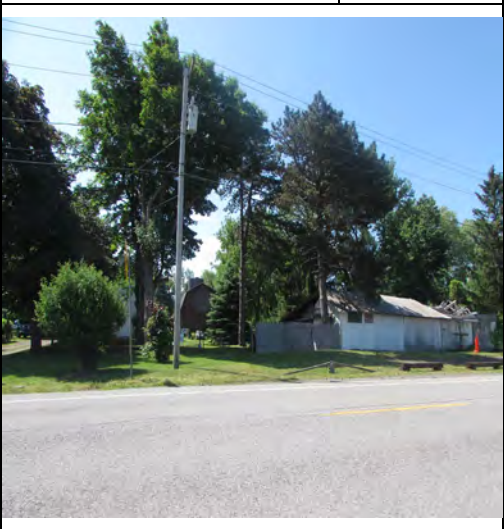
Address: 6338 Clinton Street Road (NY 33), Stafford	Construction Date: ca. 1890	Proposed Eligibility: Not Eligible

Property Name: Farm USN: Pending Description: This property is comprised of a circa-1890 house, three circa-1900 barns, and one shed. The two-story house exhibits substantial alterations, including new cladding, altered window openings with vinyl windows, and rear additions. The house has a side gable roof and one exterior brick chimney. The two frame gambrel-roof barns are largely obscured by vegetation surrounding the property. The one-story frame barn with gabled roof is in poor condition, and is located on a commercially-zoned parcel adjacent to the parcel containing the house and barns.
Address: 6380 Clinton Street Road (NY 33), Stafford	Construction Date: ca. 1870	Proposed Eligibility: Not Eligible

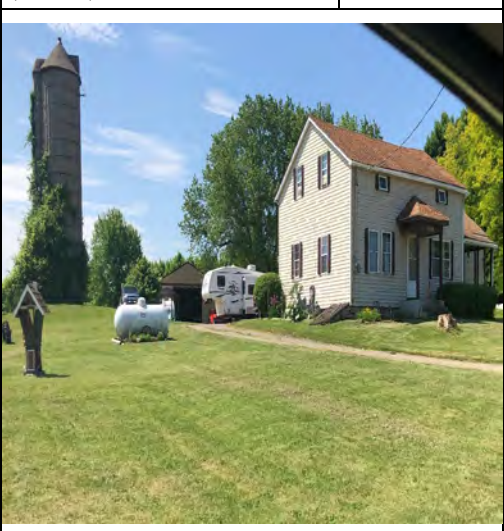
Property Name: Farm USN: Pending Description: This property includes a circa-1870 farmhouse, a prefabricated metal pole barn, a circa-1920 frame garage, and a concrete stave solo with conical roof. The one-and-one-half-story frame house features a side gable roof covered with asphalt shingles, vinyl siding, and a large side addition. The symmetrical façade (north elevation) features a central door with altered entry porch, flanked by paired vinyl 8/8 sash windows with inoperable shutters. Frieze-band windows with inoperable shutters are present on the façade. Side elevations also feature vinyl windows. Cellar access is located on the east elevation. A porch is located in the L formed by the main mass of the house and the side addition. The garage has a metal roof and vinyl siding, and is located just south of the house.

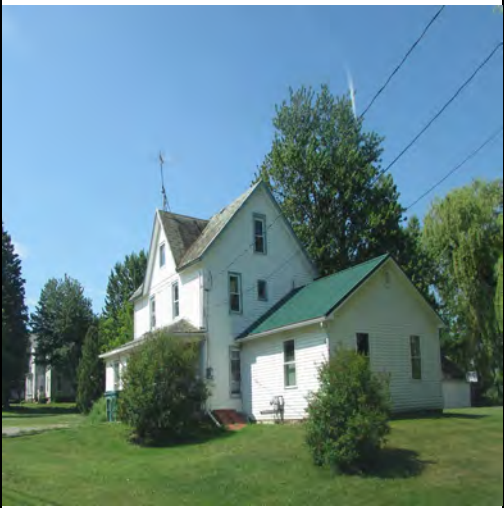
Address: 7644 Byron Holley Road, Byron	Construction Date: ca. 1900	Proposed Eligibility: Not Eligible

Property Name: House USN: Pending Description: This is a circa-1900, frame, two-story, center gable dwelling covered with synthetic siding. It features a partially enclosed, full-width front porch under a half-hipped roof supported by plain square posts. Windows throughout are 1/1 sashes, except for a single fixed-pane light in the center gable. One exterior concrete block chimney is present on the south elevation. The one-story rear ell with rear shed addition and the one-story north addition are covered with metal gabled roofs. Cellar access is located on the north elevation. A one-bay gable-front garage is located to the west of the dwelling.
Address: 7636 Byron Holley Road, Byron	Construction Date: ca. 1880	Proposed Eligibility: Not Eligible
 		Property Name: House USN: Pending Description: This is a circa-1880, frame, two-story, gable front and wing dwelling covered with vinyl siding. It features a cross gable roof covered with asphalt shingles and an enclosed front porch. The façade (east elevation) includes synthetic 1/1 sash windows—two on each story of the gable end—and two on the second story of the wing. The enclosed front porch includes synthetic 1/1 sash windows and a multi-pane door. A rear gabled addition connects to an open porch on the north elevation of the house that features decorative square posts. The south elevation includes two synthetic 1/1 sash windows on each story. A one-bay gable-front garage is located to the southwest of the dwelling.

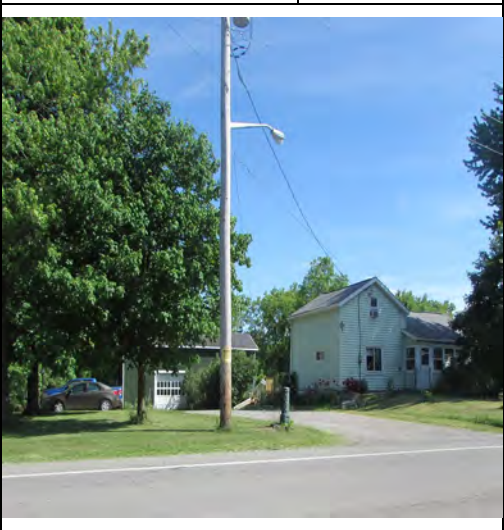
Address: 7469 Bank Street Road, Elba	Construction Date: ca. 1880	Proposed Eligibility: Not Eligible

Property Name: House USN: Pending Description: This resource is a circa-1880, gable front and wing, frame dwelling with associated garage/barn. The dwelling is clad in vinyl siding, has modern windows, and has a cross gable roof of asphalt shingles. The façade (northwestern elevation) has an enclosed porch on the one-story wing. The porch has windows across the front, and the door is near the gable. The gable is one-and-one-half stories, and it has a pair of windows on the first level and a single window in the gable. The northeastern elevation has a single pair of windows on the first level. The southwestern elevation has an exterior concrete block chimney. The garage/barn is one-and-one-half story, frame construction with a side gable, cat slide roof of asphalt shingles. There is a single bay with a multi light door.

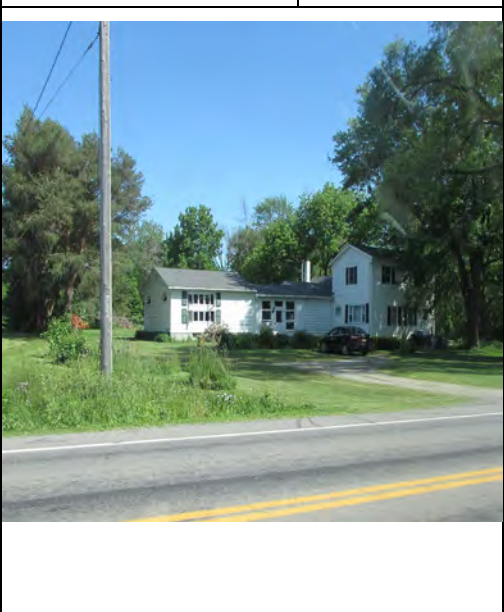
Address: 7351 Bank Street Road, Elba	Construction Date: ca. 1870	Proposed Eligibility: Not Eligible

Property Name: House USN: Pending Description: This is a circa-1870, vernacular style dwelling with modern renovations that have stripped it of its historical integrity of feeling, design, materials, and workmanship. The dwelling is clad in vinyl siding and has modern windows. There are many additions that are not sympathetic to the historic two-and-one-half story core. The façade (northwestern elevation) of the core is three bays and has an entrance at the southwestern corner. There are two windows northeast of it, and the second level has two windows. The northeastern elevation of the core has a picture window flanked by sash windows, and another smaller rectangular window next to it. The second story has a single window. Extending from a rear addition is a one-story breezeway, with a door flanked by three windows and a transom on top. Northeast of the breezeway is a larger one-story addition with aluminum siding and two ribbons of five casement windows. The side exterior of this has two more windows.

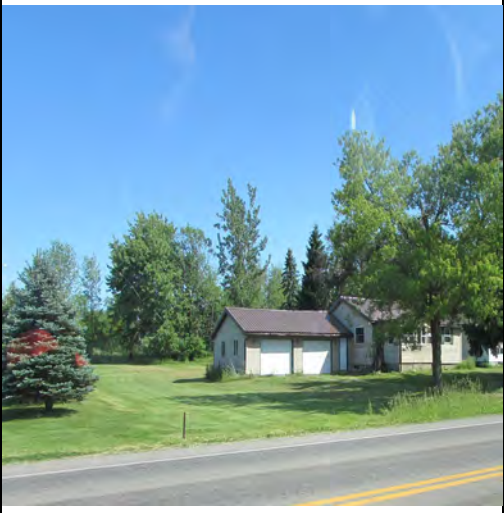
Address: 7345 Bank Street Road, Elba	Construction Date: ca. 1960	Proposed Eligibility: Not Eligible

Property Name: House USN: Pending Description: This is a circa-1960, one-story Ranch style house. The side gable house is clad in vinyl siding and rests on a concrete block foundation. The façade (northwestern elevation) has a bay window in a front gable and a single window at the southwestern end. The southwestern elevation has windows and an exterior concrete block foundation. The northeastern elevation has two windows on the house, and there is an attached two-bay garage at the northeastern end with two windows.
Address: 7331 Bank Street Road, Byron	Construction Date: ca. 1830	Proposed Eligibility: Not Eligible

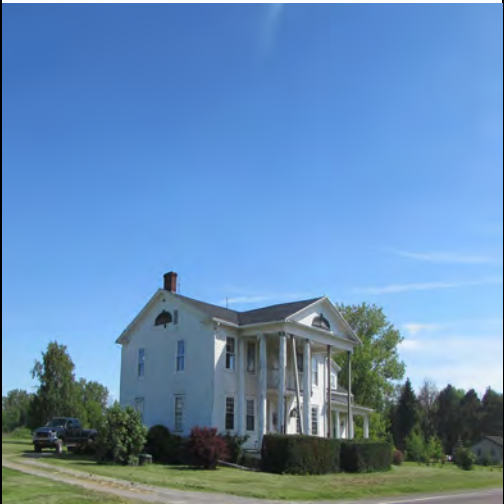
Property Name: House USN: Pending Description: This is a circa-1830, early Greek Revival style dwelling with a wing. The large, two-and-one-half story, five bay-wide house has a side gable roof of asphalt shingles and interior end chimney. It is clad with vinyl siding and has modern windows, one-over-one sash on the second level and others with false muntins on the first level. The façade (northwest elevation) has a two-story portico has a front gable roof with a lunette. Colossal Ionic order columns topped with volutes support the roof: some are in disrepair, and modern wood supports have been added to help support the roof. The five-ranked fenestration is symmetrical vertically and horizontally. Each level has a central door (the main level with original multi-light sidelights) and two evenly spaced single windows flank the door. The second level door has an upper porch with Ionic order columns and an open rail balustrade. The façade of the wing is also symmetrical: a central door flanked by windows, all covered by a porch with Ionic order columns. There is a dormer with two small lights over the door. The original cornice with a Greek key motif wraps across the façade on both the core and wing. The northeastern elevation is symmetrical with two windows on each level, both vertically aligned. There is a lunette in the gable like that in the portico gable and cornice returns, with the Greek key motif wrapping the corner. The southwestern elevation of the wing has a concrete block chimney, two windows on the first level, and a single one of the second.

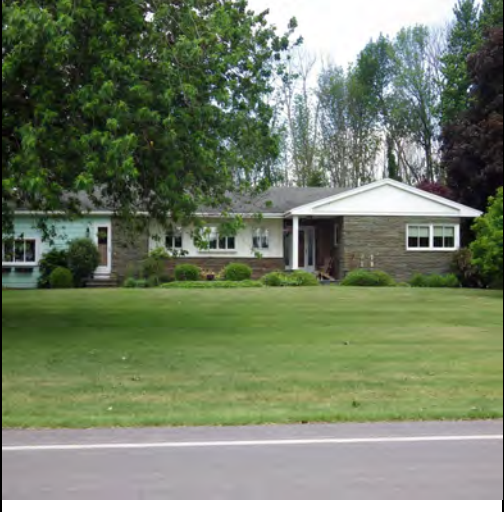
Address: 7232 Byron Holley Road, Byron	Construction Date: ca. 1960	Proposed Eligibility: Not Eligible

Property Name: House USN: Pending Description: This is a circa-1960, frame ranch house. The one-story building is covered in a mix of aluminum siding and faux stone. The footprint is an ell, with the recessed entrance on the façade (east elevation) set into the ell. The front gable portion is clad in synthetic stone and there is a pair of windows at the corner. South of the entrance is a pair of windows, followed by a ribbon of vertical lights, and then another pair, all under a wide eave. There is an addition at the southern end, and this has a door and set of windows. At the southern end there is a garage entrance.

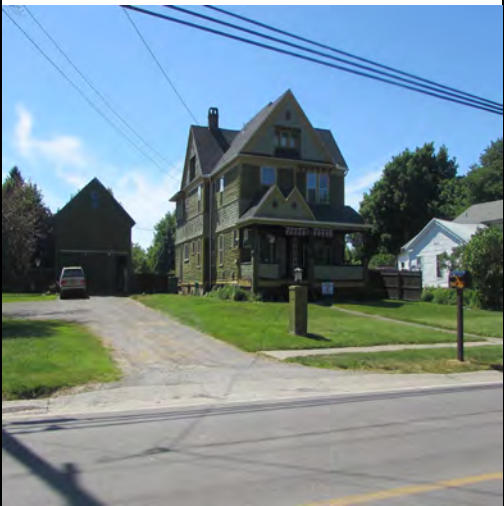
Address: 7586 Byron Holley Road, Byron	Construction Date: ca. 1895	Proposed Eligibility: Eligible

<p>Property Name: House USN: Pending Description: This is a circa-1895, Queen Anne style dwelling and associated carriage house/garage. The two-and-one-half story house has much of its original ornamentation and has been well maintained over time. The frame house is clad in original weatherboarding, shingles, and decorative elements. The multi-gable roof is covered in asphalt shingles, and there is an interior brick chimney. The façade (eastern elevation) is two bays and asymmetrical. A full-width porch fronts the house. Over the door is a double gable with fish scale imbrication and decorative circles. Paired columns on brick bases support the roof. The porch is enclosed with fish scale-covered walls. The entrance is off-center, and has sidelights. South of the entrance is a square window. North of the entrance is a picture window. The central square window has sidelights and a transom, and is encased by a curved enframement. The second story has a squared, multi-light window over the entrance. North of that is a pair of windows with brackets at the eave above them. The off-center gable has a trio of windows in a recess, and those too are topped with brackets. The gable mimics the one on the porch with fish scale imbrication and the decorative circle. The south elevation has multiple windows along the first level. There is a door at the rear of the house. This level is clad in horizontal weatherboard. Over that is a wide band of shingles separating the levels. The second story windows are set into the horizontal weatherboard. The gable is like the one on the façade with recessed windows and imbrication. The north elevation has a central porch over an entrance. The porch roof is supported by the same paired columns on brick bases as the façade. Additional windows pierce the elevation. The second story has five windows across it. There are two gables on this elevation. Southeast of the house is a one-and-one-half story carriage house/garage. There is a sliding barn door on the front and a multi light window in the gable.</p>

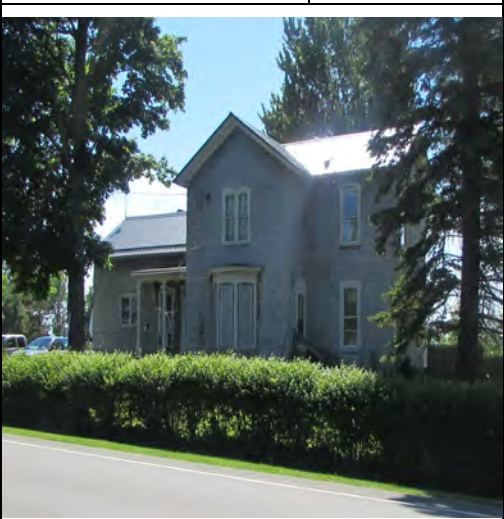
Address: 7656 Byron Holley Road, Byron	Construction Date: ca. 1860	Proposed Eligibility: Not Eligible

Property Name: House USN: Pending Description: This is a circa-1890, Italianate style, gable front and wing dwelling with associated barn/garage. The southern portion of the dwelling is two-and-one-half stories, while the northern wing is one-and-one-half story. The house has a cross gable, metal roof and is clad in asbestos siding. The façade (east elevation) has its entrance tucked into the corner near the gable. There is a small porch with decorative brackets and wooden columns. A single window is next to the door, and a pair of modern windows are north of the door. The gable wing has a three-sided bay window on the first level, and a pair of arched two-over-two window over that. On the other wing, there are single two-over-two windows. A door with a decorative pediment is tucked into the corner of the gable. The northern elevation has a single six light window on the first level, ad a larger one-over-one window with a pedimented lintel in the gable. There is an enclosed porch on the rear of the building. Northeast of the dwelling is a circa 1900 two-story, frame garage/barn. It is clad in vertical wood siding and has a window in the gable.

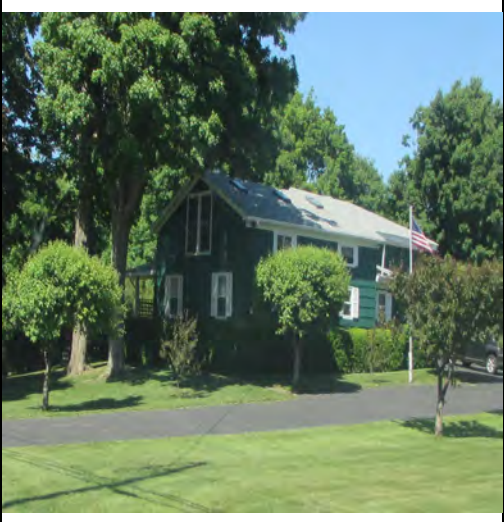
Address: 7655 Byron Holley Road, Byron	Construction Date: ca. 1870	Proposed Eligibility: Not Eligible

Property Name: House USN: Pending Description: This is a circa-1870 one-and-one-half story vernacular dwelling and associated garage. The dwelling has many modern alterations, like modern windows and skylights that detract from its historic integrity. The house is clad in weatherboarding, and the side gable roof has asphalt shingles and skylights. There are small windows at the roofline on the façade. The south elevation has two windows on the main level, and in the gable there is a pair of large windows. There is a porch in the southwest corner. There is a two-bay frame garage southeast of the dwelling.

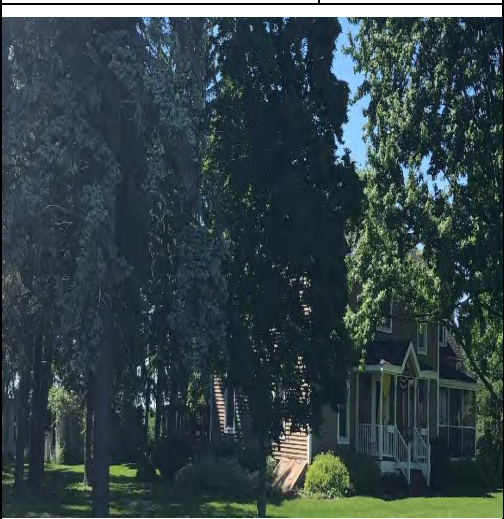
Address: 7790 Byron Holley Road, Stafford	Construction Date: ca. 1900	Proposed Eligibility: Not Eligible

<p>Property Name: House and Barn USN: Pending Description: This resource is a farm with a circa 1900 gable front dwelling that has been heavily modified and retains little historic integrity. The two-and-one-half story frame dwelling is clad in vinyl siding, has modern windows, and a side addition. The roof is clad in asphalt shingles and there is a stone foundation. The façade (east addition) of the core of the dwelling is symmetrical, with a centered entrance flanked by single windows. There is a partial width porch over the door, and this has a small gable over the stairs, turned post supports, and an open rail balustrade. Over the porch is a pair of windows that are flanked by two more windows on either side. In the gable is another window. There is a screened-in porch at the northern end. The southern elevation has two windows on the first level and one on the second and in the gable. Associated with this dwelling is a circa 1880 springhouse, a large circa 1880 bank barn, silo and garage. The small frame springhouse is located north of the dwelling. The bank barn has a stone foundation, vertical weatherboard siding and a gambrel roof. There is a large ell addition on the northwest corner of the barn. The bank is on the southern elevation. There is a silo north of the barn. A garage on the property was obscured during this survey.</p>

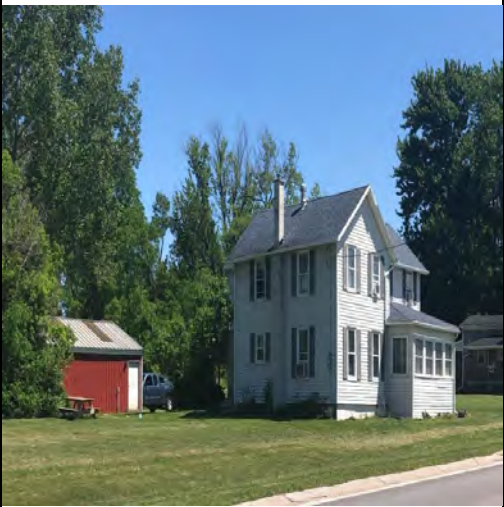
Address: 7609 Byron Holley Road, Byron	Construction Date: ca. 1890	Proposed Eligibility: Not Eligible

Property Name: House USN: Pending Description: This is a circa-1890, gable-front and wing house with many modern alterations. The two-and-one-half story frame dwelling is clad in vinyl siding and has modern windows across the house. The side gable roof is clad with asphalt shingles. Along the wing on the façade (west elevation) there is an enclosed porch. The roof has a hipped roof and four windows on the façade. The entrance to the porch is on the southern end. Over the porch are two single windows. The front gable has two single windows on each level. The northern elevation has two single windows on each level, with an exterior concrete block chimney between them. The southern elevation has two single windows on each level on the gable end. There is a one-and-one-half story addition on the eastern elevation and on its southern elevation there is a small porch with a shed roof and metal supports. There are two windows east of the porch. There is a modern one-story garage and a shed northeast of the dwelling. Southeast of the dwelling is a circa 1900 one-and-one-half story, frame garage/carriage house.

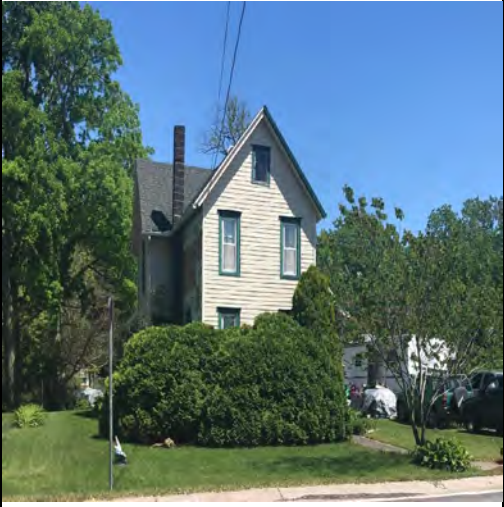
Address: 7597 Byron Holley Road, Byron	Construction Date: ca. 1880	Proposed Eligibility: Not Eligible

Property Name: House USN: Pending Description: This is a circa-1880, gable-front and wing dwelling with garage/carriage shed. The two-and-one-half story frame dwelling is clad in vinyl siding, has modern one-over-one windows, and has a metal, cross gable roof. The façade (west elevation) has a small porch with a shed roof tucked into the corner at the wing. The porch is small, but has decorative brackets and turned posts for supports as well as a spindle rail balustrade. In the gable end, there are two single windows on each level and window in the gable. The northern elevation has a window on the lower level and an exterior concrete block chimney. The gable extends out from the core, and there are windows in this elevation. The southern elevation has a window overlooking the porch, and in the gable end, two single windows on each elevation. Southeast of the dwelling is a circa-1900, one-and-one-half story, frame garage/carriage house.

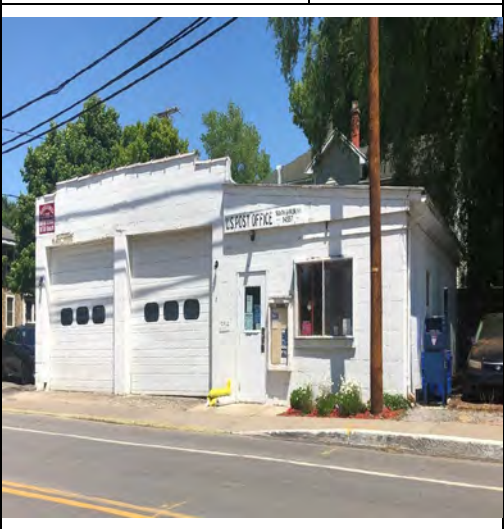
Address: 7543 Byron Holley Road, Byron	Construction Date: 1954	Proposed Eligibility: Not Eligible

Property Name: Underpass Auto/South Byron Post Office USN: Pending Description: This is a 1954 service station that now serves as a post office. The one-story building is constructed of concrete block. There are two garage bays, an office with a door, and two windows on the façade (west elevation). There is a stepped parapet over the garage bays. The south elevation has two windows. The north elevation has a door with lights and a window. The east elevation has windows as well.
Address: N/A Byron Holley Road , Byron	Construction Date: circa 1853, 1904	Proposed Eligibility: Eligible

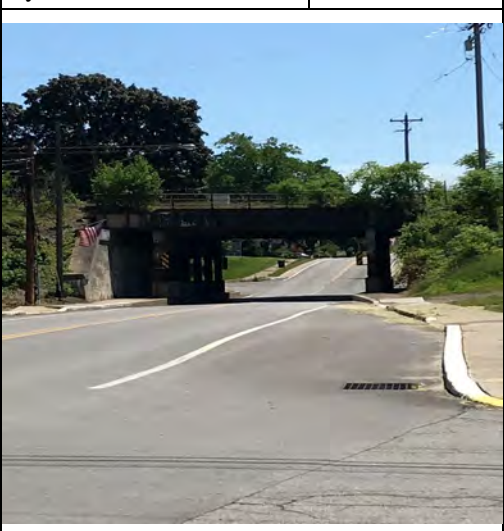
Property Name: New York Central (Main Line) CSX USN: Pending Description: The former New York Central & Hudson River Railroad in the APE consists of two sets of steel rail tracks on wood ties and stone ballast. The rail line proceeds in a northeast to southwest direction through the project area. This segment of railroad within the APE includes four bridges that contribute to its historic significance. Other culverts over creeks may be part of the railroad, but they are not visible from public roadways. The underpasses feature poured concrete, masonry abutments and wingwalls that support a steel-plate girder double-track bridges and date from 1902 to 1904. This segment of railroad right-of-way contributes to historic significance of the New York Central & Hudson River Railroad in other parts of New York.

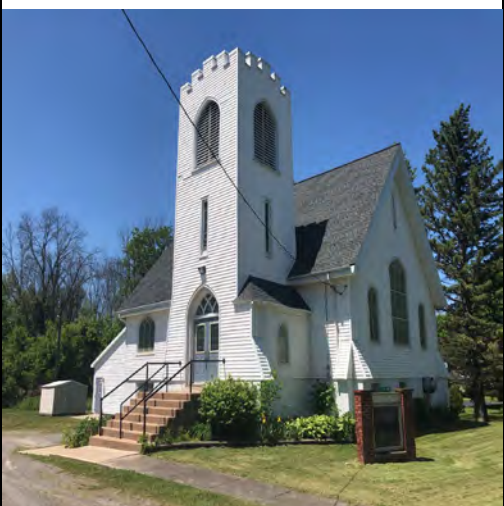
Address: 7521 Byron Holley Road, Byron	Construction Date: ca. 1910	Proposed Eligibility: Not Eligible

<p>Property Name: South Byron United Methodist Church USN: Pending Description: The South Byron United Methodist Church is a circa-1910, Gothic Revival style building on the west side of Byron-Holley Road. The one-and-one-half story, frame building has a foundation covered in stucco, while the remainder of the building is clad in vinyl siding. The steeply pitched roof is covered in asphalt shingles. Entrance to the church is on the south elevation, with concrete steps leading to double doors within the base of a tower. Segmented arch stained glass top the doors. The shaft of the tower has single, stained glass windows on each elevation. The belfry has large, arched vents on each elevation. The top is a crenelated parapet. East of the tower are pairs of basement windows and segmented arch stained glass windows. This style of window carries onto the façade (east elevation), where there is a large central one flanked by two smaller windows.</p>

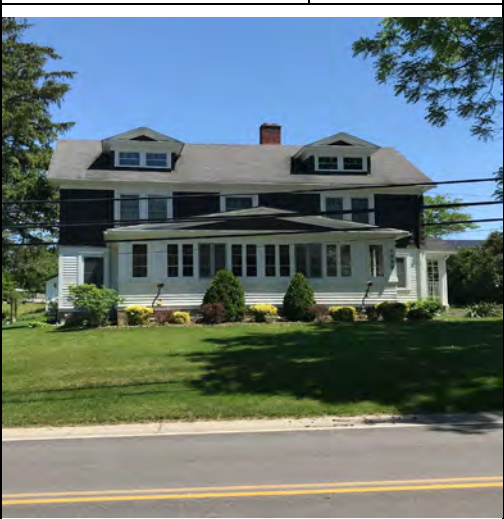
Address: 7529 Byron Holley Road , Byron	Construction Date: ca. 1920	Proposed Eligibility: Eligible

<p>Property Name: House</p> <p>USN: Pending</p> <p>Description: This is a circa-1920, New England Colonial style dwelling. The two-and-one-half story dwelling retains many original elements and is a good example of its type. The side gable roof is covered with asphalt shingles, and there is an interior brick chimney stack that pierces the roof at the ridge line. Weatherboards cover the lower portion of the house, and wood shingles cover the upper storey. The house stands on a cut-stone foundation. Windows are modern six-over-one and lack shutters. The façade (west elevation) is dominated by a large, enclosed porch. The one-story porch has a low pitched, front gable roof. The gable is enclosed. Vertical three-light windows wrap around the porch; some windows are separated by original square porch columns. The second level has a central, multi-light window and two pairs of windows evenly spaced. Over the mullioned windows are dormers in the slope of the roof with mullioned windows and closed gables. The south elevation is now the entrance to the house. Centered on the elevation is a porch with a pediment roof, supported by columns. Lattice adorns the sides. On either side of the entrance, there are pairs of windows. On the second level, there are two widely spaced windows. The gable has cornice returns, and there is a single window in the gable field. The northern elevation has a low, centered door with windows on either side. The second floor has windows vertically aligned with those of the first floor. The gable is like the north elevation's gable. East of the dwelling is a one-and-one-half story carriage house/shed. The frame building has a sliding barn door and a window in the gable.</p>

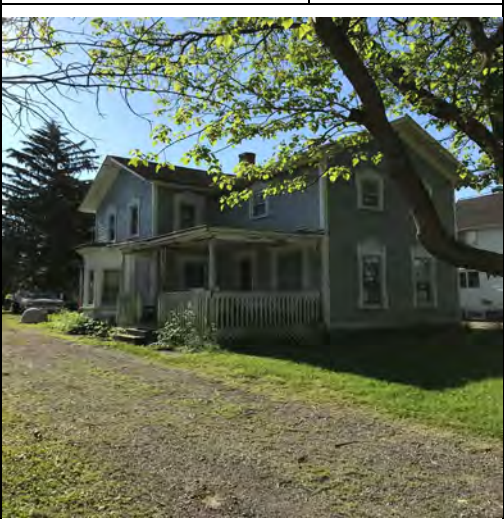
Address: 6933 Byron Holley Road , Byron	Construction Date: ca. 1900	Proposed Eligibility: Not Eligible

Property Name: House USN: Pending Description: This is a circa-1900, gable-front and wing style dwelling with Greek Revival influence. The two-and-one-half story house has its original weatherboard siding and ornate window pediments. The cross gable roof is asphalt shingles with an interior brick chimney, and the dwelling has a cross-shaped footprint. The façade (west elevation) is the gable front, and it is symmetrical with two horizontally and vertically aligned windows on each level. The north elevation has a porch set into the gable end and wing and this has the entrance into the house. The porch has a shed roof with wood supports and an open rail balustrade encircling it. Two windows open onto the porch. The second level has two windows overlooking the porch. Towards the rear in the gable there is a three-sided bay on the first level, and two windows over it. The first level of the south elevation has a single window near the front and two smaller windows in the gable, and a fourth one at the rear. The second level has a single window in the gable end. Northeast of the dwelling is a circa-1900 frame barn.

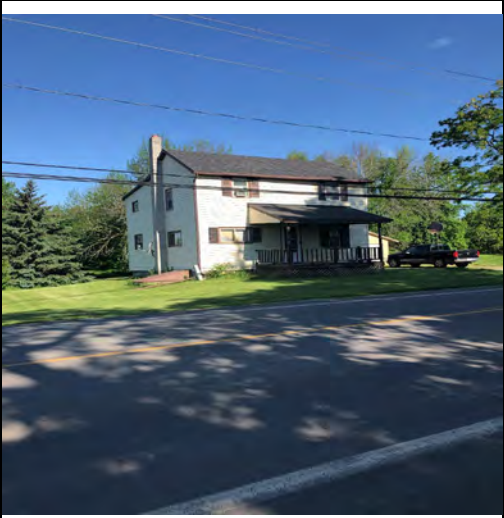
Address: 6944 Byron Holley Road, Byron	Construction Date: ca. 1860 (Tax assessor)	Proposed Eligibility: Not Eligible

Property Name: House USN: Pending Description: This is a circa-1860, two-and-one-half story dwelling with a modern garage. The dwelling has a rectangular footprint and has many modern alterations that have resulted in a loss of historic integrity. The dwelling is covered in vinyl siding and has modern windows with shutters. The dwelling has a side gable roof of asphalt shingles and a stone foundation. The modern porch on the façade (east elevation) is not sympathetic to the age of the building. The partial width porch has a shed roof supported by squared wood posts. There is an open rail balustrade. The door is centered, and north of the door is a single window and to the south a pair of windows. The second level has two widely spaced single windows. The northern elevation has three rectangular sliding windows, and there is a door with a small porch. The porch again has a shed roof, wood supports, balustrade, and a ramp leading to it. The second level has a single sash window and a rectangular window. The southern elevation has an exterior concrete block chimney and a bulkhead. There are two windows on the first level and two on the second. There is a circa-1980 garage northwest of the dwelling.

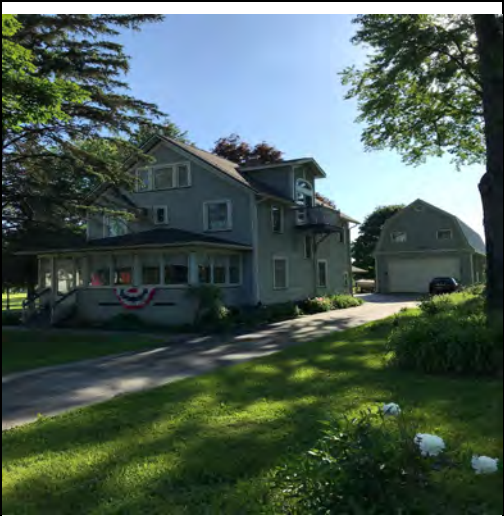
Address: 6907 Byron Holley Road , Byron	Construction Date: ca. 1910	Proposed Eligibility: Not Eligible

Property Name: House USN: Pending Description: This is a circa-1910, vernacular style, frame dwelling and associated garage. The two-and-one-half story dwelling has modern renovations like vinyl siding, and modern windows that detract from its historic integrity. The front gable roof is clad in asphalt shingles and the house is on a pressed concrete block foundation. The façade (west elevation) has a full width enclosed porch with a shed roof. Windows encircle the porch. The entrance is at the northern end. Over the porch is a centered small window, and two larger ones at the sides. In the gable, there is a trio of windows. The southern elevation has two large and one small windows on the first level. The second level has three windows. There is a dormer with a door leading onto a small, cantilevered deck. The northern elevation has windows on the first elevation, and a small porch towards the rear. The porch has a shed roof, turned post supports and an open rail balustrade. The second level has four windows across it. Southeast of the dwelling is a circa-2000 barn/garage with a front façade.

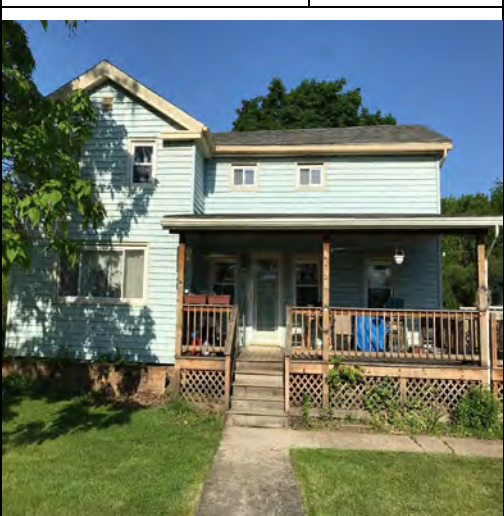
Address: 6898 Byron Holley Road , Byron	Construction Date: ca. 1890	Proposed Eligibility: Not Eligible

Property Name: House USN: Pending Description: This is a circa-1890, gable front and wing style, frame dwelling. The two-and-one-half story house has many modifications that detract from its historic integrity. The house is clad in vinyl siding and it has modern windows and front porch. It rests on a brick foundation. The façade (east elevation) has a porch that extends along its wing. It has wood supports and open rail balustrade and lattice along the bottom. Steps lead to the door fronted by a modern storm door. There are three windows looking out onto the porch. Over the porch, two smaller sliding windows are near the eave. On the gable, there is a modern picture window on the first level, and two windows on the second level. There is a cornice return at the gable. The northern elevation has a ramp leading on the porch. In the gable end, there is a small pair of sliding windows on the first level and a single window in the gable. There is a rear addition, and this elevation has three windows. The southern elevation has a single sliding window on the first level. The remainder of this elevation is obscured by trees. There is a large rear addition along the wing of this house.

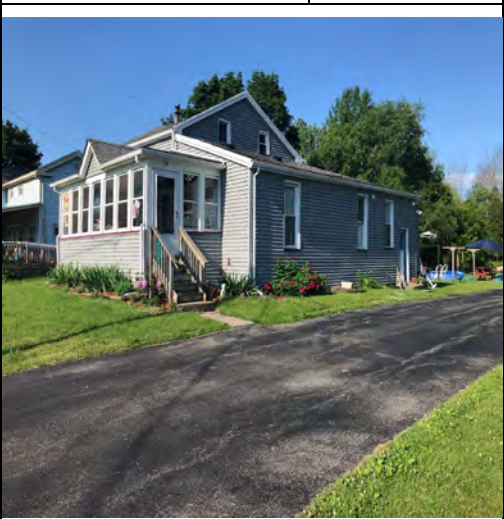
Address: 6894 Byron Holley Road, Byron	Construction Date: ca. 1880	Proposed Eligibility: Not Eligible

Property Name: House USN: Pending Description: This is a circa-1880, wood frame dwelling with modern renovations and additions. The one-and-one-half story house is clad in vinyl siding and has modern windows. The side gable roof is covered in asphalt shingles. The façade (east elevation) has a large, enclosed front porch lined with windows. There is a central gable on the roof. A lone window is tucked into the corner south of the porch. Entrance to the porch and house are on the north elevation, where a set of wooden steps lead to the door. Also, on the northern elevation is a large one-story shed addition with three windows and a door. On the core of the dwelling, two windows are evident in the gable. The southern elevation has three windows on the first level and two windows in the gable. The cornice returns are remaining remnants of the historic feel of this building. There is an addition on the western elevation.

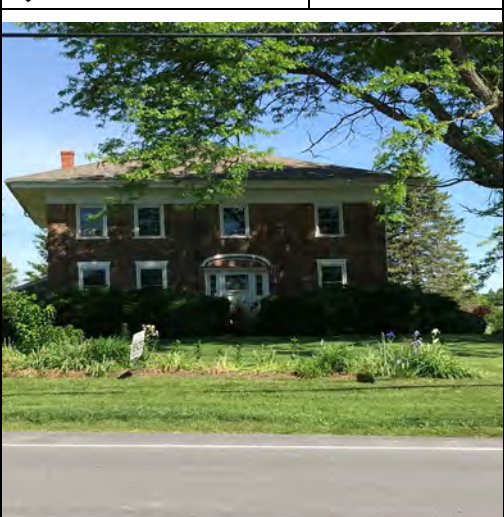
Address: 7463 Byron Holley Road , Byron	Construction Date: ca. 1840	Proposed Eligibility: Eligible

Property Name: House USN: Pending Description: This is a circa-1840, brick, Federal-style dwelling. The large house has a square footprint, and has a hipped roof of asphalt shingles. A wide, plain cornice wraps around the house, just beneath a wide eave. The three-bay façade (west elevation) is relatively plain. Brick pilasters run the height of the house. The slightly off-center entrance has a wood door with lights, and is flanked by sidelights. Over the entrance is a filled-in fan light. North of the entry are two single one-over-one windows with splayed lintels. South of the entry is a single window. The second level has four windows, each over a window or the entrance. Second story windows lack the larger splayed lintels. The south elevation has four windows across the first level, and three on the second level. The north elevation has three windows on the first level, and a bulkhead. There are only two windows in the second level. There is also an interior brick chimney. There is a one-and-one-half story addition at the northeastern corner. This may be historic, as it has nine-over-six sash windows and six-light clerestory windows. There is also a modern sun-room addition at the southeastern corner. Northeast of the dwelling there is a modern, two-bay garage.

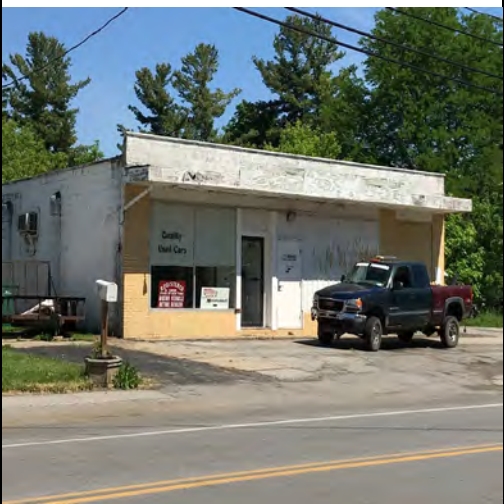
Address: 6893 Byron Holley Road , Byron	Construction Date: ca. 1957	Proposed Eligibility: Not Eligible

<p>Property Name: Elite Motorcoach Auto Shop USN: Pending Description: This is a circa-1957, one-story concrete block commercial building. The façade (western elevation) has two central doors. The southern side of the façade is covered with board, but the northern side still houses an office and there is a glass door and two large plate glass windows. The north elevation is concrete block. The south elevation has five garage bays with modern pull-down doors.</p>

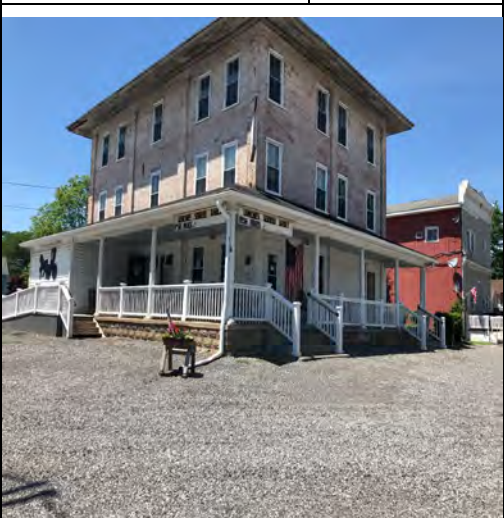
Address: 6874 Byron Holley Road, Byron	Construction Date: ca. 1845	Proposed Eligibility: Not Eligible

<p>Property Name: Byron Hotel USN: Pending Description: The Byron Hotel is a circa-1845 three-story, brick building located at the main intersection in Byron. The Federal-style, four-bay-wide building has a hipped roof of asphalt shingles with wide eaves and an interior brick chimney at the rear. Windows across the building are two-over-two, double-hung, wood sash windows topped with vertical brick lintels. The façade (east elevation) has a porch that wraps around to the southern elevation. Doric columns support the porch roof, and an open rail balustrade encircles the porch, which is on a pressed concrete block foundation. There are two sets up steps leading to two doors at the corners. There is a central window between them. The second and third levels each have four vertically symmetrical windows, and brick pilasters run along the edge and up the center of the facade. The sign extends from the southeastern corner. The southern elevation has the porch on the first level, and at the western end it has been enclosed. The second and third levels are identical: five windows are symmetrically placed across the elevation and they are separated by two central pilasters and bracketed by two more at the corners. The west elevation has a bulkhead. The first floor has three windows and a door at the northwestern corner. Again, the upper levels are identical with three windows across each. The northern elevation has a large one-story addition that is covered in vinyl siding. This addition has compromised integrity of design. The second level of the hotel has two regular windows and a central smaller one. The third story has five evenly spaced windows.</p>

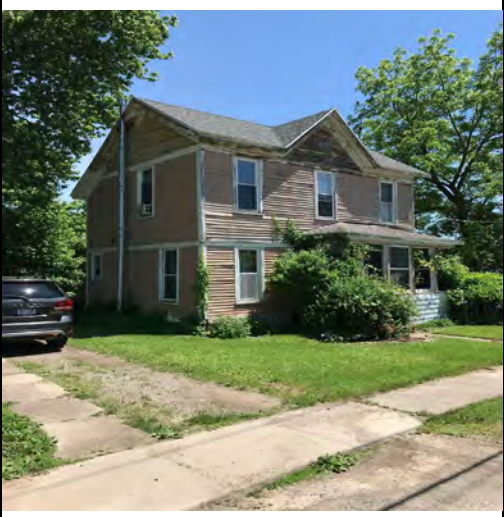
Address: 6863 Byron Holley Road , Byron	Construction Date: ca. 1880	Proposed Eligibility: Not Eligible

<p>Property Name: House USN: Pending Description: This is a circa-1880 two-and-one-half story Gothic Revival dwelling. The three-bay frame house is clad in weatherboarding and has a cross-gable asphalt shingle roof. The façade (west elevation) has a partial-width enclosed porch that obscures the entrance. There is a single window north of the entrance. The second level has three evenly spaced one-over-one windows and a central gable. The south elevation has two single windows on both levels that are vertically aligned. The ell has a small porch with a shed roof and an entrance off that. The north elevation has two windows on the first story and a single on the second. There is a metal pipe chimney also on this elevation. There is a two-bay, wood frame garage southeast of the dwelling.</p>

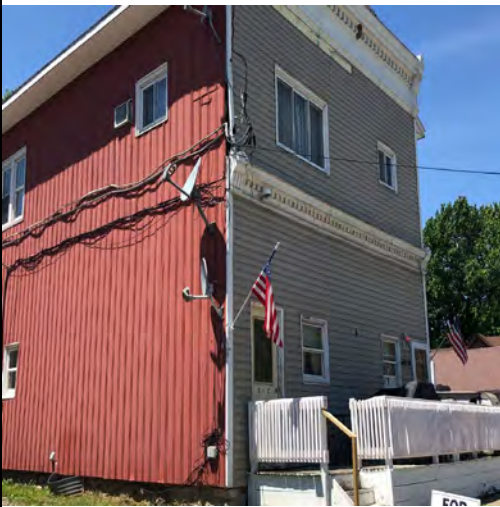
Address: 6870 Byron Holley Rd, Byron	Construction Date: c. 1860	Proposed Eligibility: Not Eligible

Property Name: Apartments USN: Pending Description: This is a circa-1860, two-story tall, frame apartment building. The building has a front gable roof hidden by a parapet. The façade (eastern elevation) has been significantly altered, but some original details remain. These details include corbels at the corners, bands of dentils and wide cornice. On the main level, there are two doors at each end of the building. Next to those are modern one-over-one windows. The second level has a trio of windows and a smaller pair of windows north of it. There is a full-width porch across the front of the building. These alterations have compromised integrity of workmanship and materials. The sides of the building are clad in a vertical siding. The northern elevation has two small windows and a door. The second elevation has three small windows and a door with a covered set of stairs leading to the ground level. The southern elevation has three windows on the ground level and four on the second level. Window apertures throughout the building have been altered, thereby compromising integrity of design.

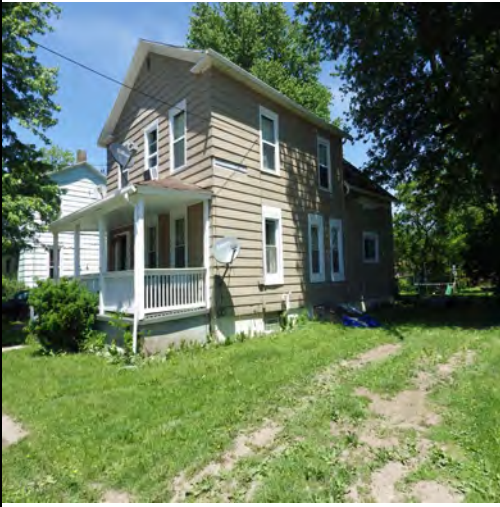
Address: 6859 Byron Holley Road , Byron	Construction Date: ca. 1880	Proposed Eligibility: Not Eligible

Property Name: House USN: Pending Description: This is a circa-1880, two-and-one-half story, Greek Revival-influenced dwelling. The dwelling is clad in modern siding, has modern one-over-one windows, and has a front gable roof and rests on a concrete foundation. The façade (western elevation) has three bays. The full-width porch has a hipped roof supported by squared posts. An open-rail balustrade encircles the porch. Offset concrete steps lead to a door at the northern end of the porch. South of the door are two single windows. The second level has three single windows across it. There are cornice returns at the gable. The southern elevation has three windows on the main level and two on the second. There is an addition on the eastern elevation, and there is one window facing south. On the northern addition there is a single window on the second level. There are two concrete block chimneys. The addition has two windows on this elevation.

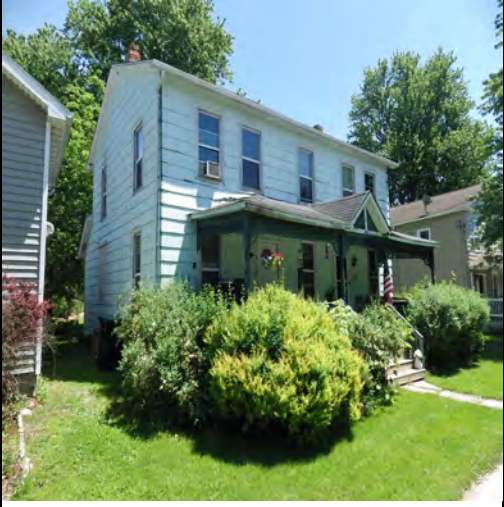
Property Name: House USN: Pending Description: This is a circa-1870, five-bay, two-and-one-half story frame dwelling. The dwelling is clad in aluminum siding, and has a side-gable roof of asphalt shingles. There are interior chimneys on both ends, and the brick one is crumbling. The façade (western elevation) has a nearly full-width porch with a hipped roof that supported by turned posts. At the roof line there is spindles, and decorative brackets are at the posts. There is an open-rail balustrade surrounding the porch. Over the central stairs is a pediment with decorative stickwork. There are two off-center modern doors and three modern window along the porch. The second level has five evenly spaced windows. The northern elevation has two vertically symmetrical windows on each level. The rear one on the first level is covered with wood. The southern elevation is the same, and the rear main level window is covered with plastic. The eastern elevation has a single story addition.

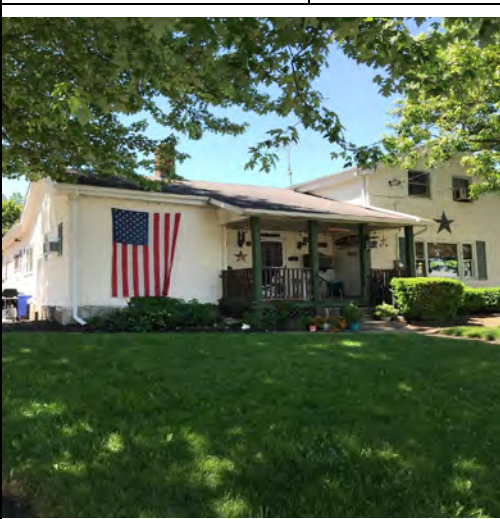
Address: 6834 Byron Holley Road, Byron	Construction Date: ca. 1865	Proposed Eligibility: Not Eligible

Property Name: House USN: Pending Description: This is a circa-1865, one-and-one-half story, gable front and wing frame dwelling. It is clad in asbestos shingles, has an asphalt shingle roof, and rests on a stone foundation. The façade (eastern elevation) has a small, recessed porch on the wing. The door is off center. The gable has a large picture window with sash windows on either side of it and shutters. There are two windows in the gable. The north elevation has a picture window with two sash windows, and smaller window to the west. The addition has three windows and an exterior concrete block chimney. The western elevation has a small window on the main level of the historic core, and another in the gable. On the addition, there is a pair of windows. The southern addition has three windows and two doors, and a modern wooden porch on the addition. There is a single bay garage north of the dwelling.

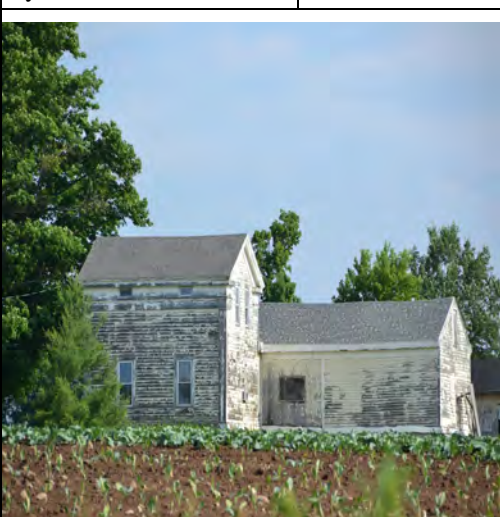
Address: 6227 Merriman Road, Byron	Construction Date: 1840	Proposed Eligibility: Eligible

Property Name: House and Barns USN: 03706.000057 Description: The property at 6227 Merriman Road, Byron is a two-story Greek Revival-style residence in an agricultural landscape. Where many local examples have altered fenestration and materials, this one has original materials and decorative elements including wide friezes and corner pilasters. Windows have been replaced. TRC Update: This Greek Revival farmhouse stands on a continuous masonry foundation of stones. Weatherboards cover the exterior walls. Pilasters mark the corners. The fenestration consists of 1/1 double-hung, vinyl sash windows. Asphalt shingles cover the gable roof. Wide bands of original wood trim are evident in the cornice and the gable ends of the two-storey house. Attic windows appear in the frieze band. A recessed porch shelters the front doorway. A brick chimney stack pierces the forward slope of the gable roof over the wing. The rear of the house has a one-story, large extension with a gable roof. A vehicle entry door has been carved into the north elevation of this addition. The parcel also includes three agricultural buildings. They are frame barns with gable roofs and vertical wood siding that do not contribute to the significance of the house. These agricultural buildings do not contribute to the significance of the house.

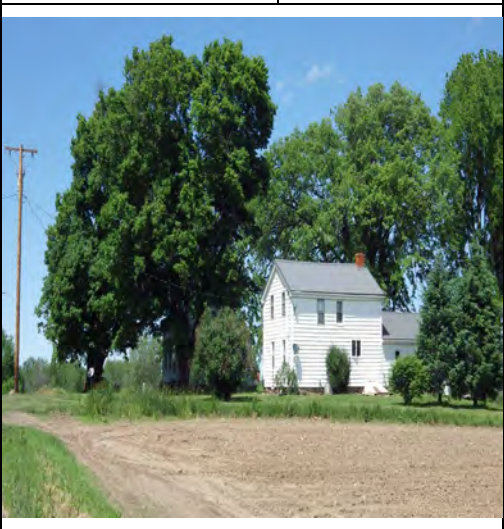
Address: 7109 Norton Road, Elba	Construction Date: 1890	Proposed Eligibility: Not Eligible

Property Name: House USN: Pending Description: This frame vernacular house has a rectangular footprint and a gable front profile. The house has aluminum siding and vinyl sash replacement windows, which have diminished integrity of materials and workmanship. A brick, internal, chimney stack pierces the roof of this two-storey house at the ridgeline near the rear wall.
Address: 7269 Norton Road, Elba	Construction Date: 1850	Proposed Eligibility: Not Eligible
