Historic Architectural Resources Survey and Effects Report

Excelsior Energy Center Project
Town of Byron, Genesee County,
New York

SHPO Project Review Number:
19PR03747

September 2020

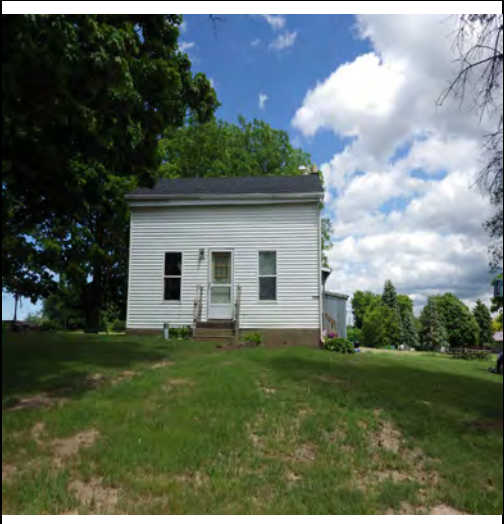
Property Name: House USN: Pending Description: This frame vernacular style house has a roughly rectangular footprint. It has vinyl siding and vinyl sash replacement windows, which have compromised the house's integrity of workmanship and materials. A rear addition has compromised integrity of design. A wood stoop leads to a new front door in the center of the facade. The house has a side gable roof.

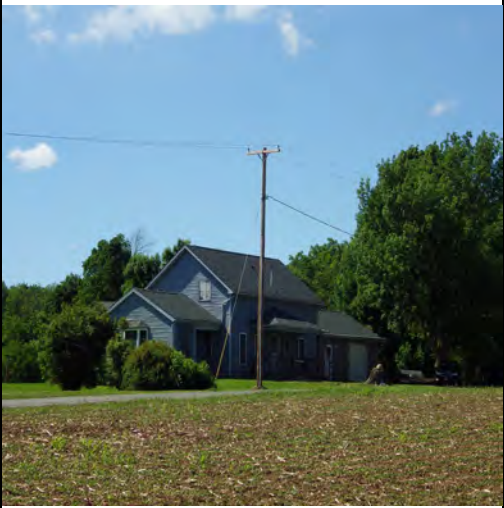
Address: 7274 Norton Road, Elba	Construction Date: ca. 1875	Proposed Eligibility: Not Eligible

Property Name: House USN: Pending Description: This frame vernacular style house has an irregular footprint. It stands one-and-a-half stories tall. The house has vinyl siding and vinyl sash replacement windows, which have compromised integrity of materials and workmanship. Additions to the rear and south elevations have compromised integrity of design. A gambrel roof, heavy timber frame barn stands south of the house and appears to date from circa 1970.
Address: 6873 Norton Road , Elba	Construction Date: ca. 1850	Proposed Eligibility: Not Eligible

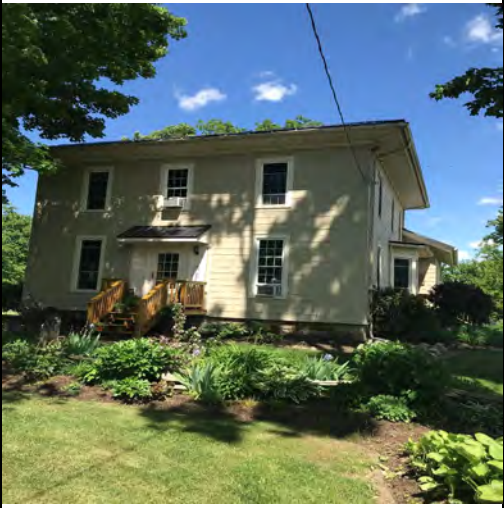
Property Name: House and Barn USN: Pending Description: This two-story house has a square footprint, standing on a continuous masonry foundation. Crimped metal covers the hipped roof. Vinyl sash replacement windows have been installed. Asbestos shingles cover the exterior. This vernacular style house may have displayed Folk Victorian undertones, but any such details have been removed. The foundation reveals cobblestone masonry that may have been covered by weatherboarding. These alterations and a rear addition have compromised the historic architectural integrity of workmanship, materials, and design. A heavy timber frame barn stands south of the house, across the driveway. The barn has vertical wood siding and asphalt shingle roofing on its gambrel roof.

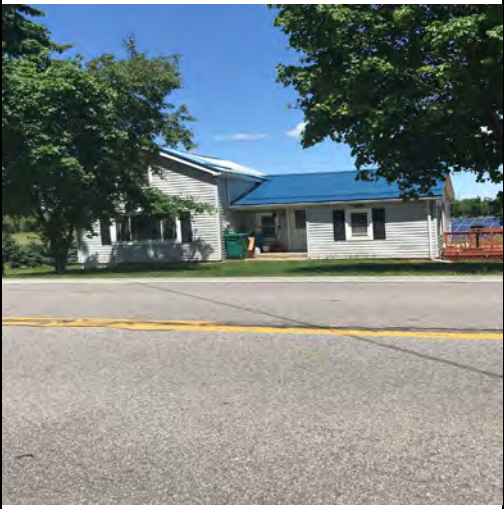
Address: 5291 Ford Road , Elba	Construction Date: 1890-1919	Proposed Eligibility: Not Eligible

Property Name: House USN: Pending Description: This frame house is vernacular in character, with past undertones of the Greek Revival style, diminished by alterations. Vinyl siding and vinyl sash replacement windows have been installed. A wood deck has been appended to the east elevation. The house stands one-and-one-half-stories tall.
Address: 6167 Merriman Road, Byron	Construction Date: ca. 1870	Proposed Eligibility: Not Eligible
 		Property Name: Farm USN: Pending Description: This frame vernacular style house has faded Greek Revival undertones that have been diminished by alterations. The house stands one-and-a-half stories tall. It has a rectangular footprint. The house has asbestos shingles, vinyl sash replacement windows, resized window apertures, and a new front door, which have compromised the house's integrity of design, workmanship, and materials. A brick chimney stack pierces the ridgeline of the roof of the addition on the south elevation of the house. A heavy timber frame barn with a gambrel roof stands north of the house, but vegetation obscures views of it.

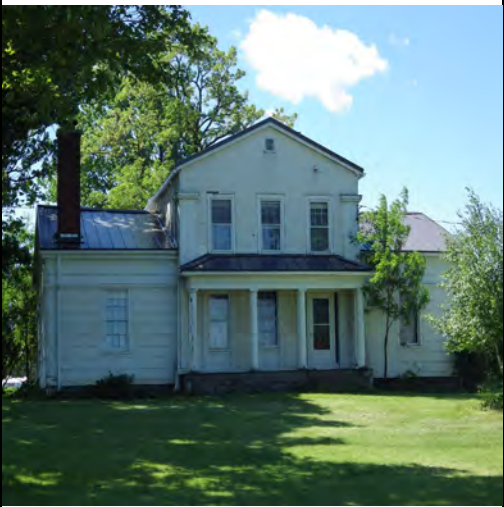
Address: 4914 Edgerton Road , Elba	Construction Date: circa 1830	Proposed Eligibility: Eligible

Property Name: Farm USN: Pending Description: This Greek Revival style farmhouse stands on a continuous masonry foundation of stones. Asbestos shingles cover the exterior walls. The fenestration consists of 6/6 double-hung, wood sash windows. Pre-crimped metal covers the gable roof. Wide bands of original wood trim are evident in the cornice and the gable ends. Doric order column support the three-bay-wide porch that shelters a front door with crossset surrounds. Pilasters define the corners of the house. A brick chimney stack pierces the forward slope of the gable roof over the east wing. The rear of the frame house has a one-story stone extension that may have functioned as a kitchen or springhouse. The house exhibits tripartite-bilateral symmetry, a hallmark of the Greek Revival style. The parcel also includes four agricultural buildings. There are two, heavy timber frame barns with gable roofs and vertical wood siding. Two metal outbuildings with rectangular footprints stand south of the house. These agricultural buildings do not contribute to the significance of the house. Setting beyond the recommended NRHP boundary does not contribute to the NRHP qualifying characteristics of the house.

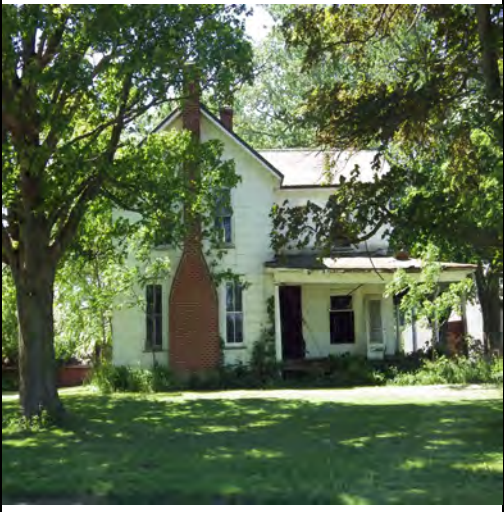
Address: 5020 Edgerton Road , Elba	Construction Date: 1870	Proposed Eligibility: Not Eligible

Property Name: Farm USN: Pending Description: This Folk Victorian style house has an L-shaped floor plan with a large rear addition. The fenestration consists of 2/2, double-hung, wood sash windows. Asbestos shingle siding has been applied to the exterior. The front porch, which is collapsing, has Tuscan order columns. A new, shouldered brick chimney stack has been built against the facade (north elevation). Alterations and neglect have compromised integrity of workmanship, design, and materials. Pre-crimped metal roofing covers the intersecting gable roof. The agricultural outbuildings appear to be new, except for a heavy timber frame ground barn with a gable roof, metal roofing, and vertical metal siding. Metal grain bins and pole sheds for farm equipment stand proximal to the house.

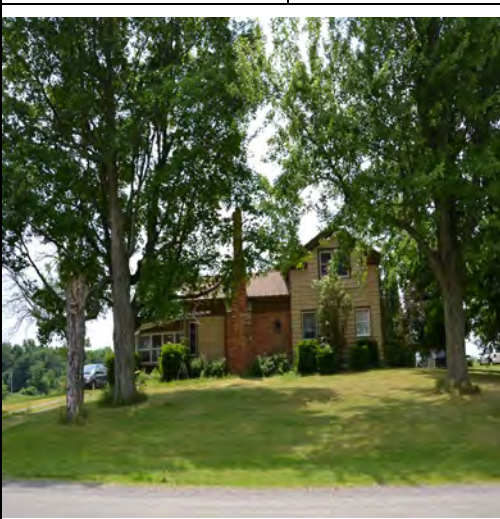
Address: 6674 Griswold Rd, Stafford	Construction Date: 1840	Proposed Eligibility: Eligible

Property Name: House USN: 03704.000040 Description: This Greek Revival house has been altered. Vegetation screens most views of the house from the roadway. The side porch has been enclosed. A large rear addition has been constructed. Aluminum siding has been applied to the exterior. A new brick chimney stack has been constructed against the facade (north elevation). Replacement windows and storm windows have been installed throughout the house. Window apertures have been reduced in size adjacent to the chimney. The original section of the house has an L-shaped floorplan. There are returns in the eaves. Brick veneer has been applied to portions of the facade adjacent to the chimney stack. Three barns stand across the road from the house. They are heavy timber frame buildings with vertical wood siding. They are in a state of advanced deterioration. The barns stand on a separate tax parcel, and they do not contribute to the significance of the house. There is a new metal shell vehicle storage building standing behind the house.

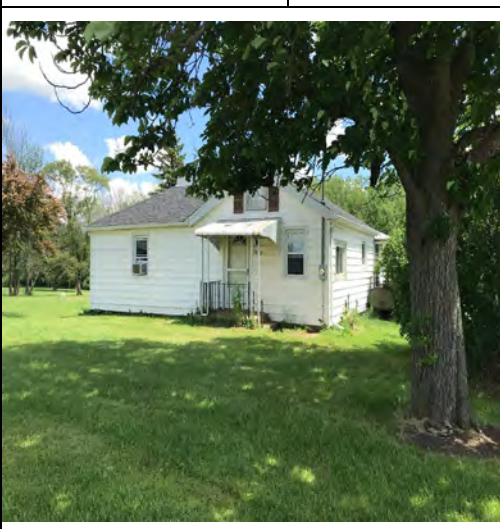
Address: 5412 Edgerton Road, Elba	Construction Date: ca. 1850	Proposed Eligibility: Not Eligible

Property Name: House USN: Pending Description: This is a circa-1850, frame, vernacular style dwelling with a large garage and breezeway addition on the rear. The one-and-one-half story building is clad in aluminum siding and has a cross gable roof of asphalt shingles. The façade (northwestern elevation) has a modern door with a fanlight under a metal awning that shields a small concrete porch. There are two one-over one windows on the first level and a six-light window in the gable. The northeastern elevation has a single and a pair of windows, and on the addition a garage door and single windows. The southwestern elevation has a pair of windows on the core, and then the large garage and breezeway addition extends from the house. The addition has a regular-sized door and a large garage door.

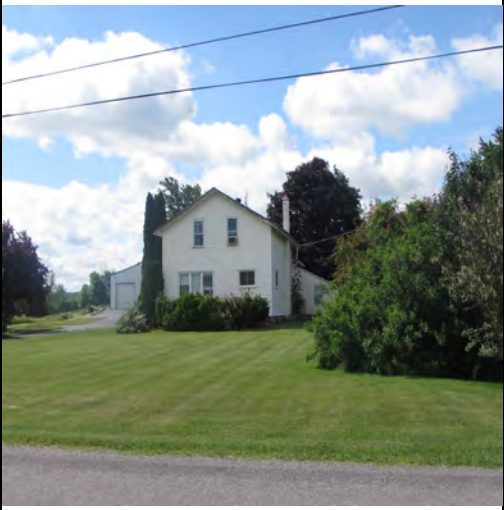
Address: 6786 Griswold Road, Le Roy	Construction Date: ca. 1870	Proposed Eligibility: Not Eligible

Property Name: House USN: Pending Description: This is a frame, circa-1850, vernacular style dwelling with modern modifications. The one-and-one-half story dwelling is clad in vinyl siding and has modern windows. The two-bay, front gable façade (northern elevation) has a trio of windows and a pair of windows on the first level, and two single sash windows in the gable. The western elevation has a single window on the first level and an exterior chimney. The eastern elevation has a window and a door. There is a rear addition and south of the house is a modern garage.
Address: 6968 Lyman Road, Byron	Construction Date:	Proposed Eligibility: Not Eligible

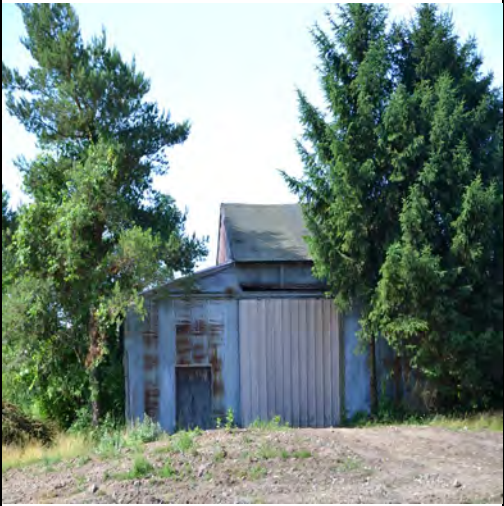
Property Name: Outbuilding USN: Pending Description: Property assessor data and aerial imagery indicate the presence of a circa-1870 residence on this property; however, the residential building appears to be demolished or removed from the site. If extant, it is completely obscured from view by vegetation surrounding the building. The property includes one small metal outbuilding with a gable roof and shed addition.

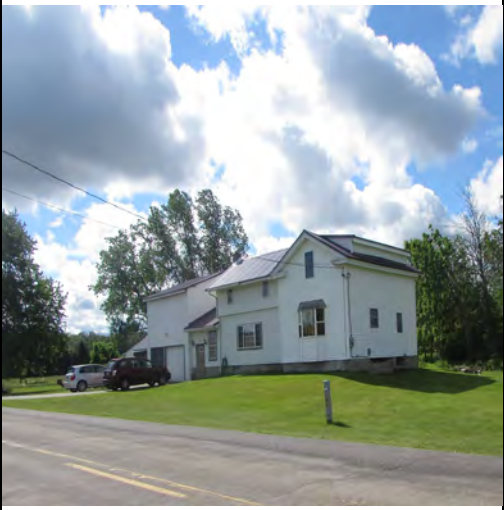
Address: 7016 Lyman Road, Byron	Construction Date: ca. 1860	Proposed Eligibility: Not Eligible

Property Name: House USN: Pending Description: This is a circa-1860 frame house, originally with gable-front-and-wing form. Additions, alterations, and removal of original details and materials have irrevocably diminished the integrity of the house. A second story has been added to the wing, along with a hyphen and attached garage with upper level on the east end of the original house. The roof of the gable-front section has been modified. Fenestration is all modern replacements.
Address: 7199 Dublin Road, Bergen	Construction Date: ca. 1920	Proposed Eligibility: Not Eligible

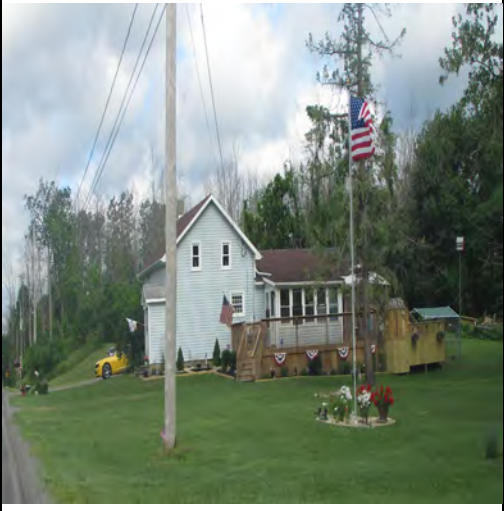
Property Name: House USN: Pending Description: This is a frame, circa-1920, vernacular dwelling with many modern alterations. The one-and-one-half story house is clad in vinyl siding and has modern windows. There is a large, one-story addition on the rear and a one-bay garage on the western end. The façade (southern elevation) is simple, with a picture window with sidelights and an off-center door with an enclosed, pedimented entry. The eastern elevation has a single window on the first level and two in the gable. The addition has multiple windows across this elevation. A large wooden porch encompasses this side, and there a door on the addition leading onto the porch.

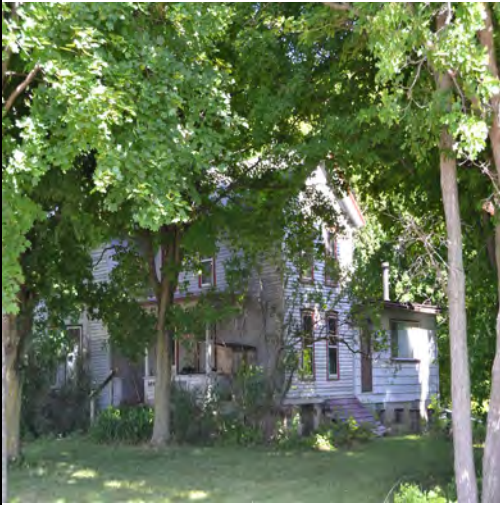
Address: 6845 Griswold Road,	Construction Date: ca. 1865	Proposed Eligibility: Eligible

<p>Property Name: House USN: Pending Description: This resource is comprised of a circa-1865 house and a circa-1930 garage. The house is a two-story, frame, Italianate style house with a cross gable roof covered with asphalt shingles, weatherboard cladding, and irregular footprint. The asymmetrical façade (south elevation) features a two-story bay window with conical roof and decorative wood molding on the gable end, and a two-bay wide porch. The porch is supported by decorative square wood posts and a weatherboard-clad knee wall with partial railing detail. The entry door—a single-leaf wood door with two arched lights—and adjacent 1/1 wood sash window are set in decorative wood pedimented frames. The second story includes two replacement 1/1 sash windows in decorative wood pedimented frames. The house sits upon a continuous stone foundation. Fenestration on side elevations are wood 2/2 double-hung sashes in decorative wood pedimented frames. Cellar access is located on the east elevation. One interior brick chimney is located on the west end of the house. The house includes a two-story rear ell clad with weatherboard, and with a continuous stone foundation. Fenestration on the ell are replacement 1/1 sashes in simple wood frames. On the east end of the ell, connecting to the north elevation of the main mass, is a one-story frame addition with a concrete block foundation and flat roof. One circa-1930 frame garage with wood exterior and gabled roof covered with asphalt shingles is located to the northwest of the house. It has two original wood garage doors.</p>

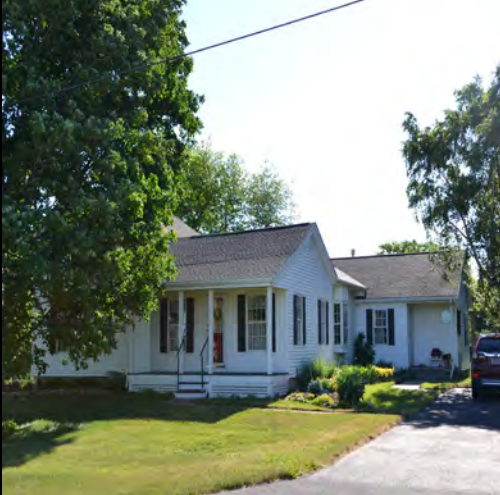
Address: 7717 Ivison Road, Byron	Construction Date: ca. 1860	Proposed Eligibility: Not Eligible

<p>Property Name: House USN: Pending Description: This is a one-and-one-half-story, circa-1860 Greek Revival style house with a gable front and wing form. The foundation is coursed sandstone blocks with raised mortar joints. The two-bay gable front section features four 6/6 sash windows with inoperable shutters. A shed-roof porch extends the full width of the wing, supported by replacement square wood posts. A modern door is flanked by vinyl 8/8 sash windows with inoperable shutters on the porch. An exterior chimney enclosed with vinyl siding stands at the junction of the gable front and wing sections on the façade (west elevation). Frieze-band windows, enclosed with vinyl siding, are present on the north elevation of the house. A rear addition is comprised of gabled ell extending from the original wing section, and a side-gabled section extending southward from the ell. The property also includes a detached frame garage with one vehicle bay, board and batten siding, and vinyl 6/6 sash windows. At least two frame buildings are located east of the house on the property, but are not visible, including a large, gable-roof barn with metal roof, metal cladding, and large sliding barn doors, and small frame shed.</p>

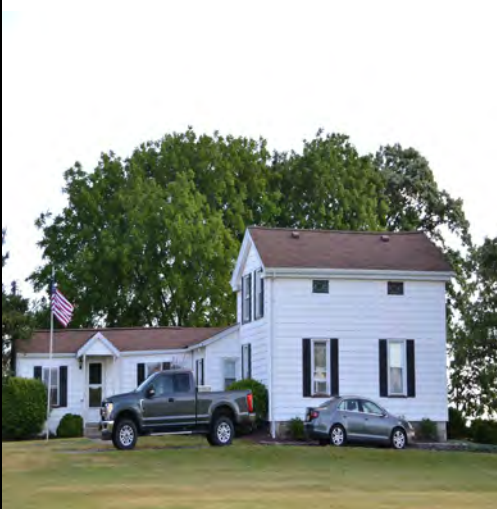
Address: 6607 Ivison Road,	Construction Date: ca. 1850	Proposed Eligibility: Eligible

<p>Property Name: Farm USN: Pending Description: This resource is comprised of a circa-1850 house and four circa-1920 outbuildings. The house is a two-story frame gable-front-and-wing house, originally built in the Greek Revival style. While the form remains, most other architectural elements associated with the style are not extant. The house has a cross gable roof covered with asphalt shingles, aluminum siding, and irregular footprint. The façade (east elevation) features a two-story gable end section with a three-bay, one-story wing. An added partial-width porch is appended to the wing section, with a hipped-roof and carved brackets on square wood posts. The porch is likely a later addition, inconsistent with the original style of the house. Fenestration throughout is 1/1 replacement sashes, some with false shutters. A one-story gable-roofed ell extends west from the wing. While the house foundation is continuous parged brick, the foundation of the ell is poured concrete. A secondary entrance to the house is located on the south elevation of the ell. Remnant architectural details of the house's original style include frieze-band windows with metal grates and cornice returns. One interior brick chimney is located within the original wing. The property includes four outbuildings, including a circa-1920 frame barn with gambrel roof and new metal exterior cladding, connected to an older, smaller gabled shed of concrete block and wood construction; a two-story frame barn with gable roof, original sliding hayloft door, and 4-pane and 6-pane windows; a circa-1920 concrete block and wood frame garage with gable roof, two modern garage doors, and one exterior concrete block flue stack; and a circa-1920 barn of wood and concrete block construction with original wood barn doors and 6-pane windows.</p>

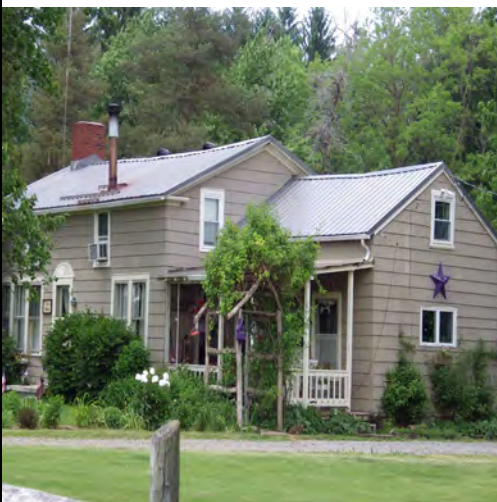
Address: 5981 Mullen Road ,	Construction Date: 1824	Proposed Eligibility: Not Eligible

<p>Property Name: House USN: Pending Description: This is a two-story, circa-1824 house with a side gable metal roof, exterior composite siding, and one interior brick chimney. A smaller, one-and-one-half-story wing projects from the main mass on the east end of the house. The façade features a central single-leaf glazed door and 3/1 sash windows in a group of three and in a pair. Windows on the second story are 1/1 vinyl sashes. A shed-roof porch extends the full width of the wing, supported by modern square wood posts and railings. A detached three-bay frame garage with side gable roof is located at the northeast corner of the house.</p>

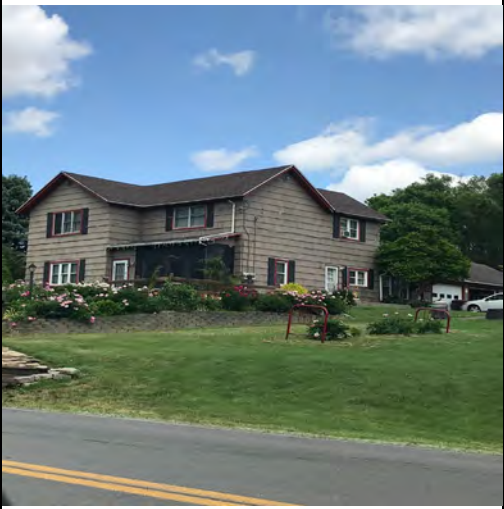
Address: 5693 Griswold Road , Stafford	Construction Date: ca. 1900	Proposed Eligibility: Not Eligible

Property Name: House USN: Pending Description: This is a circa-1900, frame, two-story house with a cross-gable roof covered with asphalt shingles, and asbestos siding. The façade (south elevation) features a partially enclosed porch along the wing section of the house and 1/1 sash windows in pairs or groupings of three with inoperable shutters. The entry is located at the west end of the porch and is enclosed. Fenestration on side elevations is also 1/1 sashes in pairs or groupings of three. The house has a one-story rear addition and attached two-bay garage on the north elevation of the rear addition. The property also includes two circa-1900 barns, connected at one corner. One is a bank barn with stone foundation and basement level and gambrel roof. The second frame barn, situated perpendicular to the first, features two wood sliding barn doors on the south elevation. A modern metal pole building is also present on the property.

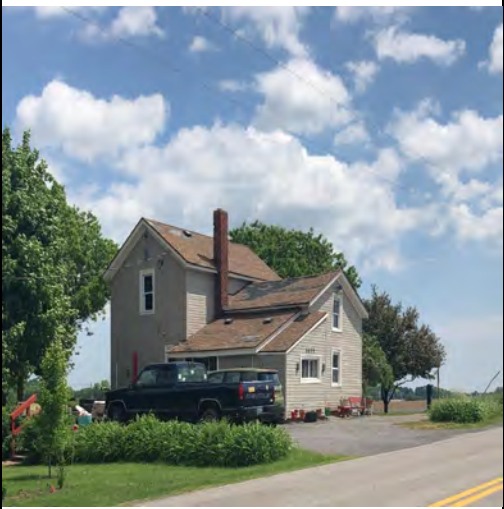
Address: 6609 Griswold Road, Stafford	Construction Date: ca. 1870	Proposed Eligibility: Not Eligible

Property Name: House USN: Pending Description: This property is comprised of a circa-1870, frame house and a circa-1900 frame barn. The house, clad with vinyl siding, features a gable-front and wing form, with a two-story gable section and one-and-one-half-story wing. An added hipped-roof sunroof is present on the façade (east elevation). Fenestration is primarily 1/1 vinyl sashes. An interior brick chimney is present at the junction of the wing and the gable-front section of the house. A rear addition with shed roof extends from the west elevation of the wing. Additions and alterations to siding and fenestration have compromised the house's integrity of design, workmanship, materials, and historic feeling. The frame barn has a metal gable roof and timber cladding. The north end of the barn includes open bays for equipment storage while the south elevation features two sliding timber doors. A shed extension is present on the west elevation of the barn, clad with asbestos shingles and with two equipment storage bays on the west elevation.

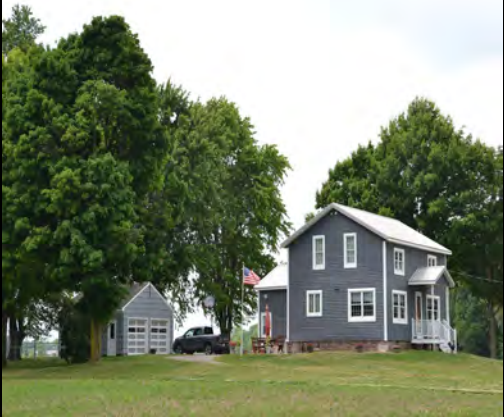
Address: 6402 Griswold Road, Stafford	Construction Date: ca. 1850	Proposed Eligibility: Not Eligible

Property Name: Farm USN: Pending Description: This farm property is comprised of a circa-1850, frame house and a circa-1960 garage on the south side of Griswold Road, and a complex of agricultural buildings and structures on the north side of the road. The two-story house features a metal side-gable roof, continuous brick foundation, and vinyl siding. The symmetrical façade (north elevation) features a central door flanked by paired vinyl 8/8 sash windows on the first story and paired vinyl 6/6 sash windows on the second story. Older photography of the house shows frieze-band windows on the façade that have since been covered and replaced with new window openings. A gabled entry porch with turned posts and simple railings was recently added to the façade. Fenestration on side elevations includes vinyl 6/6 and 8/8 sash windows and vinyl casement windows. A one-story rear ell extends from the south elevation. Alterations to windows and exterior siding have compromised integrity of materials and workmanship. A two-bay, detached frame garage with front-gable roof and asbestos siding is located to the southeast of the house. On the north side of Griswold Road are five modern metal pole buildings and equipment sheds, all built after approximately 1988. According to property assessor data, one circa-1900 barn and one circa-1920 barn are located on the property; however, these have either been demolished or altered to an extent to render them unrecognizable. The property also includes six modern steel granaries.

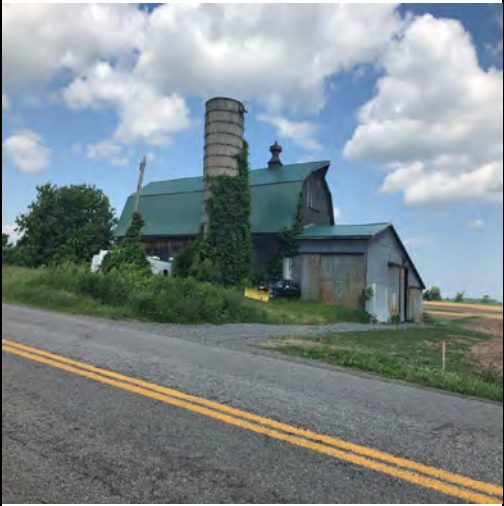
Address: N/A Griswold Road, Stafford	Construction Date: ca. 1900	Proposed Eligibility: Not Eligible

Property Name: Barn USN: Pending Description: This is a circa 1900 frame barn with a metal gambrel roof, vertical timber cladding, and one metal roof-ridge ventilator. A small gabled wing with metal cladding projects from the south elevation. A concrete stave silo without a roof stands adjacent to the south wall of the barn.

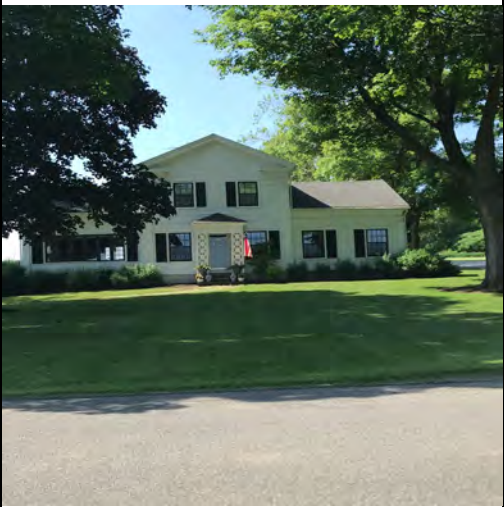
Address: 5966 Griswold Road , Stafford	Construction Date: ca. 1775	Proposed Eligibility: Not Eligible

Property Name: House USN: Pending Description: This property is comprised of a circa-1775, frame, Early Classical Revival style house and one frame barn. The house has a three-part plan featuring a dominant central, two-story, front-gable block with one-story wings on either side. The front-gable block features cornice returns, corner pilasters, and a one-story entry porch. The entry porch has an altered roof form and original columns have been replaced with decorative wood supports. The house is clad with weatherboard and the foundation is of limestone block. The one-story wings feature a plain entablature and corner pilasters, and modified fenestration. The west wing includes two modern 8/8 sash windows while the east wing features grouped windows. All fenestration on the house is modern, with those on the façade and side elevations of the original house including inoperable shutters. The house has one central interior brick chimney on the roof ridge of the front-gable block. A rear addition of unknown construction date is obscured from view by vegetation on the property. Historic aerial imagery and property assessor data indicate the property included three circa 1880-1900 barns and additional smaller outbuildings. One gable-roofed barn was identified on the property, located to the southwest of the house. It has been altered by new cladding and addition of modern garage doors on the east elevation.

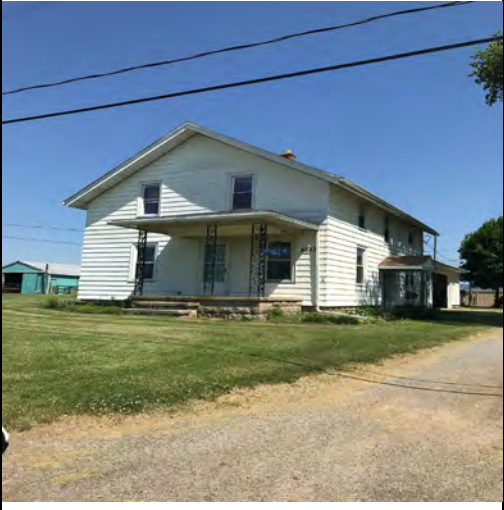
Address: 6063 Griswold Road , Stafford	Construction Date: 1920-1944	Proposed Eligibility: Not Eligible

Property Name: House USN: Pending Description: This is a circa-1920 frame, two-story house with a front gable roof, rectangular plan, one central interior brick chimney, rusticated concrete block foundation, and aluminum siding. The three-bay façade (north elevation) includes a wood paneled door, 1/1 sash windows, and a partial-width, hipped-roof porch with wrought-iron posts. Fenestration on side elevations is also 1/1 sashes. A secondary entrance is located on the east elevation, with a gabled entry porch with wrought-iron posts. A rear addition includes a garage, with bay opening on the east elevation.

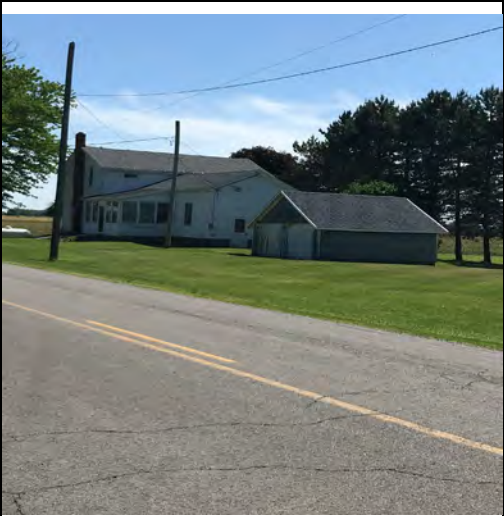
Address: 7410 Ivison Road, Byron	Construction Date: ca. 1850	Proposed Eligibility: Not Eligible

Property Name: Ivison Farm USN: Pending Description: This is a circa-1850, gable front and wing, frame farmhouse and associated outbuildings. The dwelling has a two-story front gable and a one-story wing. The frame house has weatherboard siding, and asphalt shingles cover the roof. The façade (east elevation) has an enclosed porch across part of the wing. The porch has a central door and two windows on either side. There is another window on the wing. The gable is symmetrical, with a central exterior brick chimney, and vertically aligned single windows on both levels, flanking the chimney. The north elevation has a door on the wing, and a small window on the gable front portion. The enclosed porch has windows. The other elevations were obscured at the time of this survey. North of the dwelling is a circa-1920, two-bay frame garage with shingle siding. Across Ivison Road are barns associated with this dwelling. There is a smaller, circa 1930 three-bay machine shed across from the house. South of that is a larger, circa 1950 machine shed with garage door. There is a circa-1850 ground barn and concrete silos. The barn has weatherboard siding and a gambrel roof of asphalt shingles. The elevation at Ivison Road has sliding barn doors. There is a larger addition east of the barn, and a smaller one-room on at the southwest corner. The two silos are on the north side near the road. One is missing its top.

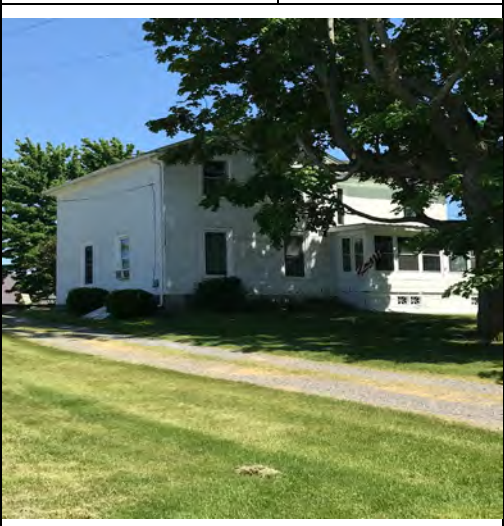
Address: 7311 Ivison Road , Byron	Construction Date: ca. 1880	Proposed Eligibility: Not Eligible

Property Name: Farm USN: Pending Description: This is a circa-1880, gable front and wing, frame farmhouse and associated outbuildings. The two-and-one-half story farmhouse is clad in aluminum siding and has one-over-one windows. The cross gable roof is asphalt shingles. The façade (west elevation) has an enclosed porch with six windows across the wing. There are two windows on the second level over the porch. The gable end has two windows on each level. The north elevation has a door and a single window. The other elevations were obscured at the time of this survey. Northeast of the house is a modern garage. East of the farmhouse is a complex of agricultural buildings, including a large barn.

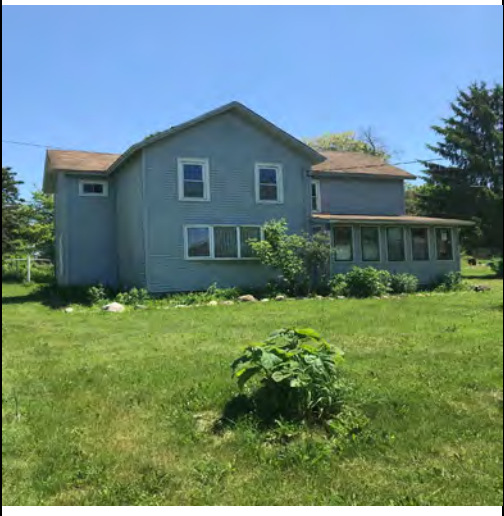
Address: 7509 Mechanic Street, Byron	Construction Date: ca. 1890	Proposed Eligibility: Not Eligible

<p>Property Name: House</p> <p>USN: Pending</p> <p>Description: This is a circa-1890, gable front and wing, frame dwelling with many modern modifications. The two-and-one-half story house is clad in vinyl siding and has modern windows. The side gable roof is asphalt shingles and there is a brick chimney. The façade (west elevation) has an enclosed porch across the wing. The porch has five windows, and the entrance is on the southern end. Over the porch is a single window. The gable has a ribbon of windows on the first level and two single on the second. The southern elevation has the door to the porch and a single window on the main level. There are two windows on the second level. The north elevation has a two-story extension from the house, with a small window at the roofline on the façade, and a single window on the first level, north side.</p>

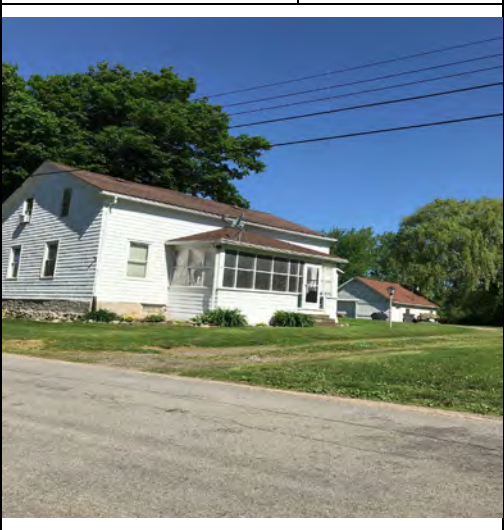
Address: 6403 Mill Pond Road , Byron	Construction Date: ca. 1880	Proposed Eligibility: Not Eligible

Property Name: House USN: Pending Description: This is a circa-1880, vernacular style, frame dwelling. The dwelling is clad in wood shingles, has a roof of asphalt shingles, and rests on a stone foundation. The façade faces east and not the road to the south. The façade has an enclosed porch with a hipped roof and windows lining walls. The entrance is at the northern end. There is a single window south of the porch. The southern elevation has two windows on the first level and two on the second. There are cornice returns at the gable. The western elevation has two small windows. Northwest of the dwelling is a circa-1920 one-and-one-half story frame garage.
Address: 6315 Mill Pond Road , Byron	Construction Date: ca. 1850	Proposed Eligibility: Eligible

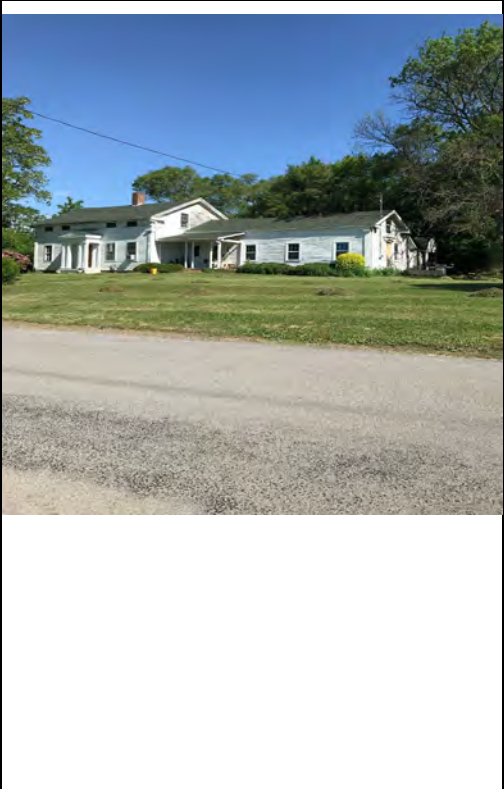
Property Name: House USN: Pending Description: This is a circa-1850, Greek Revival style house with a wing. The one-and-one-half story house is clad in its original weatherboarding and has a side-gable roof with asphalt shingles and an interior brick chimney. The five-bay façade (south elevation) is symmetrical with a central entrance and two windows on either side. The entrance is stately, with a small, classical style entry porch with a enclosed gabled roof with a wide cornice. Pairs of heavy, squared Tuscan order columns support the roof. Over the porch is a wide band of trim, with four frieze-band windows near the roofline. Decorative iron grates cover the frieze-band attic windows. The façade of the wing has a more casual entrance under a modern shed roof. Another window overlooks the porch, and three more windows are evenly spaced across the face. Squared pilasters are at each corner. The eastern elevation has a single window on the second level of the core, and cornice returns on the roofline. The elevation of the wing has another entrance, which is topped with an ornate hood. North of the door is a single window. Over the door is a six-over-six, sash window in the gable, which is framed with cornice returns. There is a small, shed addition north of the wing. The western elevation is partially obscured, but there are two windows on the second level.

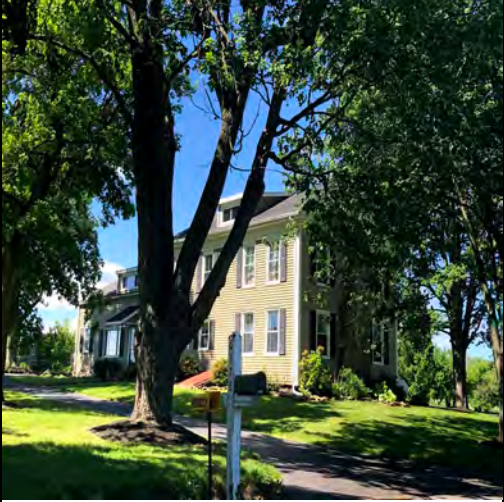
Address: 6178 Tower Hill Road, Byron	Construction Date: 1847	Proposed Eligibility: Not Eligible

Property Name: House USN: Pending Description: This house altered Greek Revival style house has a stone foundation, vinyl siding, vinyl sash replacement windows (double-hung and fixed sash types), asphalt shingle roof. The gable end has a new, external brick chimney stack. The two-story house has a rectangular footprint and a large rear addition with shed roof dormers. A new, metal shell garage and pool house has been constructed at the rear of the property adjacent to a swimming pool.
Address: 8100 Route 237, Stafford	Construction Date: ca. 1880	Proposed Eligibility: Not Eligible

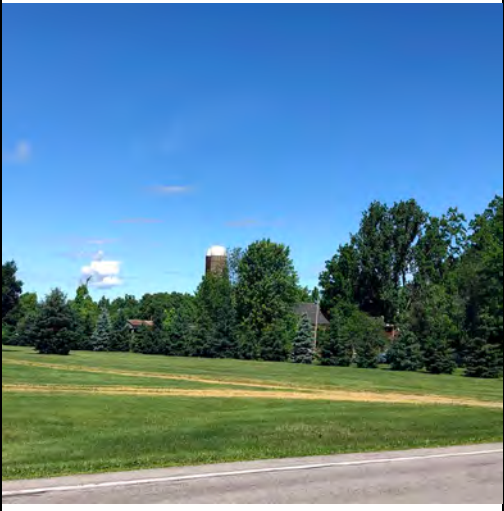
Property Name: Farm USN: Pending Description: Vegetation blocks views of most buildings and structures at this resource. The house is a Colonial Revival style house with a rectangular footprint. New windows and siding have diminished integrity of workmanship and materials. The house is two stories tall with a gable roof. The agricultural buildings include a concrete stave silo, a large, heavy timber frame barn, with additions, and a shed, based on aerial views. There is a swimming pool on the property.

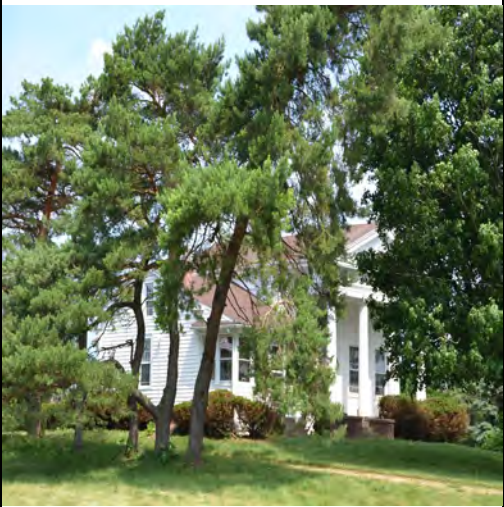
Address: 6994 Tripp Road, Byron	Construction Date: ca. 1860	Proposed Eligibility: Eligible

Property Name: House USN: Pending Description: This resource is comprised of a circa 1860 house, an altered circa 1900 barn, and a modern equipment shed. The house is a two-story frame Greek Revival style house with a gable-front and wing form. The roof is covered with asphalt shingles, while the house is clad with synthetic siding. The continuous stone foundation is parged. The façade (east elevation) is dominated by the pedimented gable end supported by four fluted Greek Doric columns. The entablature is plain except for dentils. The door is set within a simple entablature with sidelights. Fenestration includes 1/1 and 6/6 wood sashes and frieze-band windows on the side elevations. One exterior brick chimney is present on the north elevation. The wing extends south from the gable-front section of the house and features an enclosed front porch with secondary entrance and groups of 1/1 aluminum sash windows. A rear ell extends west from the rear of the gable-front section of the house, one-story in height. The property also includes a circa 1900 milking parlor/barn with a rough stacked stone foundation and modern metal cladding, and a modern metal equipment shed. Both outbuildings are located southwest of the house.

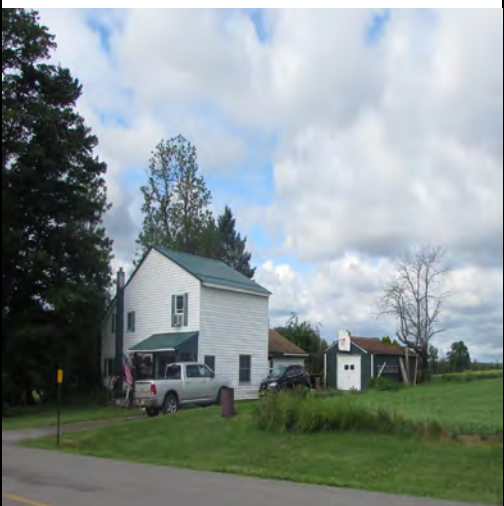
Address: 7116 Tripp Road, Byron	Construction Date: ca. 1870	Proposed Eligibility: Not Eligible

Property Name: House USN: Pending Description: This property includes a circa-1870 residence and a frame garage. The two-story frame residence exhibits significant alterations, including new cladding, roofing, and fenestration, along with changes to the roofline, window openings, and front porch. One exterior cinder block flue is present on the façade (east elevation). A one-story rear ell is also clad with synthetic siding and has modern fenestration. The detached, one-bay frame garage has a front gable roof, modern garage door, and rear addition.

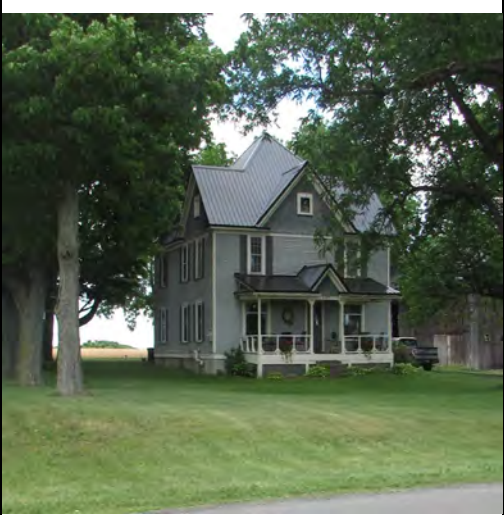
Address: 6485 Thwing Road,	Construction Date: ca. 1890	Proposed Eligibility: Eligible

<p>Property Name: House and Barn USN: Pending Description: This resource is comprised of a circa-1890 house and one circa-1910 frame barn. The house is a two-and-one-half-story frame Queen Anne style house with a metal cross-gable on hip roof and weatherboard siding. The symmetrical three-bay façade (south elevation) features a central gable covered with decorative wood shingles and a partial-width porch supported by replacement wood posts and railings. The porch has a metal shed roof with central gable clad with wood shingles in the gable field. The central single-leaf entry is flanked by 1/1 wood sash windows, while the second story and side elevation fenestration is 6/6 wood double-hung sashes with false shutters. Single pane lights are present in the gable fields of the central front gable and cross gable, which also feature the decorative wood shingles. A side porch with shed roof and weatherboard-clad knee wall is present on the east elevation, toward the rear end of the house. A one-and-one-half story frame barn with metal gable roof and continuous stone foundation is located northeast of the house. It features small square openings on the south elevation and is missing sections of exterior timber on the east elevation.</p>

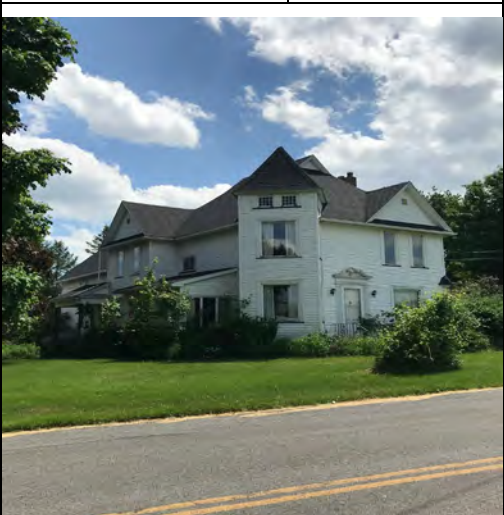
Address: 8126 Prole Road Extended,	Construction Date: ca. 1910	Proposed Eligibility: Not Eligible

<p>Property Name: Farm USN: Pending Description: This property is comprised of a circa 1900 residence, two frame barns, a silo, and a brooder house. The house two-story house features a cross-gable-on-hip roof covered with asphalt shingles, exterior aluminum siding, and a two-and-one-half-story pyramidal roof tower on the northeast corner. A one-and-one-half-story gabled section extends from the rear elevation. The entry on the façade features a broken ogee pediment and wood surround. Fenestration throughout is modern replacements, primarily single panes. Multi-pane casements are present in the half story of the tower. A shed-roof sunroom and a secondary entrance with shed-roof hood extend from the east elevation. An exterior cinder block flue is present on the west elevation. The circa 1920 barns both feature continuous stone foundations, exterior vertical timber cladding, and asphalt shingles on the roofs. One barn has an ell-plan, gambrel roof, and multi-pane windows. A smaller barn features a gable roof and sliding wood barn doors. A concrete stave silo with wood shake roof stands at the northeast gable end of this barn. A cylindrical brooder house with conical roof is located at the northwest gable end of the large barn.</p>

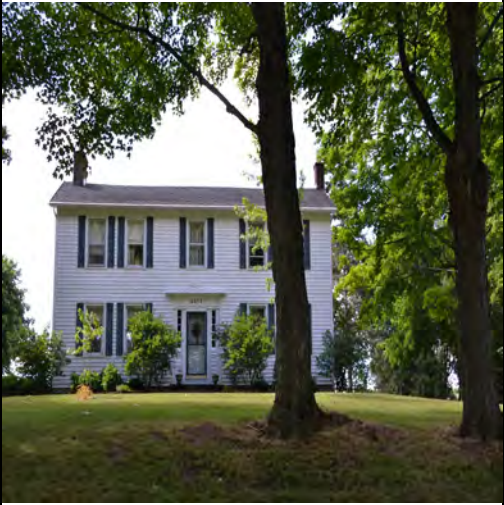
Address: 6632 Thwing Road,	Construction Date: ca. 1825	Proposed Eligibility: Not Eligible

<p>Property Name: House and Barn USN: Pending Description: This resource is comprised of a circa-1825 house, and two barns. The house is a two-story, frame Federal style house clad with synthetic siding and with a side gable roof covered with asphalt shingles. The symmetrical five-bay façade (north elevation) features a central single-leaf wood door with a simple, altered wood surround with 5-pane sidelights, and 1/1 vinyl sash windows with false shutters. The house has one exterior brick end chimney on the west elevation and one interior brick end chimney on the east elevation. The installation of vinyl siding and replacement windows has compromised integrity of workmanship and materials. A two-story, frame rear addition spans the width of the house and connects to a one-story hyphen to an attached two-bay garage. This addition has compromised integrity of design. Outbuildings include a circa-1910 frame barn with gable roof and shed garage extension, wood doors and hayloft door, and stone foundation; a circa-1910 frame barn with gambrel roof; and one smaller outbuilding, possibly a poultry house, not visible from the public right-of-way.</p>

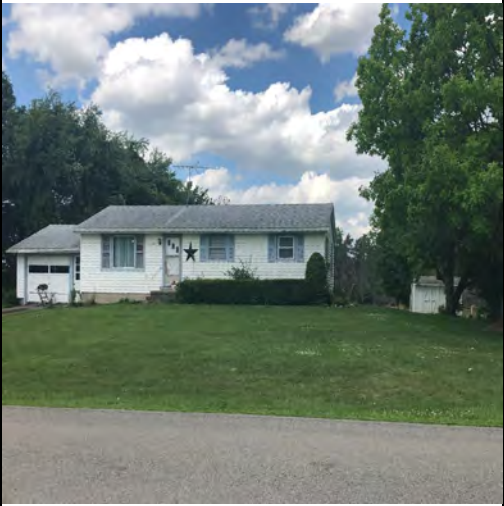
Address: 7147 Thwing Road, Le Roy	Construction Date: ca. 1964	Proposed Eligibility: Not Eligible

<p>Property Name: House USN: Pending Description: This is a circa-1965 ranch house with a side gable roof covered with asphalt shingles, rectangular plan, exterior aluminum siding, and continuous concrete foundation. The façade features an original picture window flanked by 2/2 aluminum sashes, a glazed door with storm door, and two shoulder-height windows—one an original horizontal 2/2 aluminum sash and one a vinyl replacement. The entry is accessed by a concrete stoop. The attached garage is one-bay with a overhead garage door and glazed wood entry door, located on the west elevation of the house, slightly recessed and with a lower roofline. A small wood shed is present northeast of the house.</p>

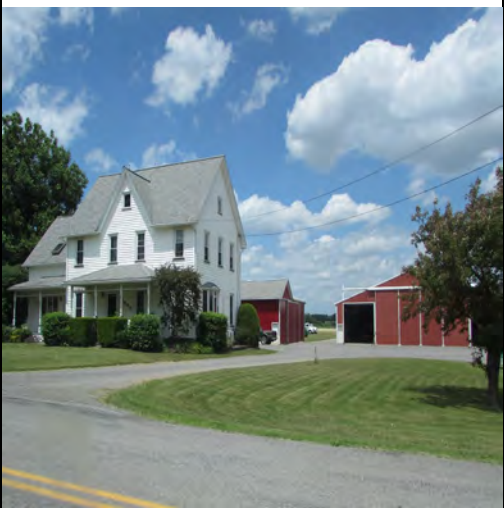
Property Name: Farm USN: Pending Description: This property is comprised of a circa-1890 house, a circa-1910 barn, and two metal pole barns. The two-and-one-half-story house features a side gable roof covered with asphalt shingles, a central gable on the façade (south elevation), and exterior vinyl siding. The four-bay façade features a half-hipped roof porch with turned wood posts and spindlework detailing. Windows are 1/1 sashes, with single-pane lights in the gable ends. An extension on the west end of the house, recessed from the primary façade, has a full-width front porch with turned wood posts and spindlework. A rear ell is connected to this side extension. The circa-1910 frame basement barn features a gambrel roof covered with asphalt shingles, continuous stone foundation laid in irregular courses, and exterior vertical timber cladding. The west elevation features two sets of sliding doors and an earthen and stone ramp to the barn's upper level. The basement entry, paired glazed wood doors, is on the south gable end. A shed extension with concrete block and frame walls is present along the east elevation. Fenestration on the basement level is single and paired 9-pane lights. A small gabled wing extends from the basement's south elevation, with a single wood sliding door. Two more modern, metal pole barns are located to the north of the house and barn.

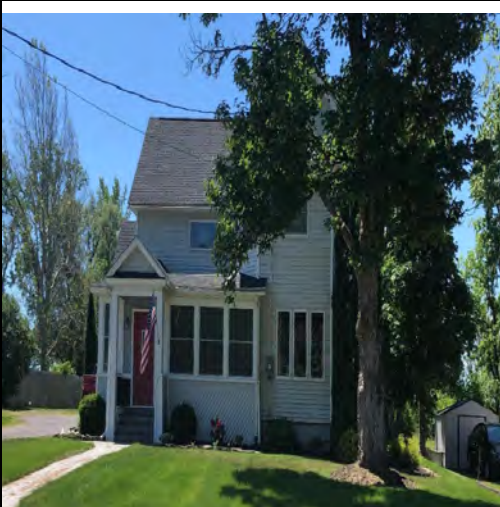
Address: 6376 Townline Road, Byron	Construction Date: ca. 1890	Proposed Eligibility: Not Eligible

<p>Property Name: House USN: Pending Description: This is a circa-1890, Queen Anne style dwelling that has undergone renovations that stripped it of its original stylistic elements. The two-and-one-half story, frame house is clad in vinyl siding and has modern windows. Asphalt shingles cover the cross gable roof, and there is an interior brick chimney. The entrance on the façade (north elevation) is at the eastern corner, and steps lead to a small, front gabled porch. The gable is supported by squared posts. West of the entrance is a small, enclosed porch with three windows. Over the entrance on the second level is a single, rectangular window over the porch. The gable front of the façade has a three-sided bay, with a trio of modern windows on the first level, and single windows on each side on the second level. The gable is closed. The eastern elevation has five windows, two of which are under a small, one-story gable. There is a porch near the rear. The other elevations were not visible during this survey. Southeast of the building is a circa 2000, two-bay garage.</p>

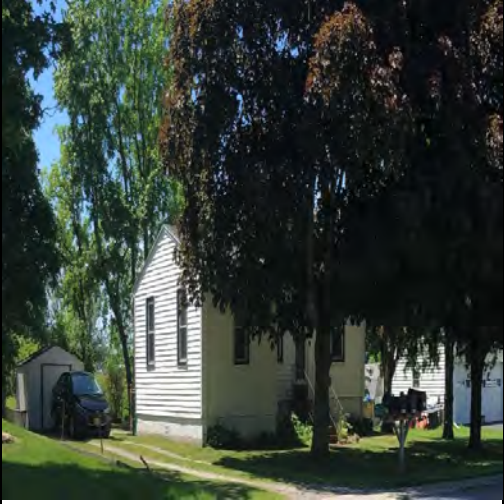
Address: 6372 Townline Road, Byron	Construction Date: ca. 1950	Proposed Eligibility: Not Eligible

Property Name: House USN: Pending Description: This is a circa 1950 minimal traditional style house. The one-story frame dwelling is clad in vinyl siding, has a side gable, asphalt shingle roof, and rests on a concrete foundation. The façade (north elevation) is simple, with a central door with concrete steps leading to it. Three windows are across the façade. The eastern elevation has two windows. There is a small modern storage shed behind the house.
Address: 6366 Townline Road, Byron	Construction Date: ca. 1900	Proposed Eligibility: Not Eligible

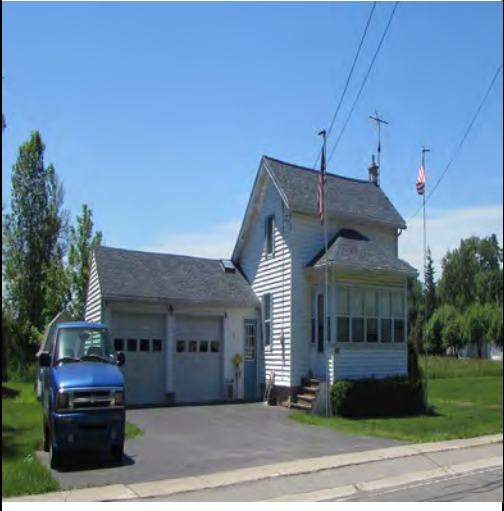
Property Name: House USN: Pending Description: This is a circa-1900, frame vernacular style house. The one-and-one-half story dwelling has a side gable, catslide roof of asphalt shingles and is clad in vinyl siding. The façade (north elevation) has an enclosed porch with a hipped roof and a band of five windows across the front, with access from the eastern end. The western elevation has an exterior concrete block chimney and three windows across the first level. There are two windows on the second level. The southern elevation has a one-story addition. The eastern elevation has a single window on each level, and there is a breezeway and two-bay garage addition.

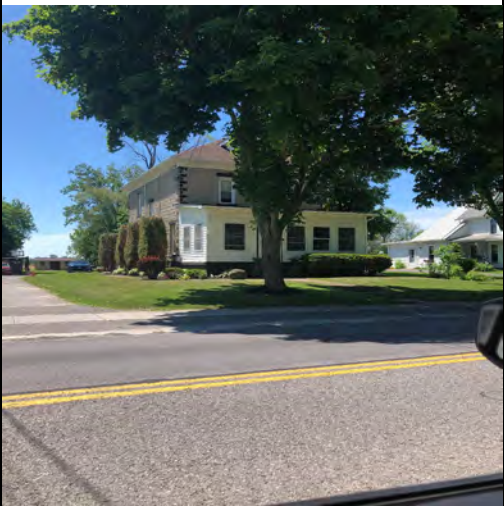
Address: 6384 Townline Road, Byron	Construction Date: ca. 1910	Proposed Eligibility: Not Eligible

Property Name: House USN: Pending Description: This is a circa-1910, American foursquare style frame dwelling. The dwelling is clad in concrete and sits on a pressed concrete foundation. Windows are all topped with lintels, and there is quoining on the façade. The hipped roof is covered with asphalt shingles. The two-bay façade (north elevation) has a full width, enclosed porch. The entrance is off-center, and there are three windows west of it and one window east of it. Over the porch, two windows pierce the elevation and there is a pedimented dormer over them. The western elevation has two windows on the porch, and two vertically aligned windows on each level. The eastern elevation has two windows on the porch, and a window mid-level and a window on the second level (the remainder of the elevation is obscured by vegetation). There is an addition on the south elevation.
