Historic Architectural Resources Survey and Effects Report

Excelsior Energy Center Project
Town of Byron, Genesee County,
New York

SHPO Project Review Number:
19PR03747

September 2020

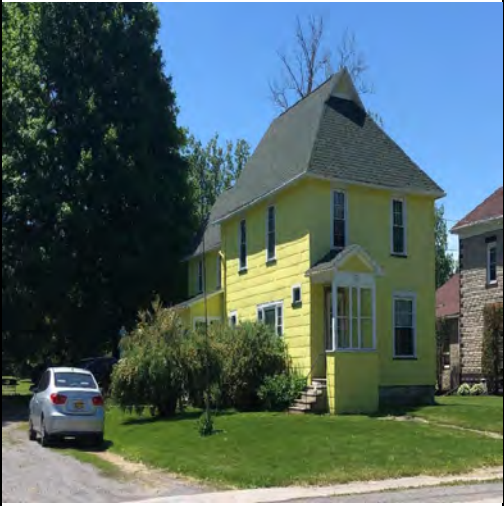
Address: 6386 Townline Road, Byron	Construction Date: ca. 1900	Proposed Eligibility: Not Eligible

Property Name: House USN: Pending Description: This is a circa-1900 American foursquare, frame dwelling. The two-and-one-half story house is clad in aluminum siding, has modern windows, and sits on a concrete foundation. The steeply pitched, hipped roof is covered with asphalt shingles. The two-bay façade (north elevation) has a small, enclosed entry porch at the northeast corner. There is a single window on the first level and two on the second. The western elevation is symmetrical with two windows vertically aligned on each level. The eastern elevation has a picture window with flanking sash windows near the front, and a single window south of it. There are two windows on the second level. There is a two-story addition on the south elevation, which has an enclosed porch, and an attached one-bay garage is at the rear.

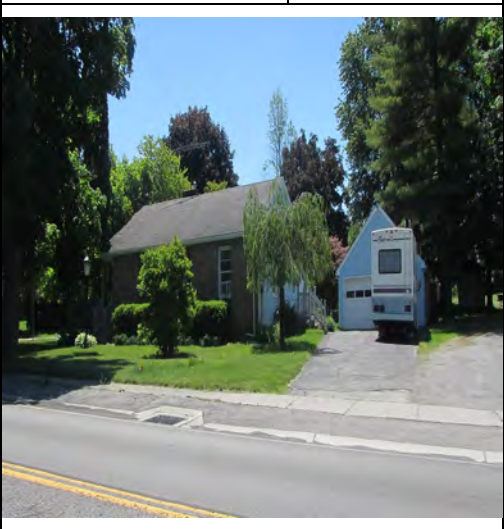
Address: 6392 Townline Road, Byron	Construction Date: ca. 1950	Proposed Eligibility: Not Eligible

Property Name: House USN: Pending Description: This is a circa-1950, minimal traditional style dwelling with associated garage. The side gable house is clad in a brick veneer on the façade and vinyl on the sides. The façade (north elevation) has a picture window with flanking sash windows, and a single window west of it. There is a porch on the eastern elevation, and this is where the main entrance is located. The western elevation has two sash windows and a circular window, and a door at the southwestern corner. The south elevation has a shed roof addition. There is a one-and-one-half story, two-bay garage southwest of the dwelling.
Address: 6398 Townline Road, Byron	Construction Date: ca. 1880	Proposed Eligibility: Not Eligible
 		Property Name: House USN: Pending Description: This is a circa-1880, gable front and wing dwelling. The gable front is two stories and the wings one story. The dwelling is clad in vinyl siding, has modern windows, and has a large one-story addition on the western end. The cross gable roof is covered in asphalt shingles. The façade (north elevation) has a symmetrical gable front, with two windows vertically aligned on each level. The original wing is to the east, and there is an uncovered porch leading to the door. The western wing has two windows on the façade. The western elevation has two windows. Northwest of the dwelling is modern, two bay garage.

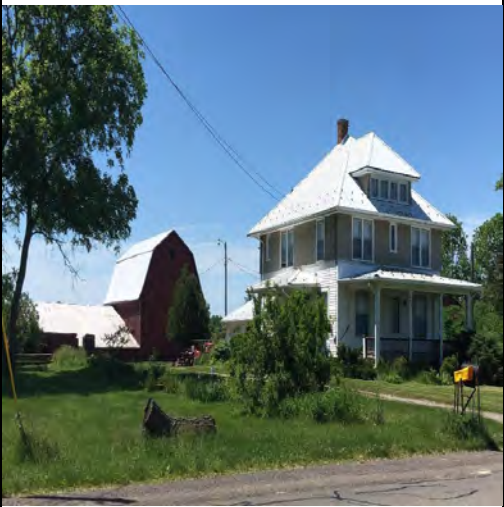
Address: 6548 Townline Road, Byron	Construction Date: ca. 1915	Proposed Eligibility: Not Eligible

Property Name: Farm USN: Pending Description: This is a large, circa-1915, American foursquare, frame dwelling and associated farm outbuildings. The two-and-one-half story house has vertical weatherboarding on the first level and wood shingles on the second. The pyramidal roof is metal and there is an interior brick chimney. The three-bay-wide façade (north elevation) has a full width porch with a low pitched, hipped roof supported by squared columns. An open rail balustrade encloses the porch, and access to porch is from the eastern side. The central door onto the porch is flanked by two single windows. The second level has a centered, narrow, single window and two evenly spaced pairs of one-over-one windows. The dormer has a ribbon of four multi-light windows. The eastern elevation has a small, covered porch, door and windows on the first level. The second level has four windows across it. The western elevation has four windows across the first level and three on the second. There is an addition on the southern elevation. South of the dwelling there is a circa-1920, ground barn with a gambrel roof. There is also a circa-1920 machine shed with a one-bay garage facing north, and two circa-1960 metal granaries.

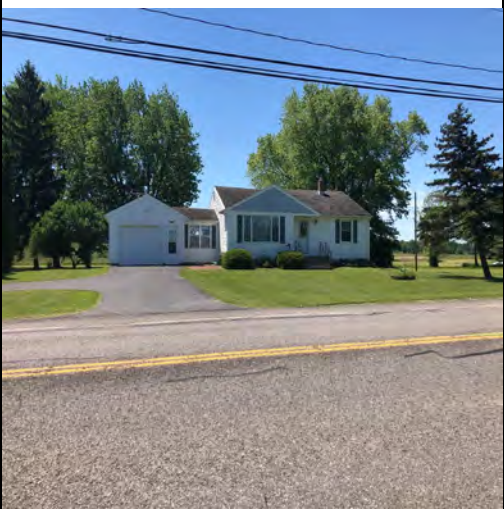
Address: 6568 Townline Road, Byron	Construction Date: ca. 1960	Proposed Eligibility: Not Eligible

Property Name: House USN: Pending Description: This is a circa-1960, Ranch-style dwelling. The one-and-one-half story frame dwelling has vinyl siding, a concrete foundation, and a cross gable roof of asphalt shingles with an interior brick chimney. The façade (north elevation) has a central door with concrete steps leading to it. West of the door is a single window. East of the door is a picture window with flanking sash windows and shutters. At the eastern end, a breezeway with two windows connects one-bay garage. The western elevation has two single windows.

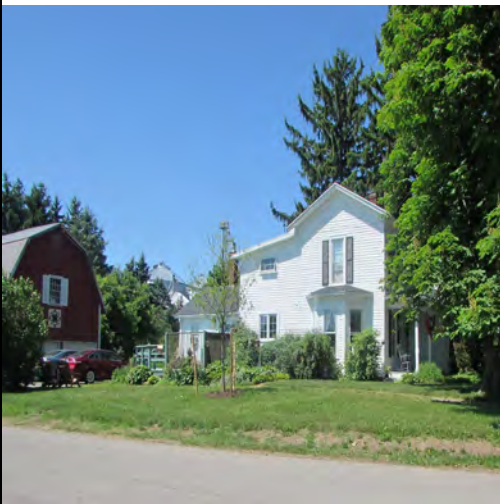
Address: 6600 Townline Road, Byron	Construction Date: ca. 1890	Proposed Eligibility: Not Eligible

Property Name: Farm USN: Pending Description: This resource is a circa-1890, gable front and wing, frame dwelling with associated garage/carriage house. The two-and-one-half story dwelling has its original weatherboard siding in its front section. New board-and-batten siding has been installed on the rear extension. Its cross gable roof is clad in asphalt shingles. The façade (north elevation) has a small porch on the wing portion of the house. The door is tucked into the corner where the wing and gable front meet. There is a window east of the door and another window vertically aligned with it on the second level of the house. The gable front has two windows on each level that are vertically aligned. The eastern elevation has a one-story, three-sided bay with windows on each side. Over the bay is a single window. There is also a pair of casement windows on the first level and an awning window on the second level. Replacement windows with vinyl sashes have been installed, diminishing integrity of workmanship and materials. On the south elevation is a one-story, attached summer kitchen with interior brick chimney and board and batten siding, which appears to be recently installed. The summer kitchen has a wooden porch with new French doors leading onto it, and there is another window overlooking the porch. The northern elevation of the kitchen has a single door, and there is a new, vinyl sash. awning window on the second level of the core of the house. A shed roof enclosure of the rear ell of the house has compromised integrity of design. Southeast of the dwelling is a one-and-one-half story barn/garage. The structure has vertical wood siding and a metal gambrel roof. There are two garage door bays on the north elevation and a single window in the gable. The east elevation has two windows.

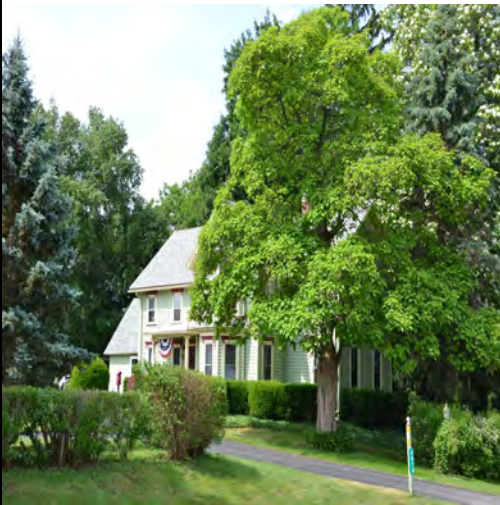
Address: 6878 Townline Road, Byron	Construction Date: ca. 1895	Proposed Eligibility: Eligible

Property Name: House USN: Pending Description: This is a circa-1895, Queen Anne style dwelling. The two-and-one-half story building stands back from Townline Road, obscured by mature trees. The two-and-one-half story dwelling is clad in its original wood siding, and has many other original architectural details. Windows are topped with historic hoodmolds. Porches have original columns. The footprint of the dwelling appears to be original, except for a small addition on the rear. The cross gable roof is clad in asphalt shingles and there is an interior chimney. The façade (northern elevation) is a gable front and has two windows in each level. The eastern elevation is the main entrance, and it faces a circular drive. A two-story bay extends under a gable. Next to that is a small porch that shields the main entrance to the house. The multi-light door has the same hoodmolding as the windows. The southern elevation has a one-and-one-half story gabled addition. Southeast of the dwelling is a 2006, two-bay garage.

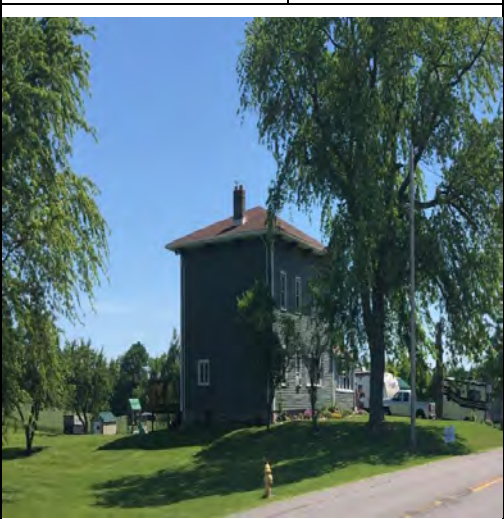
Address: 7015 Townline Road, Byron	Construction Date: ca. 1870	Proposed Eligibility: Not Eligible

<p>Property Name: House USN: Pending Description: This is a circa-1870, Italianate style, frame dwelling that has been severely compromised with modern elements so that its historical integrity is gone. The dwelling is clad in vinyl siding and has modern windows. The low pitch, pyramidal roof is clad in asphalt shingles. There are decorative brackets at the cornice and there is an interior chimney. The house sits on a stone foundation. The four-bay façade (southern elevation) has a modern picture window and two single windows on the first level. The second level has four single evenly spaced windows. The eastern elevation has a two-story addition that is slightly lower than the core. The façade has an enclosed porch with a ribbon of windows. Over the porch are two single windows. The porch entrance is on the side and there is a single window towards the rear, near a small, one story shed addition that may serve as an entry. The western elevation has a single window on the first level at the rear of the house, and there is a porch at the northwest corner of the house. There is a modern metal garage and a smaller shed northeast of the dwelling.</p>

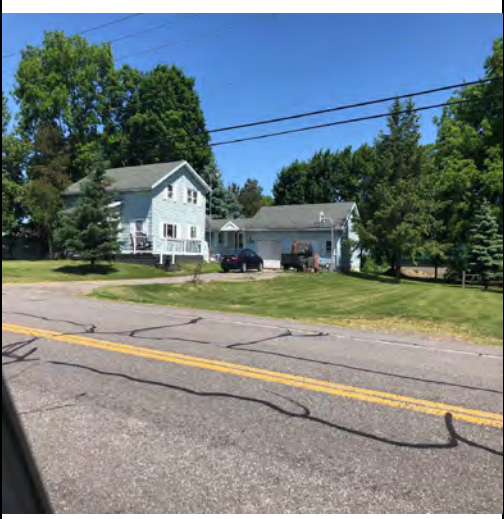
Address: 6937 Townline Road, Byron	Construction Date: ca. 1870	Proposed Eligibility: Not Eligible

<p>Property Name: House USN: Pending Description: This is a circa-1870, vernacular style, frame dwelling with an attached modern garage. The two-and-one-half story dwelling has many modern modifications, like vinyl siding, modern windows and shutters, modern wraparound porch, and a large rear addition. The side gable roof is slightly uneven, with the front lower than the rear, and it is covered in asphalt shingles. The façade (southern elevation) has a small, shed roof addition where the entrance is located. The addition has the door on the eastern end, while there are three windows across the front. There is another window east of the entrance, and another single window west of the addition. The eastern elevation has the steps to the wraparound porch, and the uncovered porch runs nearly the length of the elevation. There is a picture window with flanking casement windows, and a single window on the first elevation. The second level has a single window and a pair of windows. The northern elevation has a large, one-story, ell-shaped addition that ends in a modern two-bay garage.</p>

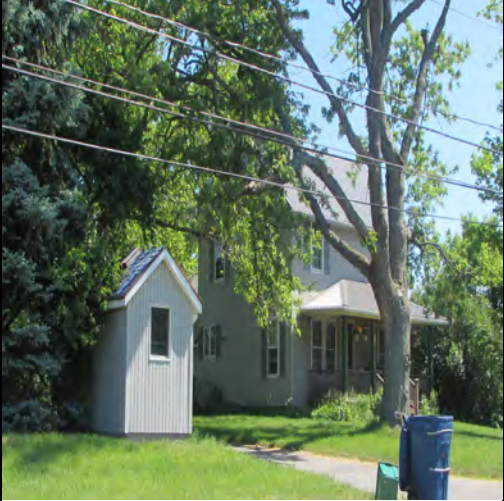
Address: 6845 Townline Road, Byron	Construction Date: ca. 1915	Proposed Eligibility: Not Eligible

Property Name: House USN: Pending Description: This is a circa-1915, vernacular style dwelling with associated garage. The two-and-one-half story dwelling is clad in vinyl siding and has modern windows with shutters. The side gable roof is standing seam metal and has an interior brick chimney. The three-bay façade (southern elevation) has a nearly full width porch with a hipped roof. The porch is enclosed with an open rail balustrade. The central door has a pair of windows to the west, and a single window to the east. Two widely spaced windows are over the porch. The western elevation has on the first level a single window near the front, and a pair of casement windows near the back. There are two windows on the second level. The northern elevation has an addition. Much of the eastern elevation has obscured at the time of this survey, but two windows on the second story and a window in the gable are visible. Northwest of the dwelling is a one-and-one-half story, frame garage.

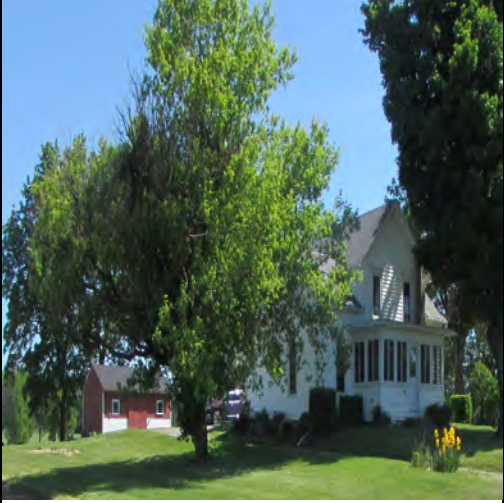
Address: 6775 Townline Road, Byron	Construction Date: ca. 1880	Proposed Eligibility: Not Eligible

Property Name: House USN: Pending Description: This is a circa-1880, center gable, frame dwelling and associated outbuilding. The two-and-one-half story dwelling has a cross gable roof of asphalt shingles. The house is covered in vinyl siding and has modern windows. The façade (south elevation) has an enclosed porch with a central door and pairs of windows. On either side of the porch are single windows. Over the porch, there are two single windows. There is an exterior concrete block chimney at the corner of the porch and core. The western wing has a single window on the first level and another in the gable. The eastern elevation's wing has a saltbox roofline. There is a single window on the first level and in the gable, and an exterior concrete block chimney. There is a window on the second level towards the rear of the house. North of dwelling is a one story, garage/carriage house.

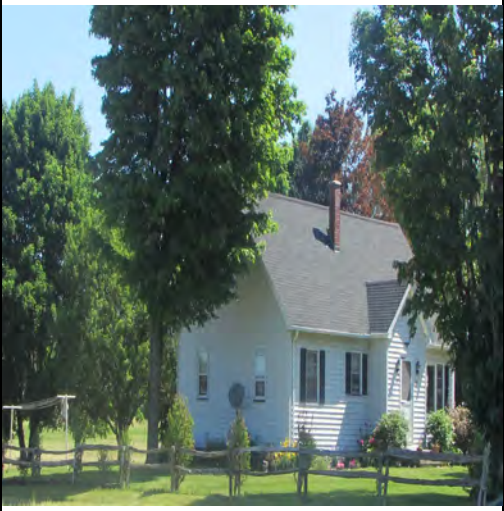
Address: 6707 Townline Road, Byron	Construction Date: ca. 1955	Proposed Eligibility: Not Eligible

Property Name: House USN: Pending Description: This is a circa-1955, Cape Cod style dwelling. The one-and-one-half story, frame dwelling has vinyl siding and a steeply pitched roof of asphalt shingles with an interior brick chimney. The façade (southern elevation) has a central entrance under a small, front gable. West of the door is a picture window flanked by sash windows. East of the entrance are two single windows. The eastern elevation has two windows on the first level and a window in the gable. The western elevation has a small porch leading to a door, and a pair of windows. The gable has a single window.
Address: 6631 Townline Road, Byron	Construction Date: ca. 1880	Proposed Eligibility: Not Eligible
 		Property Name: House USN: Pending Description: This is a circa-1880, gable front and wing, frame dwelling with associated garage. The two-and-one-half story dwelling has many modern modifications, like vinyl siding and modern windows that diminished its historical integrity, particularly integrity of materials and workmanship. The house sits on a stone foundation and has a cross gable roof of asphalt shingles. The façade (south elevation) has its main entrance on the wing, and it is shielded with a shed roof. West of the porch is a single window, and next to that is a pair of sliding windows. Over the porch is a single window. The gable front has a symmetrical façade with two evenly spaced and vertically aligned windows on each level. The western elevation has a small, one-story addition and over that a single window. The eastern elevation is symmetrical with two evenly spaced and vertically aligned windows on each level. Northwest of the house is a modern two-bay garage. Northeast is a modern shed.

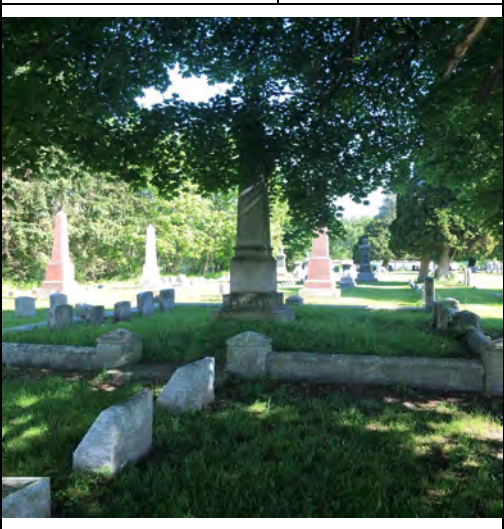
Address: N/A Swamp Road, Byron	Construction Date: 1856	Proposed Eligibility: Eligible

Property Name: Byron Cemetery USN: Pending Description: The community established this cemetery in 1856. The cemetery features specimen trees, obelisks, headstones, and footstones. Arterial paths and cartways proceed through the cemetery on a rectilinear grid.
Address: 6405 Townline Road,	Construction Date: 1889	Proposed Eligibility: Not Eligible

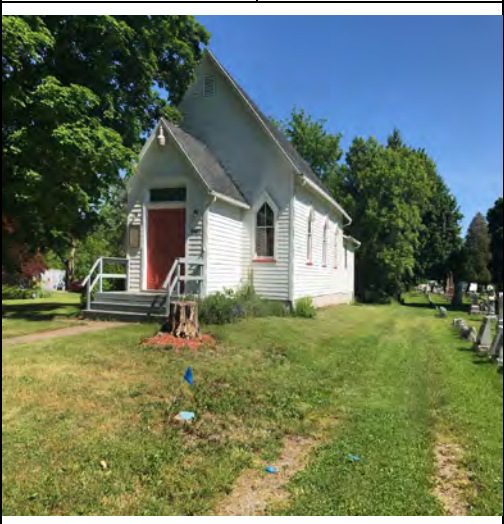
Property Name: Byron Historical Museum/Old German Lutheran Church USN: Pending Description: This gable front, Gothic Revival style church stands on a stone foundation that has been parged. The facade features an enclosed, gable roof vestibule entry. Wood steps lead to the vestibule. The fenestration consist of wood sash windows with simplified lancet arch apertures. A transom light surmounts the twin-leaf, raised panel front door. An addition has been appended to the rear of the one story church.

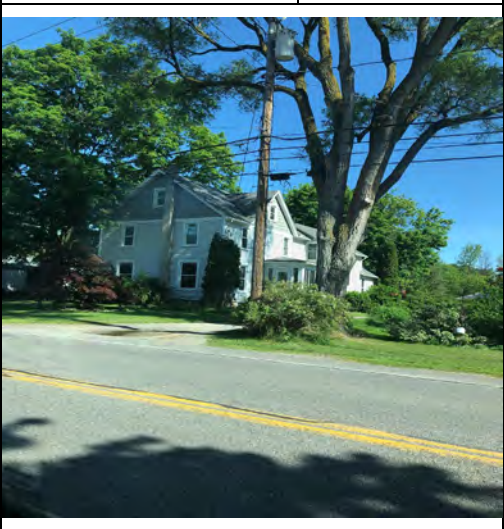
Address: 6399 Townline Road, Byron	Construction Date: ca. 1890	Proposed Eligibility: Not Eligible

Property Name: House USN: Pending Description: This is a circa-1890 gable front dwelling. The house is clad in vinyl siding, stands on a stone foundation, and has a cross gable roof of asphalt shingles. There are modern windows across the house. The façade (east elevation) does not face the road. It has an enclosed, partial width porch lined with windows, and the entrance on the south end. The second level has two widely spaced windows. There is a window in the gable. The southern elevation has two vertically aligned windows on each window, and a window in the gable. There is an exterior concrete block chimney. The western addition is like the southern addition but lacks a chimney. There is a large addition on the northern end.
Address: 6393 Townline Road, Byron	Construction Date: ca. 1955	Proposed Eligibility: Not Eligible

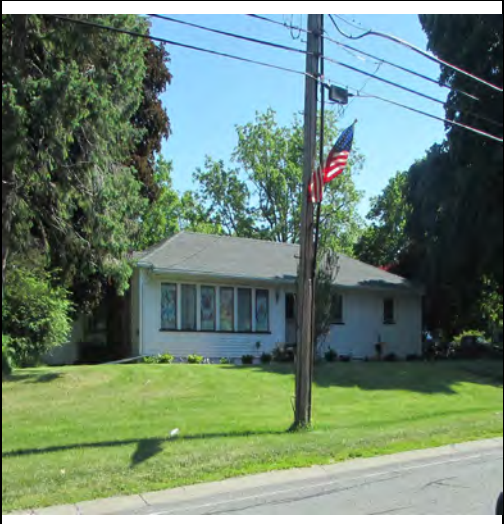
Property Name: House USN: Pending Description: This is a circa-1955, Ranch-style dwelling. The house is clad in vinyl siding and has a hipped roof of asphalt shingles and an exterior end chimney. The façade (south elevation) has a central door. West of the door is a bank of six windows. East of the door are two windows. The east elevation has a single window. There is a large addition on the north elevation. Northeast of the dwelling is a two-bay-wide garage.

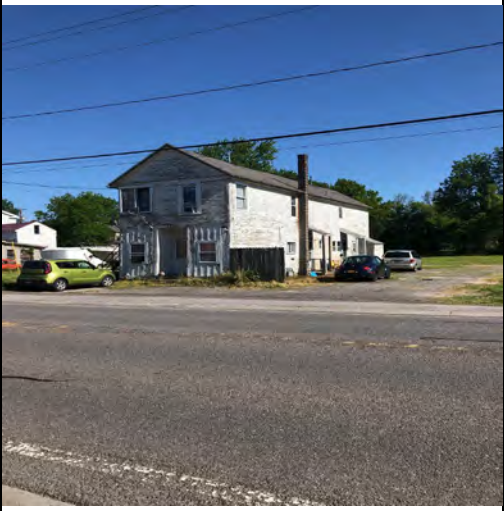
Address: 6331 Townline Road, Byron	Construction Date: ca. 1930	Proposed Eligibility: Not Eligible

Property Name: Apartments USN: Pending Description: This is a circa-1930, wood frame apartment building in poor condition. The two-bay, front gable house is clad in weatherboarding and has an asphalt shingle roof. The façade (south elevation) has a recessed central door, and two single windows flank it. The upper level has a pair of windows and a single window. The west elevation has windows along the first level. A set of metal stairs leads to the second level. Near the front next to the door, there is a row of four windows. More windows pierce the second story elevation. The east elevation has two doors, and numerous windows. There is a small shed addition at the rear. The second level has three windows and there is an exterior concrete block chimney.
Address: 6326 Townline Road , Byron	Construction Date: ca. 1930	Proposed Eligibility: Not Eligible

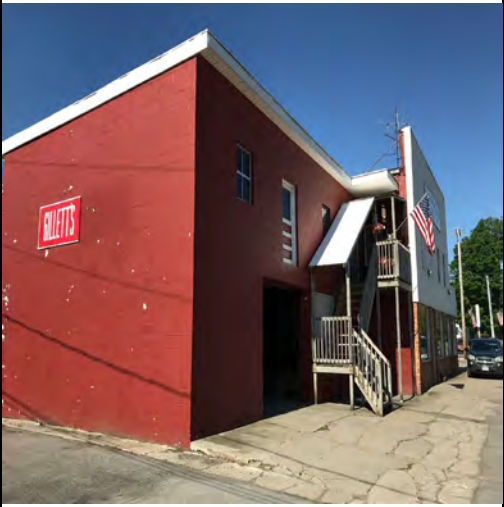
Property Name: Gillett's Hardware USN: Pending Description: This is a circa-1930, commercial building with apartments at the intersection of S.R. 262 and S.R. 237. There is the original core of the building, and east and west of it are concrete block additions used for storage and automotive work. The two-story building has its storefront on the north elevation. The four-bay façade has two entrances: one at the corner and another off-center on the façade. Four large storefront windows display the goods inside. The façade is partially covered with brickwork on the first level, and the second level is vertical metal. There are four windows over the storefront, and a sign reading "Gillett's Hardware". East of the store is a set of stairs leading to a second story porch. There is also a concrete block addition with a single-bay garage door and windows on the second level. The western elevation continues with the storefront for two windows, and then a brick façade leads to a concrete block, three-bay garage. The second level of the store is recessed and is line with windows. The southern elevation has windows into the shop.

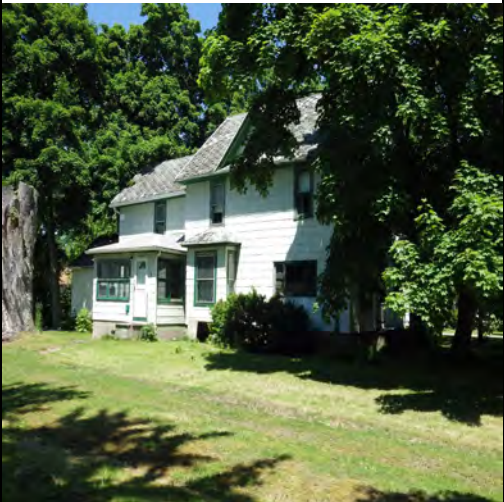
Address: 6856 Pauline Street , Byron	Construction Date: ca. 1880	Proposed Eligibility: Not Eligible

Property Name: House USN: Pending Description: This is a circa-1880, two-and-one-half story, frame, vernacular style dwelling. The three-bay house is clad in asbestos siding and sits on a stone foundation. It has modern one-over-one windows and an asphalt shingle roof. The façade (east elevation) has a central door with cement steps leading to it. Single windows flank the door. The second level has two windows vertically aligned with those below. The enclosed gable has a single window in it. The south elevation has windows near the front, and a three-side bay with windows on all sides. The second level of the core has two widely spaced windows, and a dormer. The south elevation of the addition has an enclosed porch with an entrance into the house. There is a window on the second level. The north elevation has a concrete block chimney near the front, and two windows on both levels with a central gable. There is a two-story addition on the west elevation. There is a circa-1900 barn/garage southwest of the dwelling. Over the barn doors on the east elevation, there is a hayloft door, and a dormer with a window with decorative trim. The barn’s roof is asphalt shingles. The north gable end of the barn has a sliding barn door that opens into an overgrown pen and a four-light window in the gable.

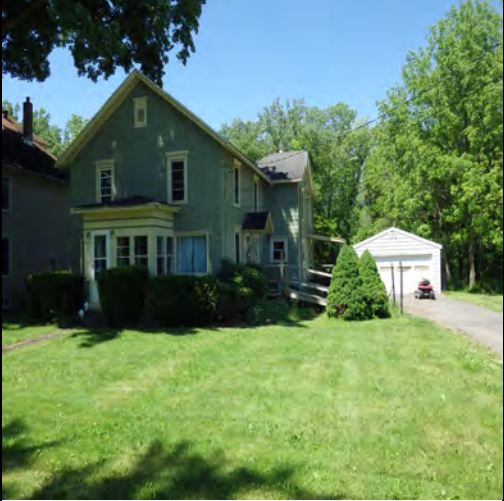
Address: 6836 Terry Street , Byron	Construction Date: ca. 1890	Proposed Eligibility: Not Eligible

Property Name: House USN: Pending Description: This is a circa-1890, two-and-one-half story, front gable vernacular dwelling. The house has been clad in siding, has modern two-over-two windows, and an asphalt roof. The façade (east elevation) has a central, enclosed porch lined with windows leading to the entrance. This is flanked by two large picture windows. The second level has two evenly spaced windows topped with lintels, and an attic vent. The north elevation has another entrance that it topped with a pediment with a wooden ramp leading to it. Single windows flank the entrance. Above each window is another window on the second level. There is a large, two-story rear addition with a cross gable roof and another entrance on the north elevation. This addition appears to be historic. The south elevation has four evenly spaced windows along the core of the dwelling. The rear was not visible. There is a circa 2006 two-bay garage northwest of the building.

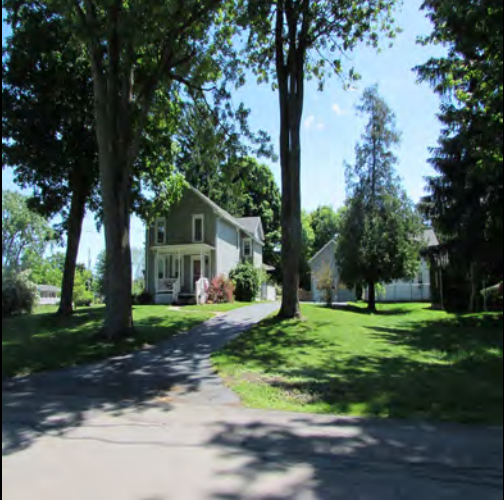
Address: 6833 Terry Street, Byron	Construction Date: 1890-1919	Proposed Eligibility: Not Eligible

Property Name: House USN: Pending Description: This is a circa-1900 two-and-one-half story, two-bay vernacular dwelling within some Queen Anne influence. The front gable dwelling is clad in vinyl siding, has an asphalt shingle roof and rests on a concrete foundation. The dwelling has modern windows throughout. The façade (west elevation) is fronted by a partial-width porch with spindle work at the roofline. Turned posts support the roof, and an open rail balustrade encloses it. Lattice surrounds the bottom, and off-center stairs lead to the door at the southwestern corner. North of the door are two single windows. The second level has two windows as well. The north elevation has an exterior concrete block chimney and a bulkhead. There are three windows on the first level and three on the second. There is a small single-story shed addition at the northeastern corner. The southern elevation is plain, with few windows. There is a two-story bay topped with a dormer with a circular window in it. There are windows on each elevation of the bay. There is also a single bay garage southeast of the dwelling.

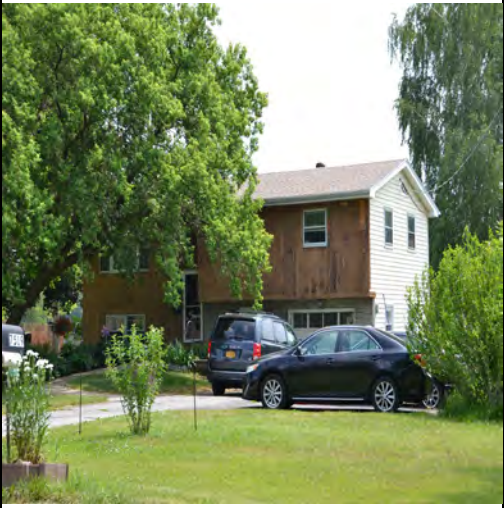
Property Name: House USN: Pending Description: This is a circa 1965 split-level dwelling. The house is clad in a mix of vertical wood vinyl siding. The side gable roof is asphalt shingles. The three-bay façade (east elevation) has a central door between the levels of home. The first level has a one-bay garage and a single window south of the door, and a pair of windows north of the door. The upper level has a large picture window and a single window. The southern elevation has two windows on each level.

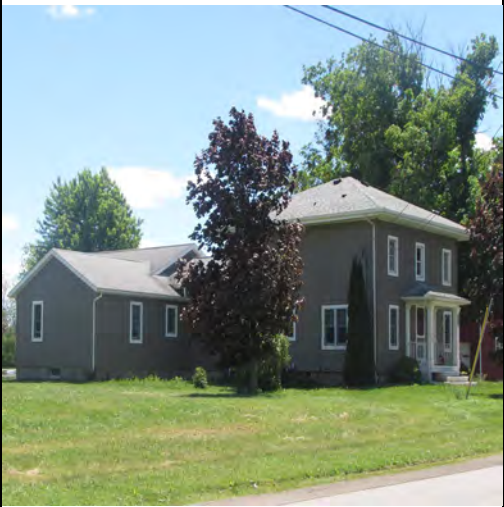
Address: 7617 West Bergen Road, Bergen	Construction Date: ca. 1870	Proposed Eligibility: Not Eligible

<p>Property Name: Farm</p> <p>USN: Pending</p> <p>Description: This is a circa 1870, Italianate style dwelling and barn. The dwelling has many modern alterations that detract from its historic integrity. The house is clad in vinyl siding and has modern windows. The rear of the house has multiple additions that sprawl outward in different directions. The hipped roof is asphalt shingles, and the building rests on a cut-stone foundation. The three-bay façade (western elevation) has a partial width porch shielding the door. The porch has a hipped roof supported by squared Tuscan columns. An open-rail balustrade is on the sides of the porch and single windows flank the porch. The second level has three evenly spaced windows that vertically align with the windows and door on the first level. The northern elevation has a pair of windows near the front and two single windows on the first level. The second level has a single window on the second level. The eastern elevation has a small one-level addition, and from that there are two other additions emerging. One extends northward and another eastward. Southeast of the dwelling are two barns. The large, circa 1880 ground barn is closest to the house. It is clad in vertical weatherboard siding and has a metal gambrel roof. The western elevation has large sliding doors that open into a pen. There is also a small, four-light window. The northern elevation has a modern garage door and a smaller, person-sized door. There are shed additions on the southern and eastern sides, and there is a concrete block milk house at the southern end. Southwest of this barn is a smaller, circa 1900 stable barn. The one-and-one-half story barn sits close to the road, and the eastern elevation opens into a fenced-in area.</p>

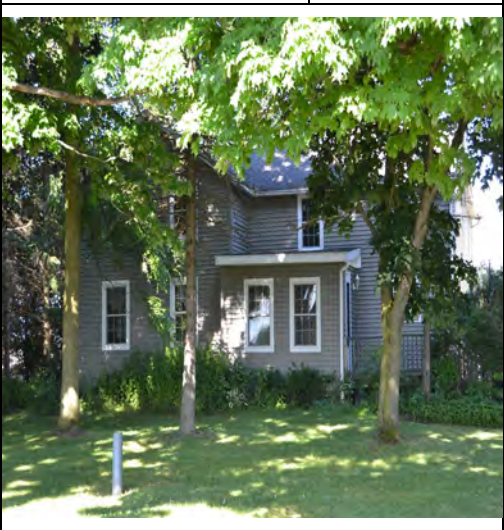
Address: 7898 Waterman Road, Stafford	Construction Date: ca. 1850	Proposed Eligibility: Not Eligible

Property Name: Farm USN: Pending Description: This is a farm property containing a circa-1850 house, a complex of attached frame barns, and one silo. The two-story house features a cross-gable roof covered with asphalt shingles, vinyl siding, and an enclosed front porch. Windows are vinyl 6/6 replacement sashes. A two-story rear addition is present. The barns date to circa 1900 and include a frame gambrel-roof barn with shed extension, connected to a gable-roof barn. A concrete stave silo is also extant. The house and barns lack architectural features and details representative of a particular architectural style.
Address: 6262 West Main Street, Byron	Construction Date: ca. 1823	Proposed Eligibility: Not Eligible

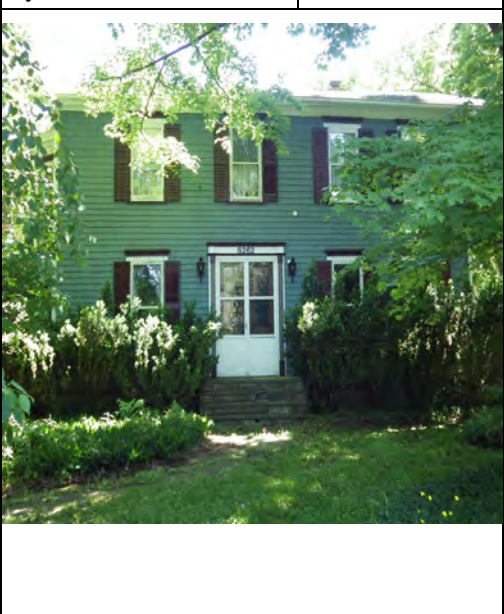
Property Name: Chapman Farm USN: Pending Description: This resource is a circa-1823, two-story, Federal-style dwelling. The four-bay-wide house has a side gable roof of asphalt shingles. The house is clad in weatherboarding. Windows are modern one-over-one, have shutters, each topped with a hood with dentils. The façade (north elevation) has an off center, double door entrance that is fronted by storm doors. Decorative pilasters flank the door, which is topped with decorative dentils. Electric lights are on either side of the door. East of the entrance are two windows; to the north is a single window. The second level has four evenly spaced windows in vertical alignment with those below. The fenestration consists of 1/1, double-hung, wood sash windows with storm windows. The eastern elevation has single, vertically aligned windows on each level. The rear of this dwelling has a massive addition that was not visible during this survey. There is also a two-story, wood-frame barn that is clad in squared shingles, a wood-frame garage, and another outbuilding.
